PHASE 2 ENVIRONMENTAL INVESTIGATION
of a site at
CORNER OF GRAFTON ROAD AND BARRINGTON
COURT, CAMDEN
for
DIDIER RYAN

Project No 2697
Report ref: 2697-P2E-1-B
Issued: 6 November 2024
Revision: B

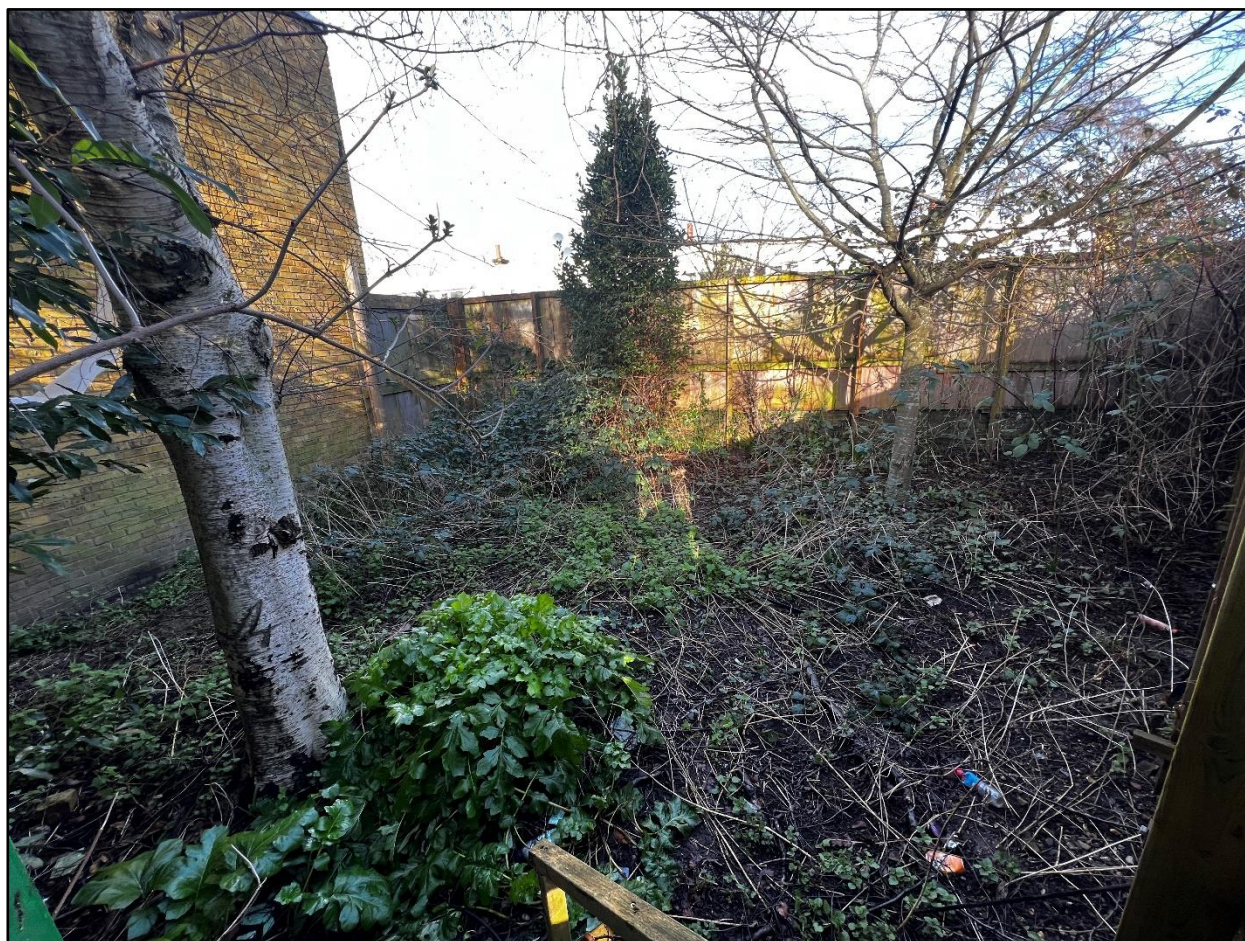
Photograph 1: View of the site from the entrance on Grafton Road

A manhole cover was located in the northeast corner of the site during the site visit.

During the site visit it was observed that the site levels are lower by approximately 750mm than the street level. Timber steps lead from the street level down to the site.

Some domestic waste was noted to be scattered around the site.

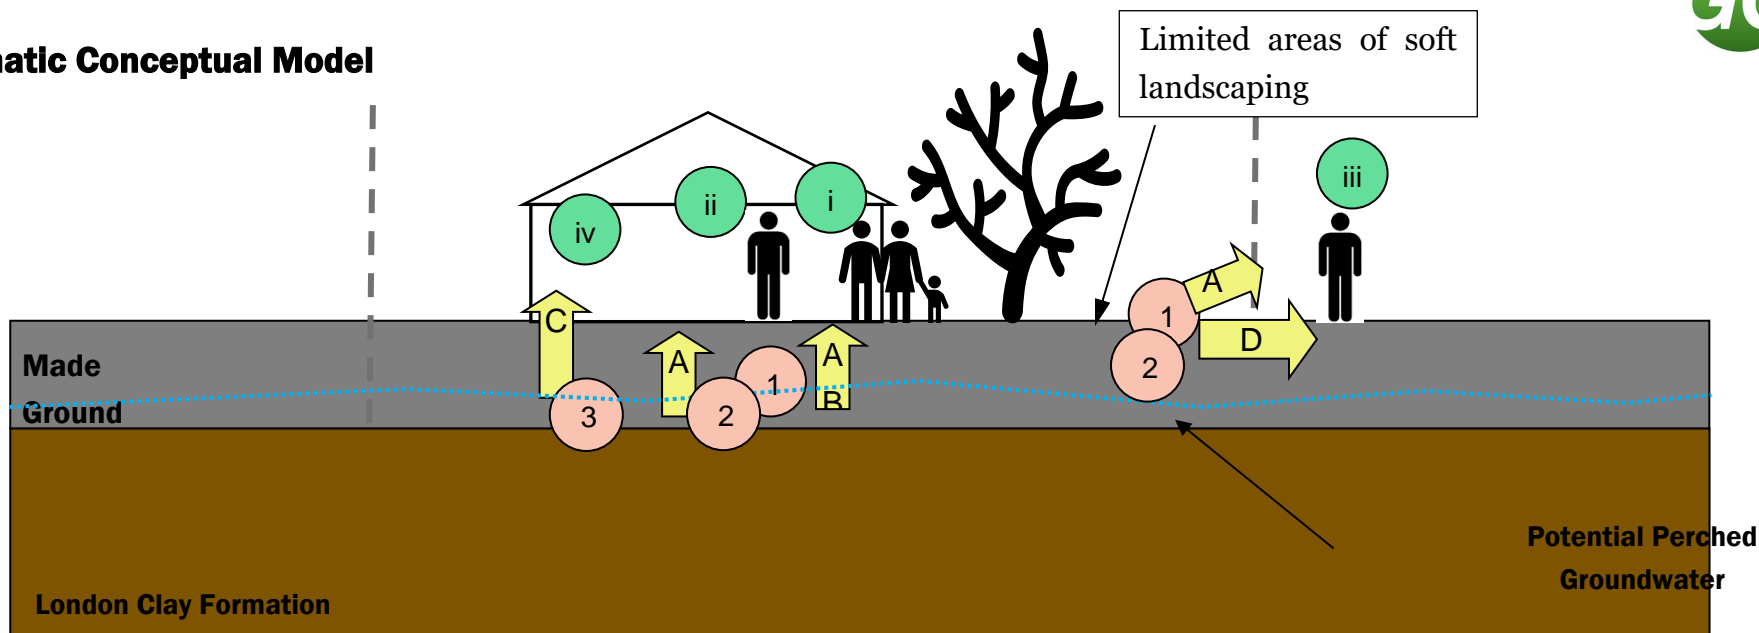
Schematic Conceptual Model

Sources	Pathways	Receptors
1 Brick works, allotment garden (On Site)	A Inhalation, ingestion, dermal contact, vapours	i Site Users
2 Imported hardcore below ground slabs & demolition debris (asbestos)	B Drinking contaminated water supply	ii Ground Workers
3 Naturally occurring contaminants	C Direct contact of soil with building materials	iii Neighbours
	D Surface water run-off	iv Proposed Building

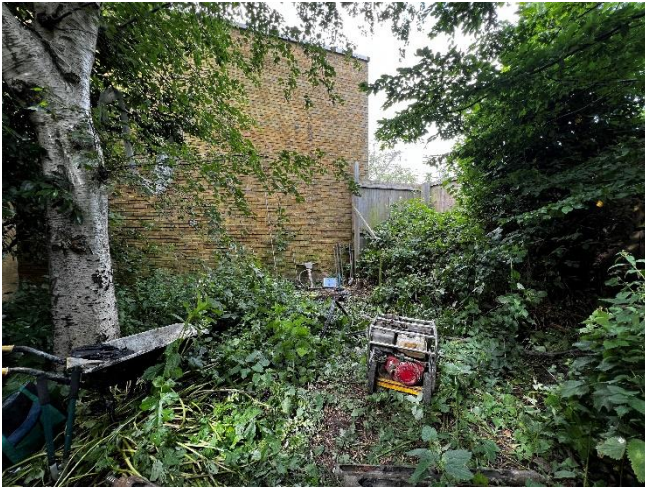
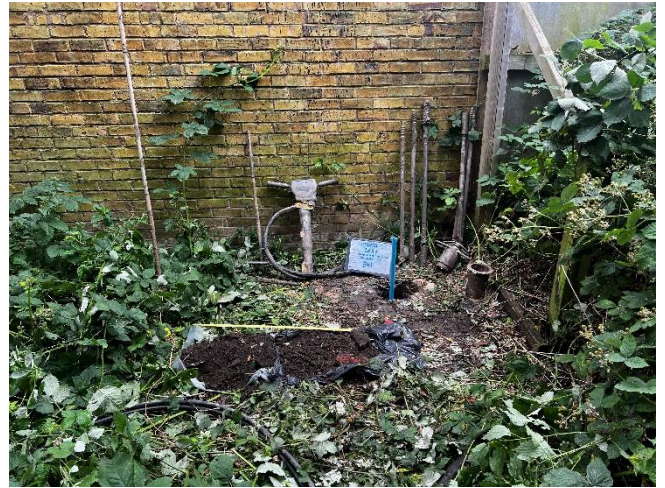
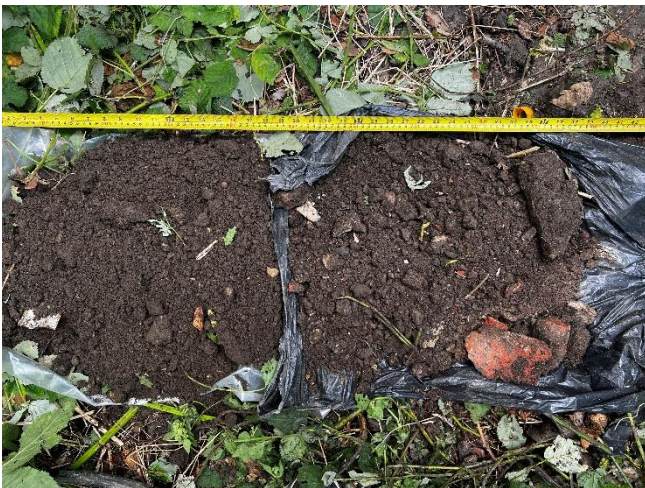
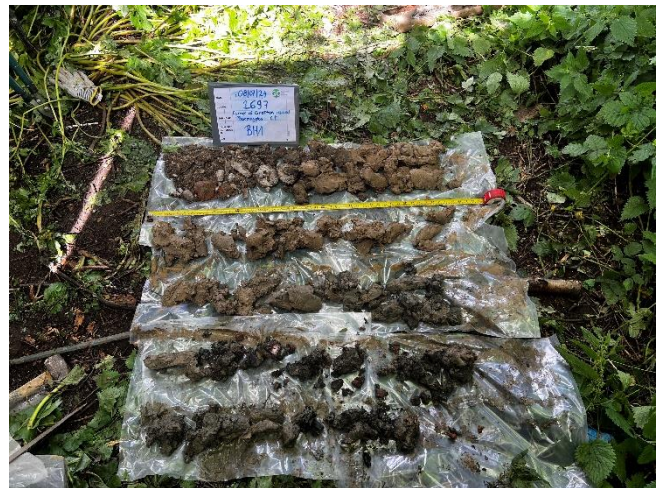
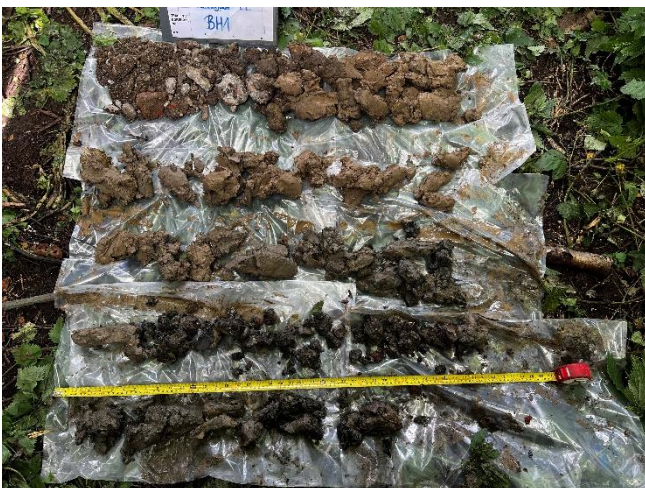
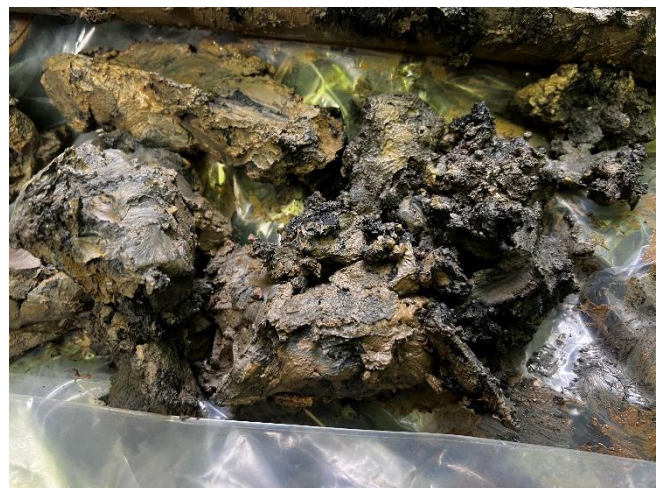
BH1

Remarks: Groundwater noted from 1.5mbgl. Decaying timber at 3.80 to 4.0m bgl with slight organic smell. BH drilled to 6mbgl, no sample recovered due to water ingress.

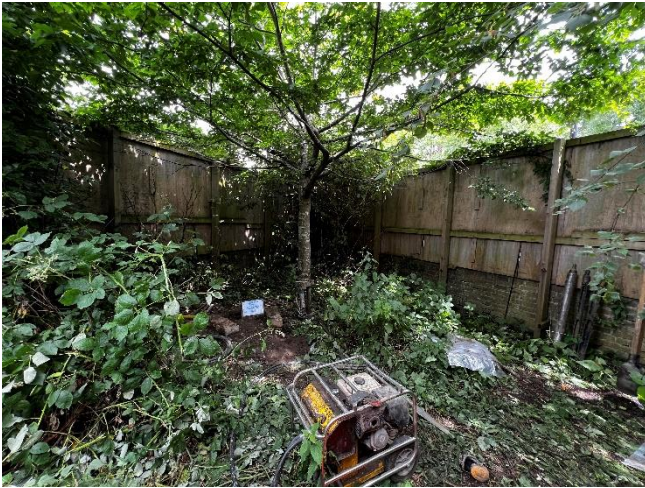
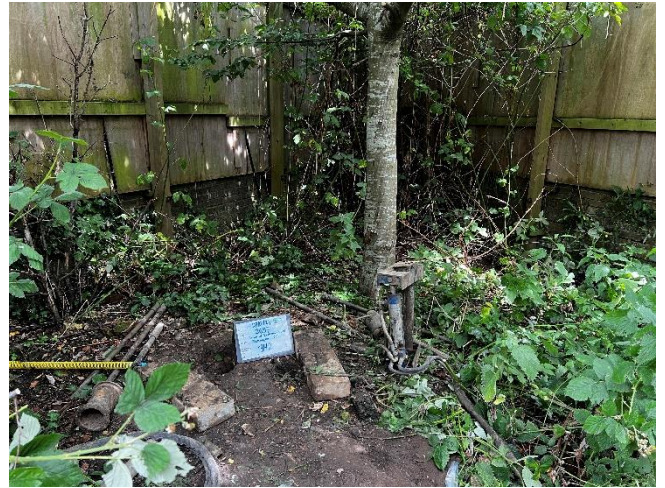
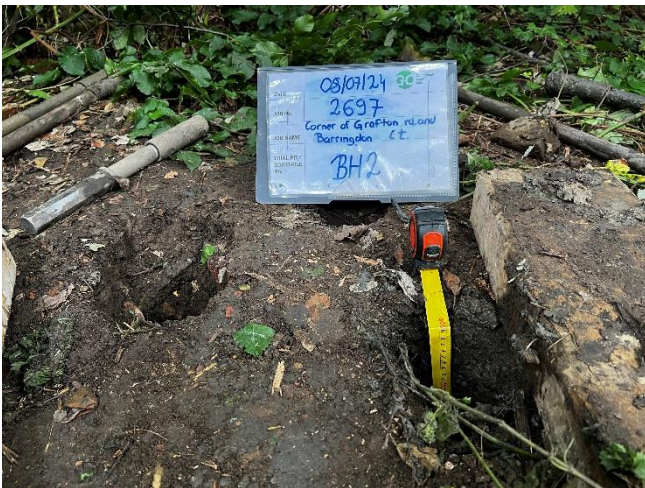
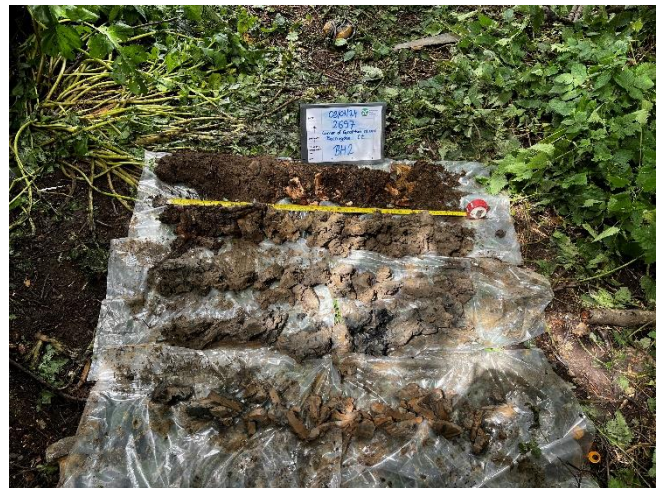
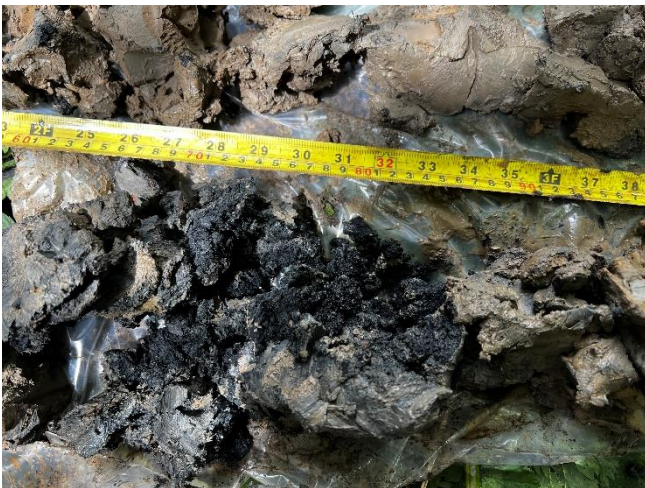
BH2

Water strike
 Remarks: Groundwater noted from 1.0mbgl. Decaying timber at 3.55 to 3.70 with slight organic smell.
 Key: C - Contamination sample W - Water sample P - PID test

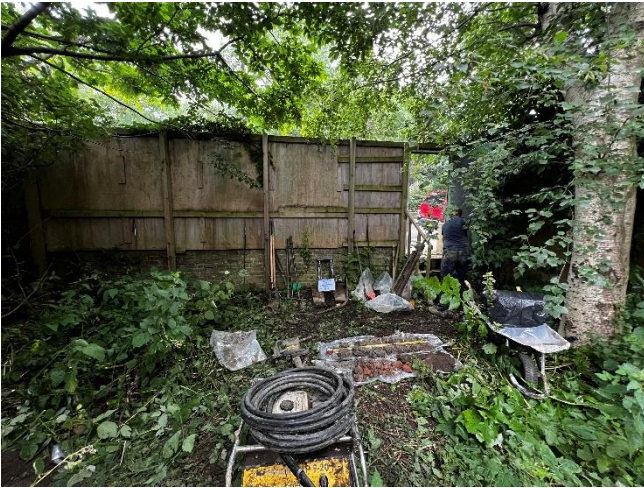
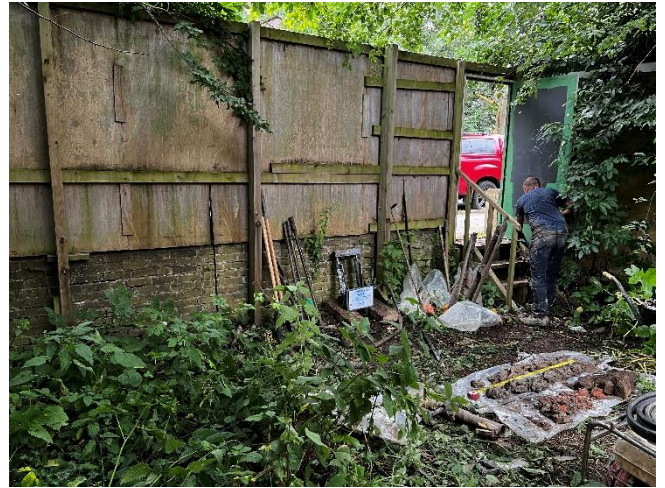
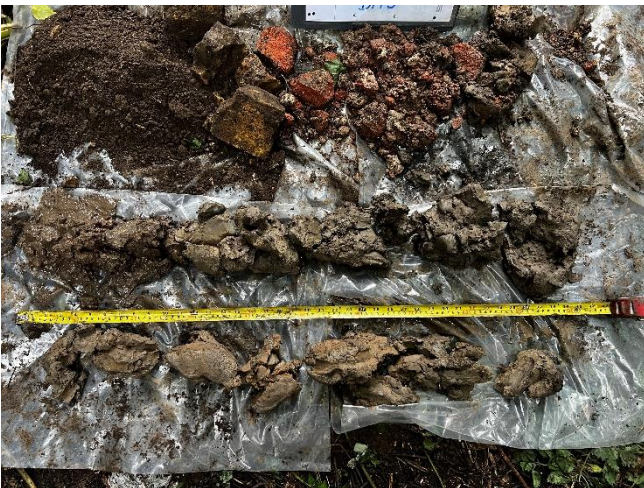
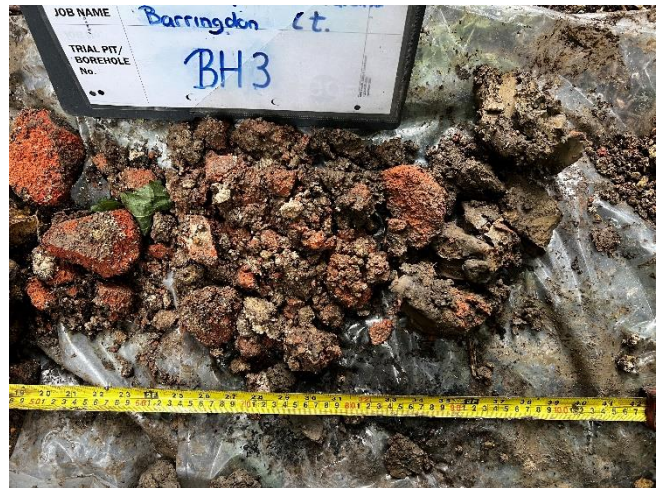
BH3

Remarks: Groundwater not noted at 1m bgl. No visual or olfactory evidence of contamination noted.
