PD1 24.01.25 Discharge of Planning Conditions

PROJECT
31 South Hill Park

TITLE
Dismantle_Second Floor Bedroom Elevations

DRAWING NUMBER 70001	REV PD1
-------------------------	------------

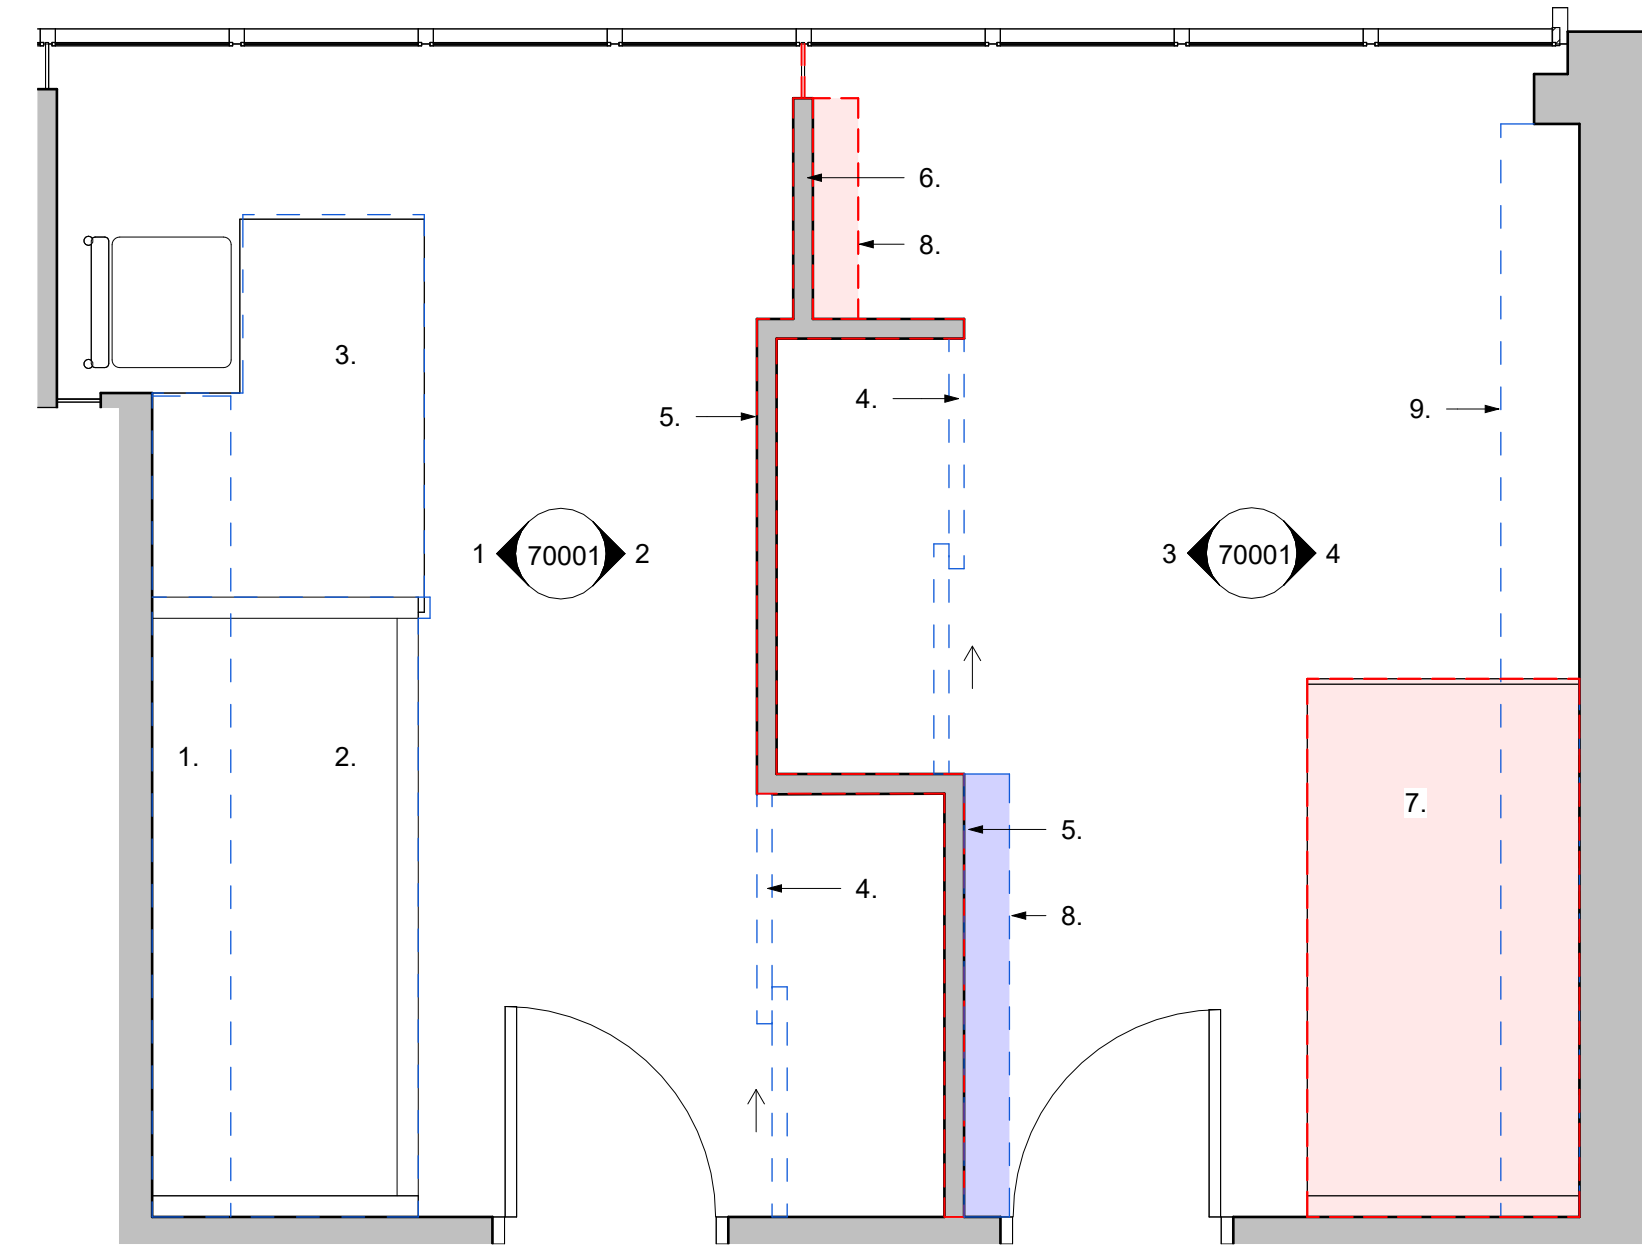
Existing/Demolition Bedroom Plan
1:25

1. Existing bespoke wall mounted shelving to be removed from wall and relocated at Lower Ground Floor level.
2. Existing fitted bed to be removed and relocated at Lower Ground Floor level.
3. Existing desk to be adjusted to fit new location.
4. Wardrobe sliding doors to be carefully removed, refurbished for re-use.
5. Existing partition wall to be removed. Ensure the recessed plasterboard shadow gap between wall and ceiling is retained. Feature to be retained as a visual record of the previous wall layout to the room and to record accurate location to allow any future reinstatement of the original room layout.
6. Non original section of partition wall to be removed.
7. One of the fitted beds to be removed.
8. Non original MDF shelving to be carefully removed and relocated to lower ground floor main room. Client to confirm final location
9. Shelf relocated in higher position

Red line indicates items to be removed.

Blue line indicates items to be carefully removed and reused.

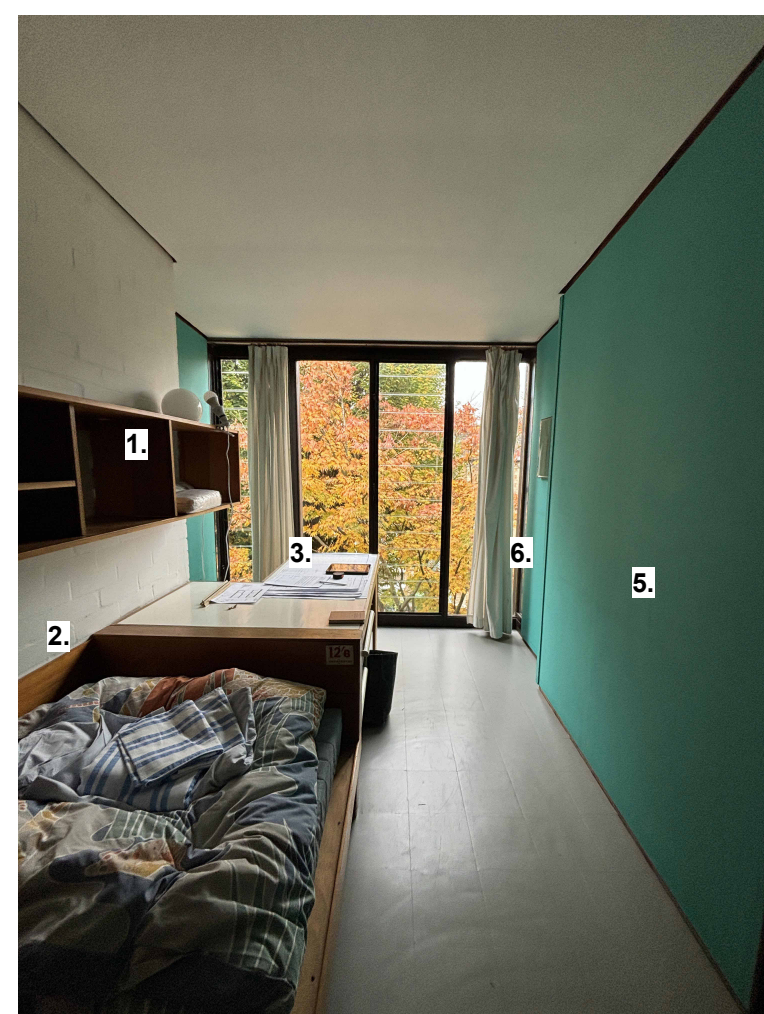
View 1 - Looking into Bedroom A
Items 1, 2, & 3 (left). Items 5 & 6 (right).

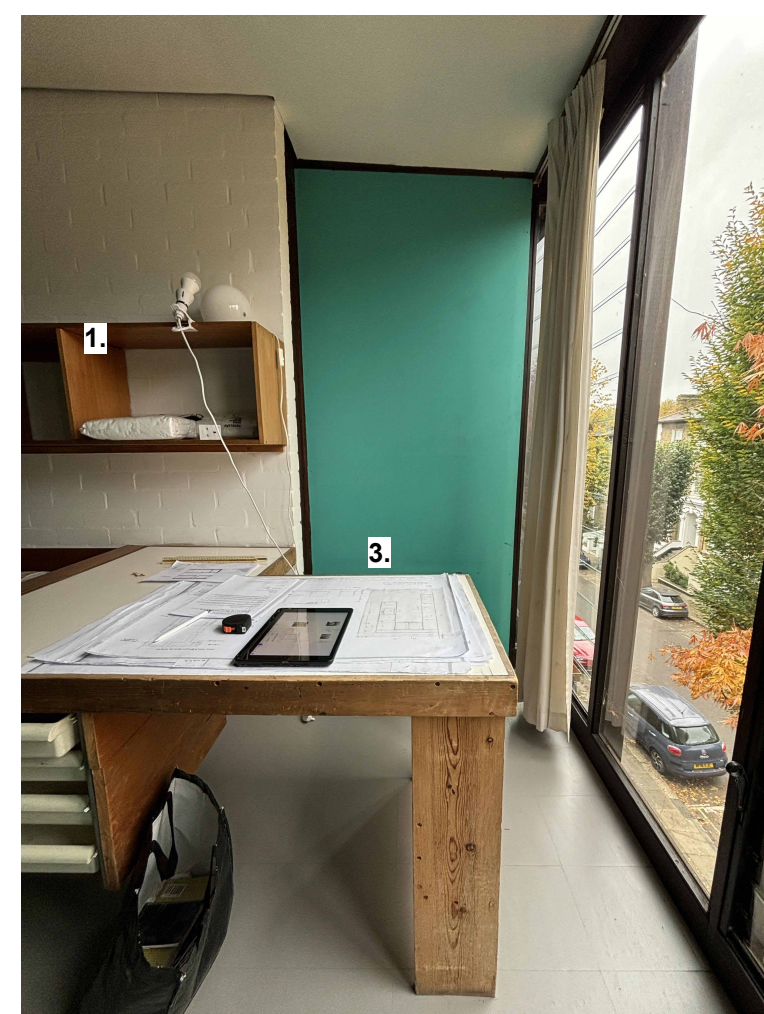
View 2 - Looking at the desk in Bedroom A
Item 3 shown in closer detail.

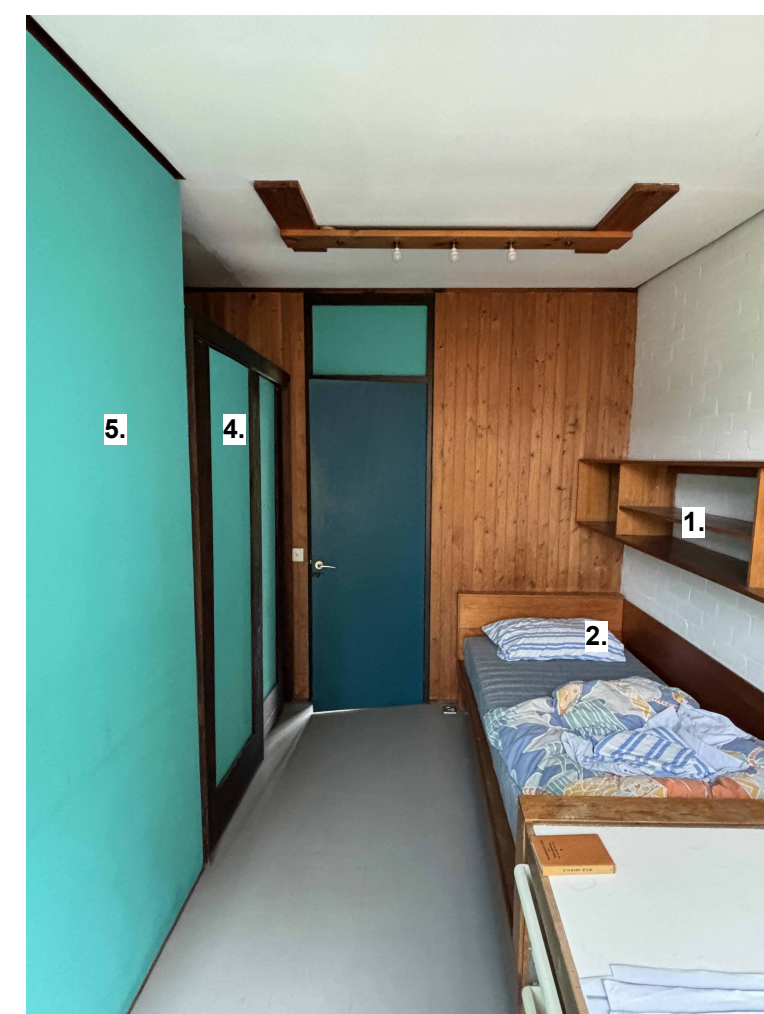
View 3 - Looking at Bedroom A from window.
Items 1, 2, & 3 (right). Items 4 & 5 (left).

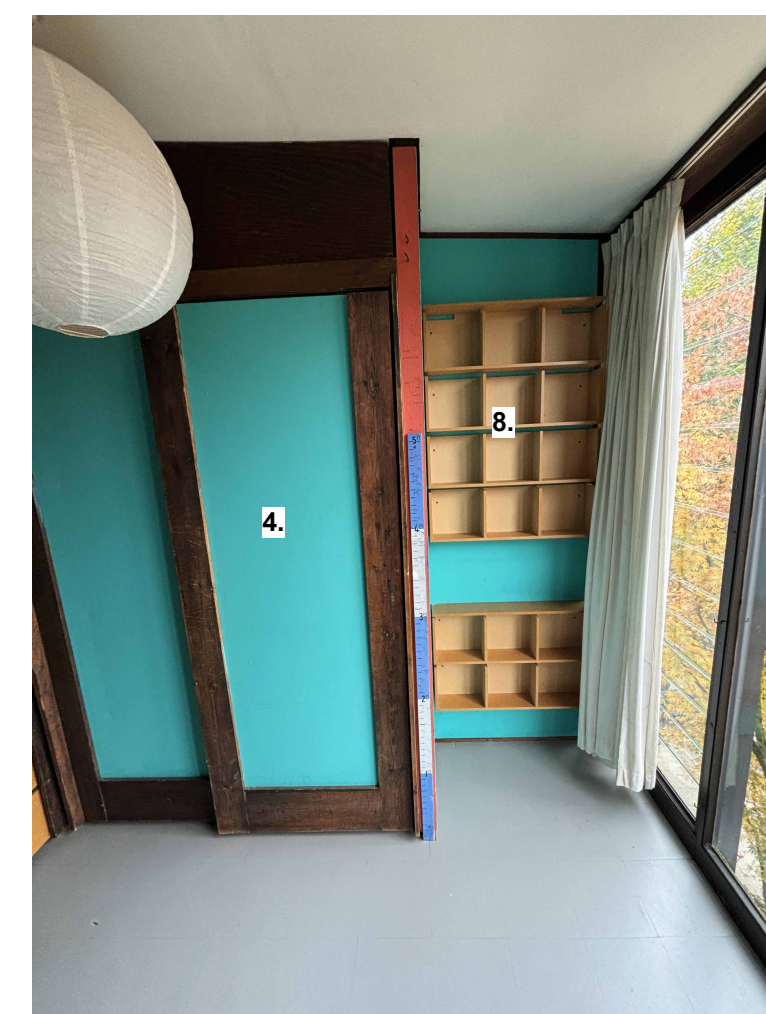
View 4 - Looking at joinery in Bedroom B.
Items 4, 6, 8 (From left to right)

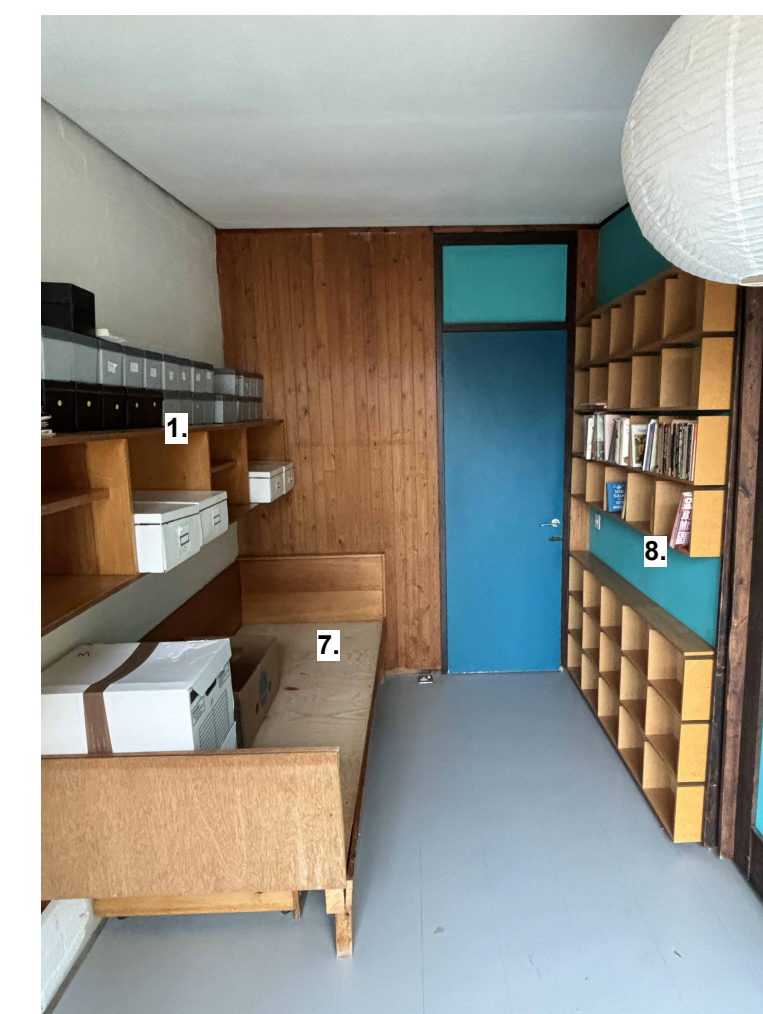
View 5 - Looking Bedroom B from window
Items 1 & 7 (left). Items 5 & 8 (right).
