TENDER

31 South Hill Park

Roof Details

PD1 24.01.25 Discharge of Planning Conditions

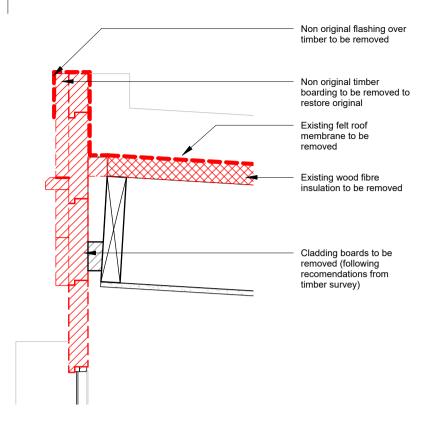
1-10 Demolition Front Roof Junction Detail

Non original flashing shown above

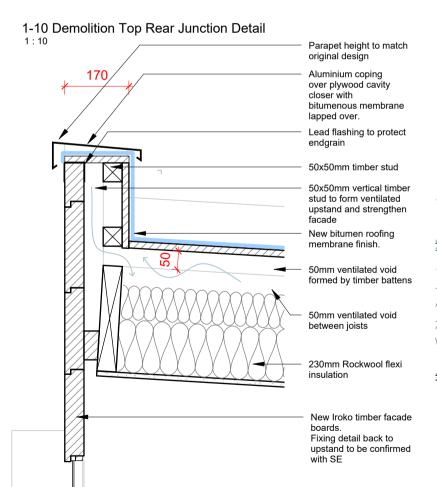
1-10 Proposed Top Rear Junction Detail

50mm ventilated void formed by timber battens

Timber stud and plywood

RWP rerouted to fall in

Existing ceiling retained
