Arboricultural Appraisal Report

Impact Assessment & Method Statement to Inform Development

3 Crediton Hill
London
NW6 1HT

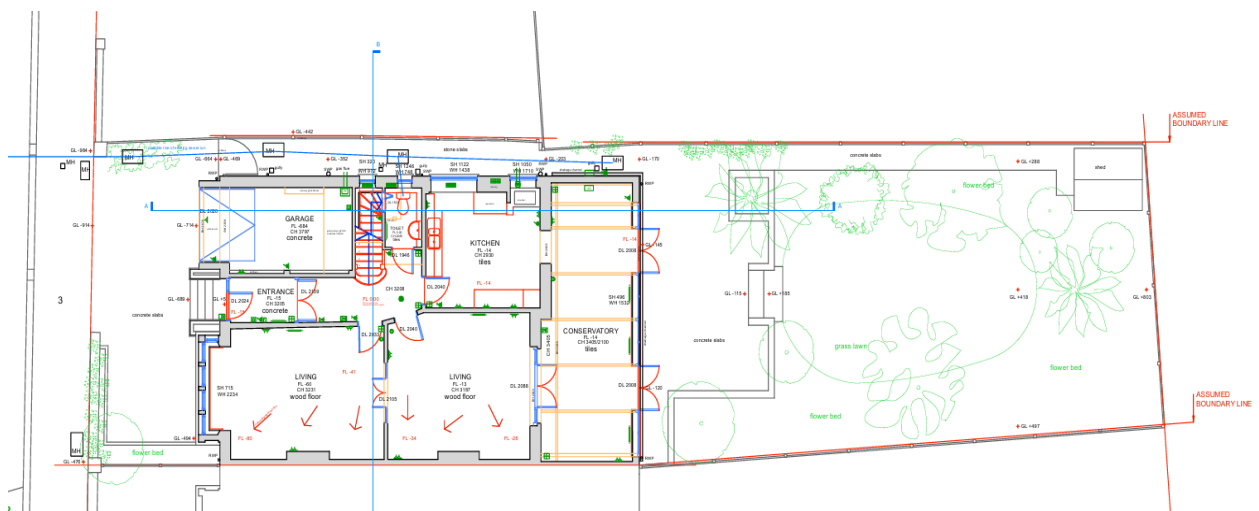
6.2 Figure 1: Existing Situation

- 6.3 Most of the recorded trees and shrubs grow within beds and brick-built planters around the rear patio and lawn.
- 6.4 Horse chestnut T1 is located just beyond the rear right-hand corner of the rear garden, with a further off-site pear tree (T2) located just beyond the rear boundary. Off-site lime T11 is located beyond the site's southern boundary, while olive T13 is within the front garden of neighbouring No 5, Crediton Hill.

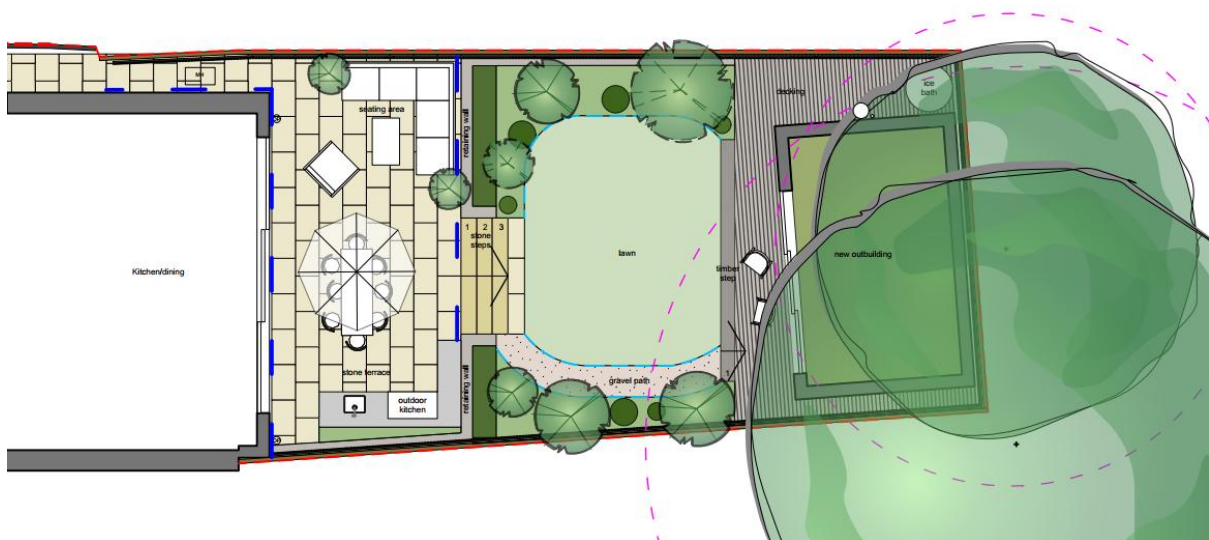
7.2 Figure 2: Proposed Situation

7.1 The proposed development is to construct a single storey outbuilding at the western end of the rear garden, extension of patio to rear of house and revised landscaping in rear garden. The building will house a gym.

8.8 The footprint of the proposed outbuilding sits within the RPAs of T1 and T2. Conventional foundation construction is likely to result in significant root loss. However, a suspended raft foundation will be constructed, supported by 15 helical steel screw piles, as detailed by Walder Sharp Consulting Structural Engineers, Drawing Ref. 0410 P.01, of September 2024. This will result in minimal root disruption to retained trees T1 and T2.

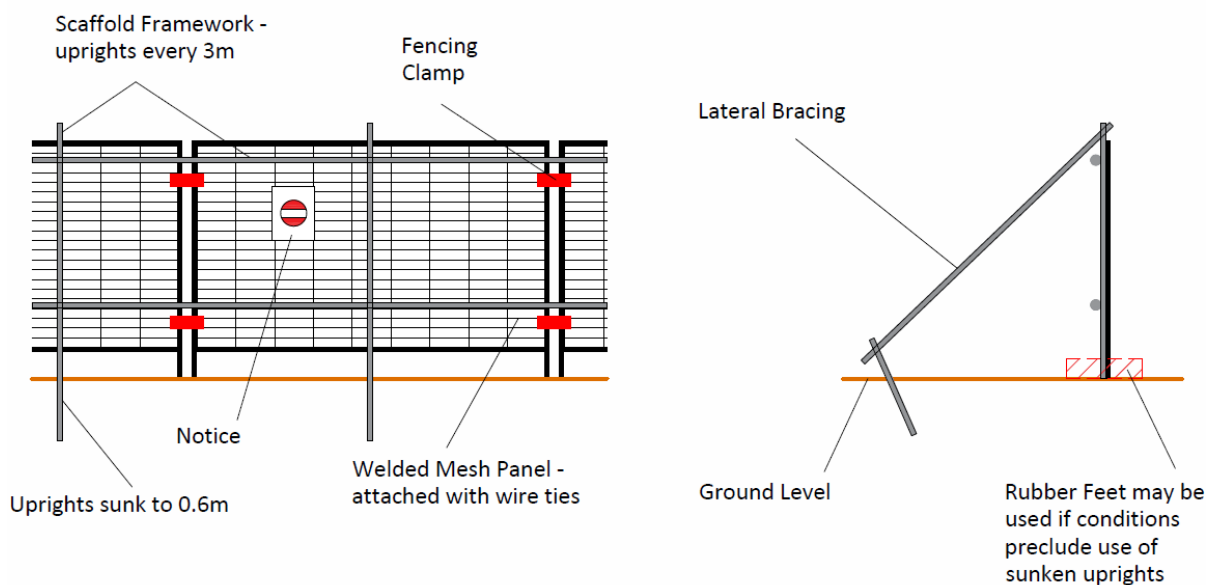
Figure 3: Fencing Specification

9.9 The current proposal requires no protective fencing following tree and shrub removal and the installation of temporary ground protection. However, a fencing specification is provided below in the event that alterations to the proposal allow further tree retention.

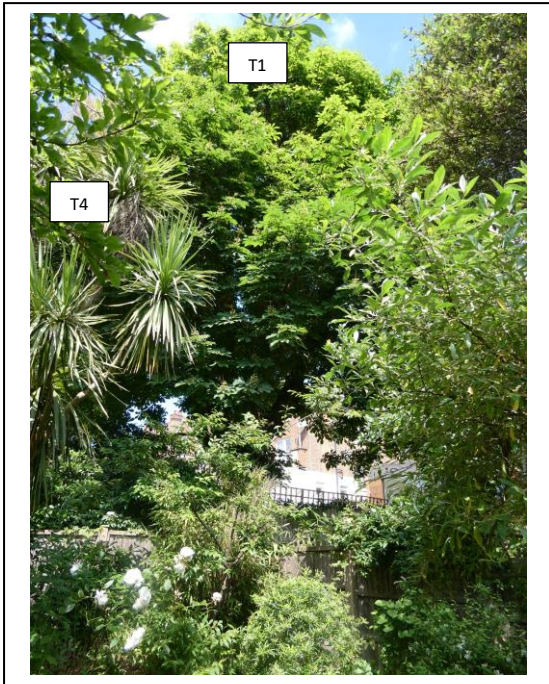
View of T1 beyond the rear and righthand boundary.

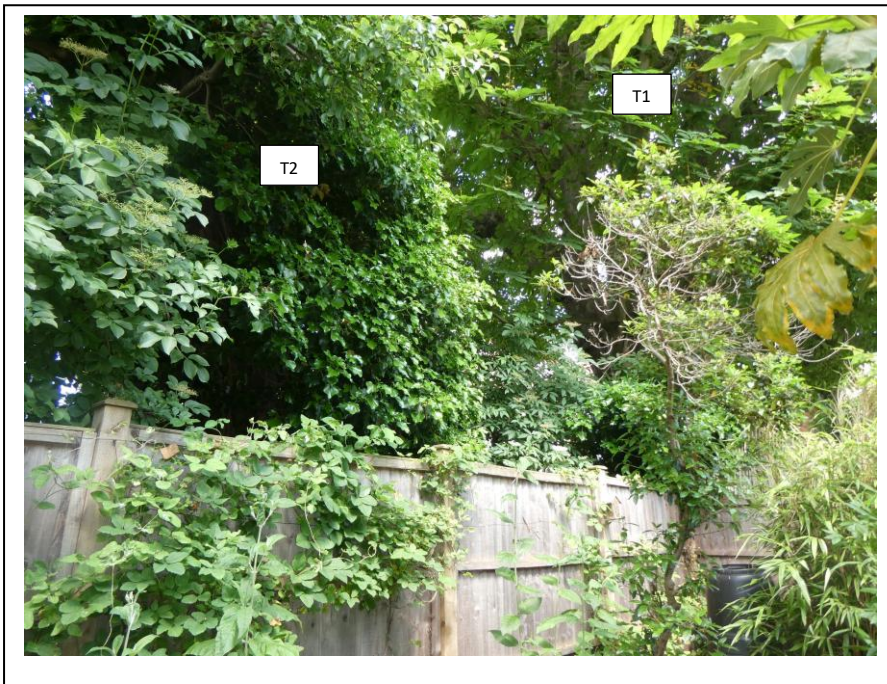
View of T1 and T2 beyond the rear boundary.
