# Arboricultural Impact Assessment Queens Crescent, Camden, London

Report Reference Number: 250124-1.1-QCCL-AIA-JBW

Queens Crescent, Camden, London, NW5 4EG

Report Title: Arboricultural Impact Assessment

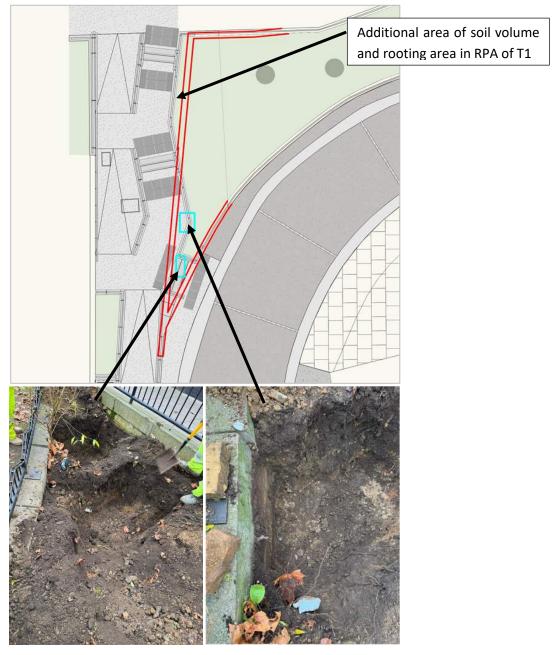
Image 1: Location of trail pits as denoted by cyan coloured boxes; alignment of existing boundary wall denoted in red.

Given the level of new incursions and the extent of existing incursions from hard surfacing and retaining walls within the RPAs of these trees, several exploratory trial pit excavations were undertaken by hand to a depth of 800cm below existing ground levels within the area of new incursion to understand the level of rooting activity within these areas. The position of these trial pits is denoted by the cyan-coloured boxes in Image 1. After careful hand excavation, no roots from T1 and T2 were found, with only minor fibrous roots from the existing vegetation and shrubs within the raised planting bed. Therefore, the level of impact on T1 and T2 is negligible and should not be considered a constraint. The soil volume of T1 will also be increased by 2% due to the re-alignment of the existing boundary wall and thus will offset the loss of new incursion in the long term in terms of lost soil volume.

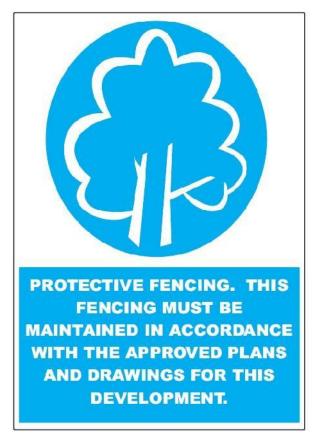
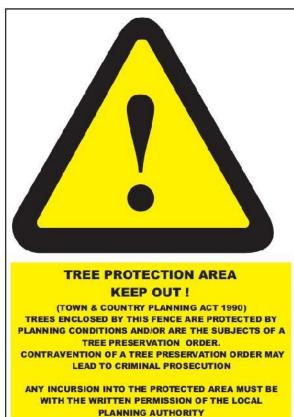
**Example Tree Protection Fencing Sign**

All protection fencing should carry identifying signs that state its purpose and proscribe its removal until all demolition and construction work is complete. An example sign is given at Appendix D.

- The CEZ will be clearly identified (see Construction Exclusion Zone sign example below)

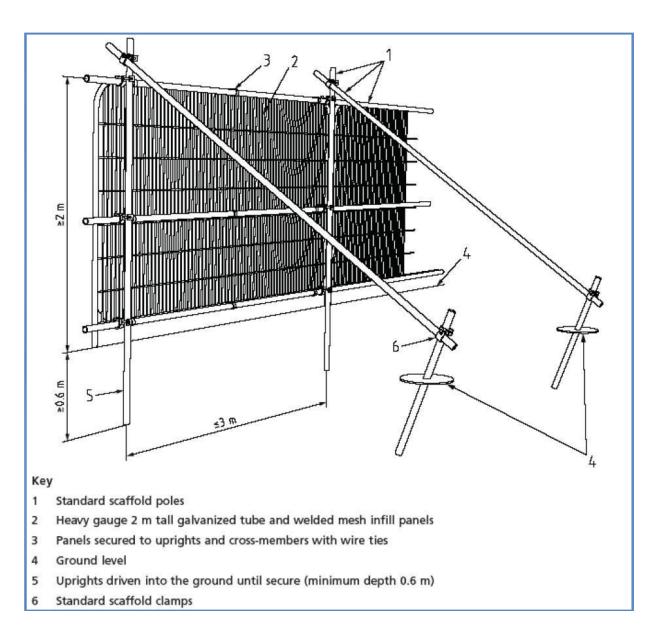
BS5837: 2012 - Figure 2 - Tree Protective Barrier

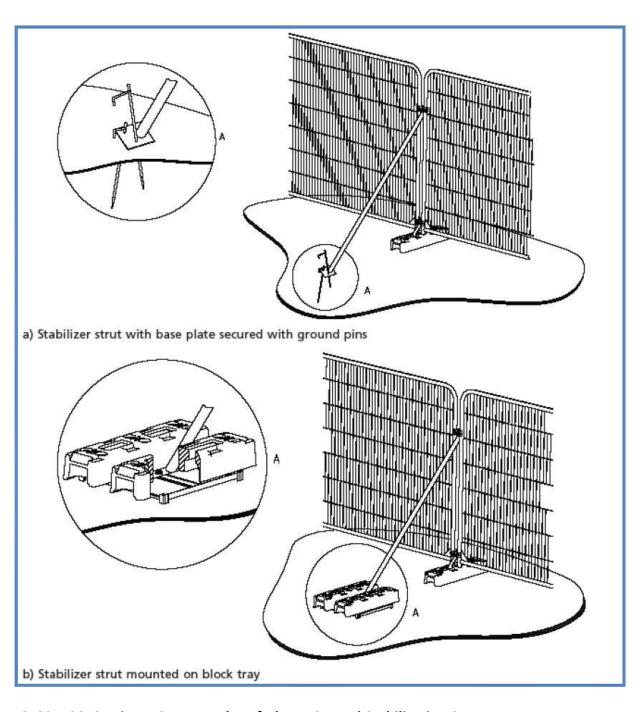
BS5837: 2012 - Figure 3 — Examples of Above Ground Stabilisation Systems

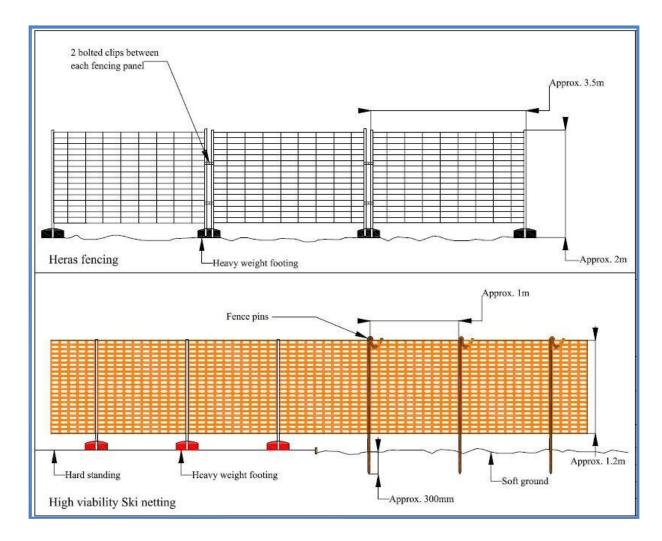
Examples of specification fencing that may be appropriate for areas of low-intensity activity

The type of barriers should match the level of activity around the retained trees. Where a high level of construction activity is expected, fencing must be braced to be robust to vehicular impact and to prevent it from being easily repositioned; a specification similar to drawing 3 in BS 5837:2012 will be suitable (reproduced at Appendix D). In areas away from the main construction activity and vehicle movement, it may be appropriate to install a lower-specification fencing, examples of which are given at Appendix D.
