Project number 11464:00 Document reference
CHALF-RYD-YY-RP-A-XXX.P1\_Planning Pre
Commencement Condition 11 Part B

## Pre Commencement Condition 11: Protection, Relocation and Restoration of Cattle Trough

Proposal for the Clean, Repair, and Relocation of the Granite Cattle Trough OM-E3289-002

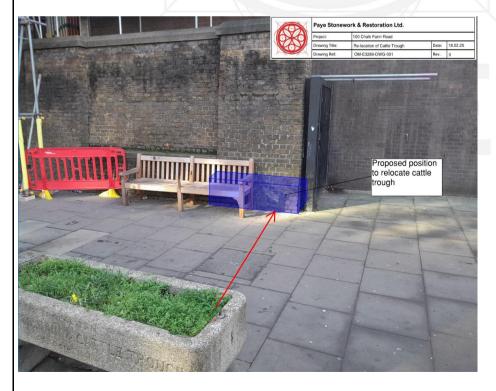
In order to relocate the cattle trough, the planters within the trough must be removed by others. Once this is complete, we can begin the relocation. So long as there is adequate space on site, we propose using a counterbalanced floor crane to lift the basin to the proposed this can be seen below. We anticipate the basin to weigh approximately 600kg, so a 1 tonne counterbalanced floor crane will be required. crane will lift the basin from fixing points/be strapped around the basin and carefully lifted from its current position, to the side. At this stage, we assume that the plinths are not fixed into the pavement, and can therefore be moved to from the existing position to the new area using traditional manual handling techniques or via the floor crane. This will set the base for the basin. The basin can then be from the area where it is set aside, and carefully lowered onto the plinth stones.

The above drawing indicates an indicative postion for the trough to be located to. The location of the trough is subject to a S278 as defined in the approved landscape drawings. The costs attached on the previous sheet are subject to change depending on the location.
