D Site Investigation and Basement Impact Assessment (GEA)

12 Pilgrims Lane London NW3 1SN

Site Investigation & Basement Impact Assessment Report

J21282 Rev 3

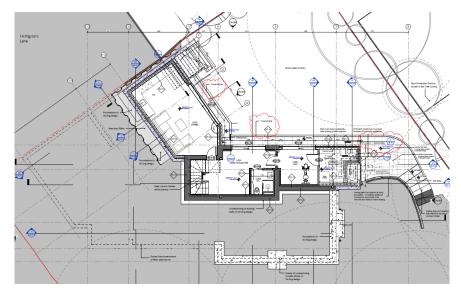
It is understood that it is proposed to extend the existing lower ground floor level, as part of significant alterations to the house. Formation level for the proposed lower ground floor level is understood to be approximately 3.20 m below the existing ground floor level.

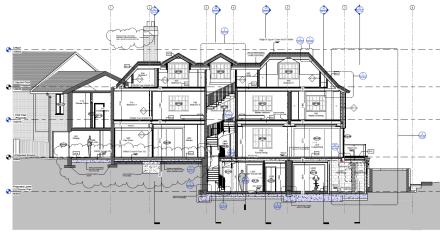
Section AA - Proposed

It is understood that it is proposed to extend the existing lower ground floor level, as part of significant alterations to the house. Formation level for the proposed lower ground floor level is understood to be approximately 3.20 m below the existing ground floor level.

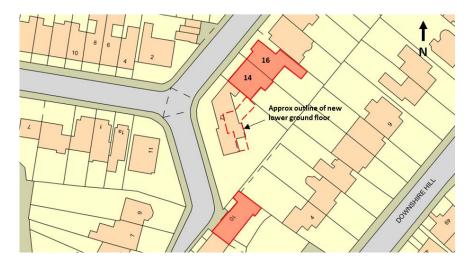
Nearby sensitive structures comprise the adjoining 14 and 16 Pilgrims Lane to the northeast and 10 Pilgrims Lane to the south, as shown on the plan below.

The heights of the buildings have been estimated from observation, and from drawings provided by the consulting engineers. The underside of the foundations of 14 Pilgrims Lane have been determined based on the trial pitting described in the previous section, and the foundations of 16 Pilgrims Lane, which adjoins 14, have been assumed to be the same. The foundations of 10 Pilgrims Lane have been assumed. The heights and underside of foundations are summarised on the table below.

Sensitive structure	Height of building above foundation level (m)	Underside of foundation, depth (m) [m ASD)
14 Pilgrims Lane	3.7 to 6.5	0.70 [99.30]
16 Pilgrims Lane	6.5	0.70 [99.30]
10 Pilgrims Lane	7.1	0.50 [97.10]

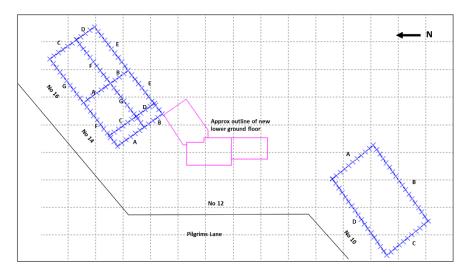
Plan view of neighbouring structures and the labelling of each wall

The sensitive structures outlined previously have been modelled as displacement lines in the analysis along which the damage assessment has been undertaken. The labelling adopted is shown on the diagram below.
