**Project:** 26A Ferncroft Avenue, NW3 7PH

**Subject:** Proposed South-West Elevation

| Project | Disc. Package. Drawing | REV |
|---|---|---|
| 494 | A.G20.E01 | H |

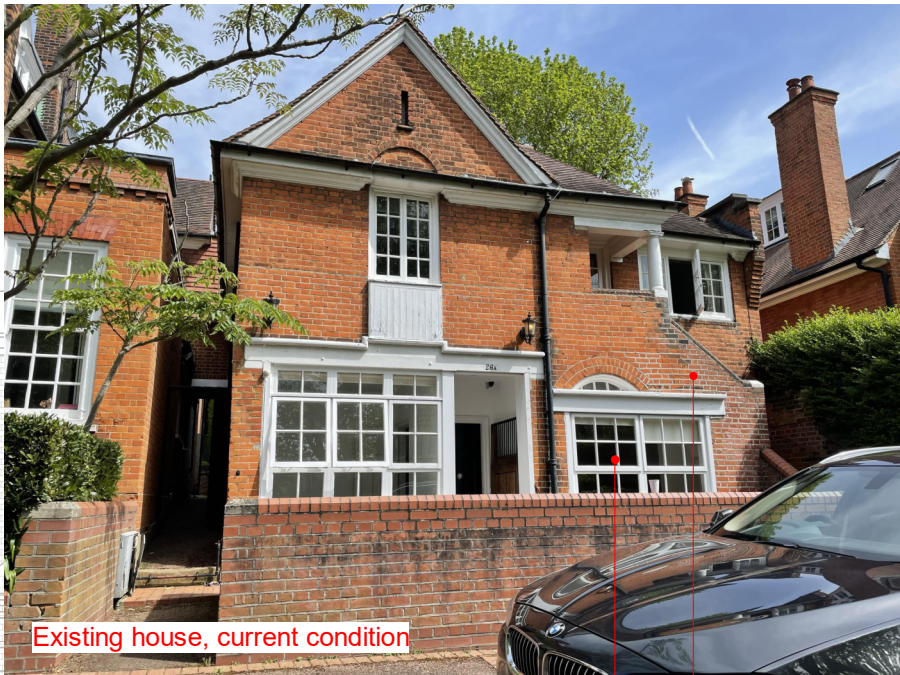
Existing house, current condition

Collapsed brickwork replaced with poor quality bricks of dimensions that differed from original brickwork, resulting in different width mortar joints. This will all be reinstated with original matching bricks taken from the rear, and repointed in lime mortar.
