The Slade School of Fine Art
Gower St London WC1E 6BT
External Repairs

Gutter Detail 2
Bottom of gutter outside Theatre Office
As Existing

4682-FBR-A1-XX-DR-A-157

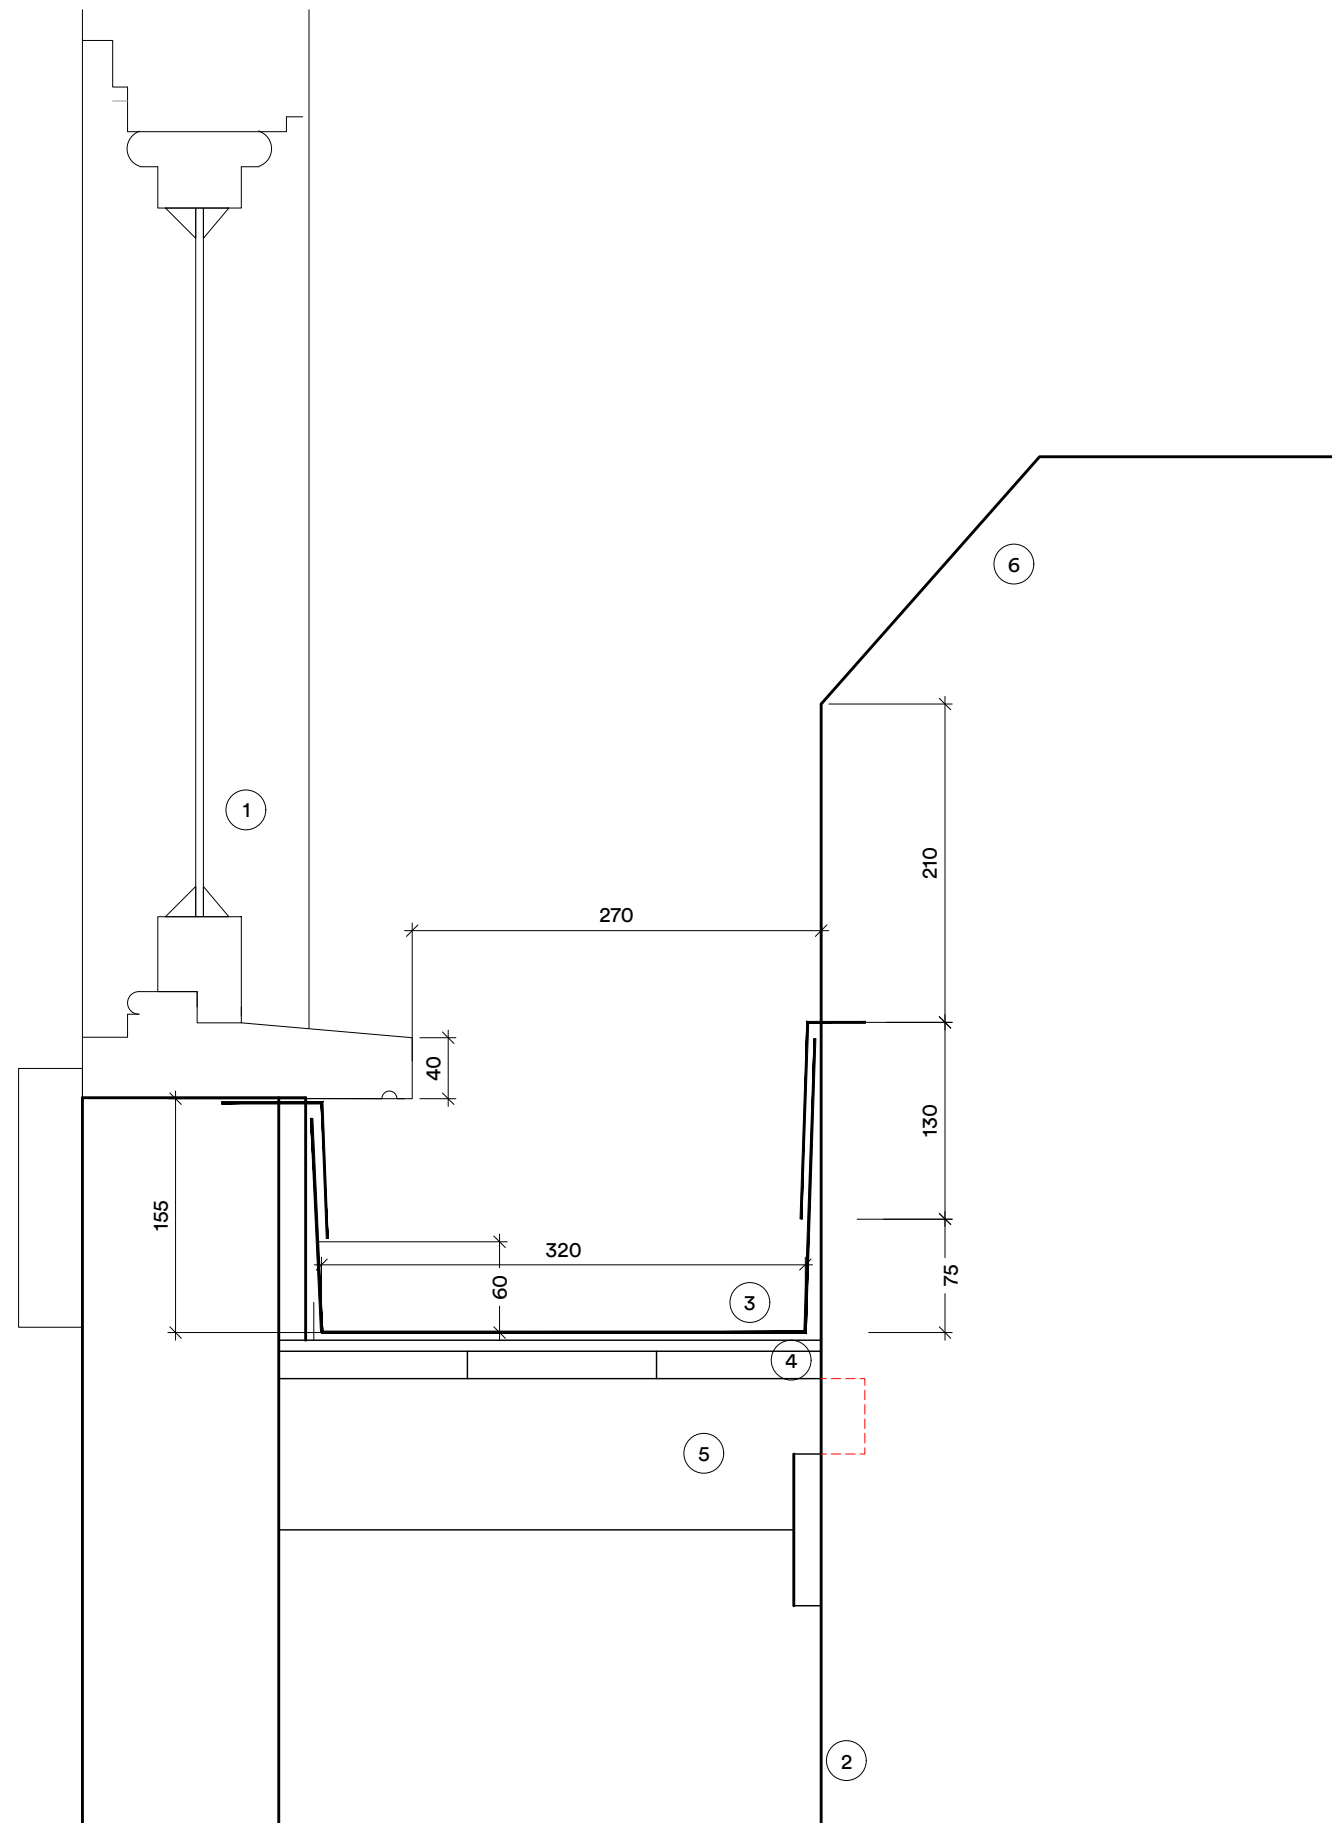
Bottom of gutter detail outside Theatre Office window

As Existing

- 1 Existing timber clerestorey Window to Store
- 2 Existing brickwork
- 3 Existing lead lined gutter
- 4 Timber furring and boards below lead gutter
- 5 Timber joists below timber boards assumed notched into brickwork
- 6 Existing facing stonework
