DRAWING NOTES: EXISTING

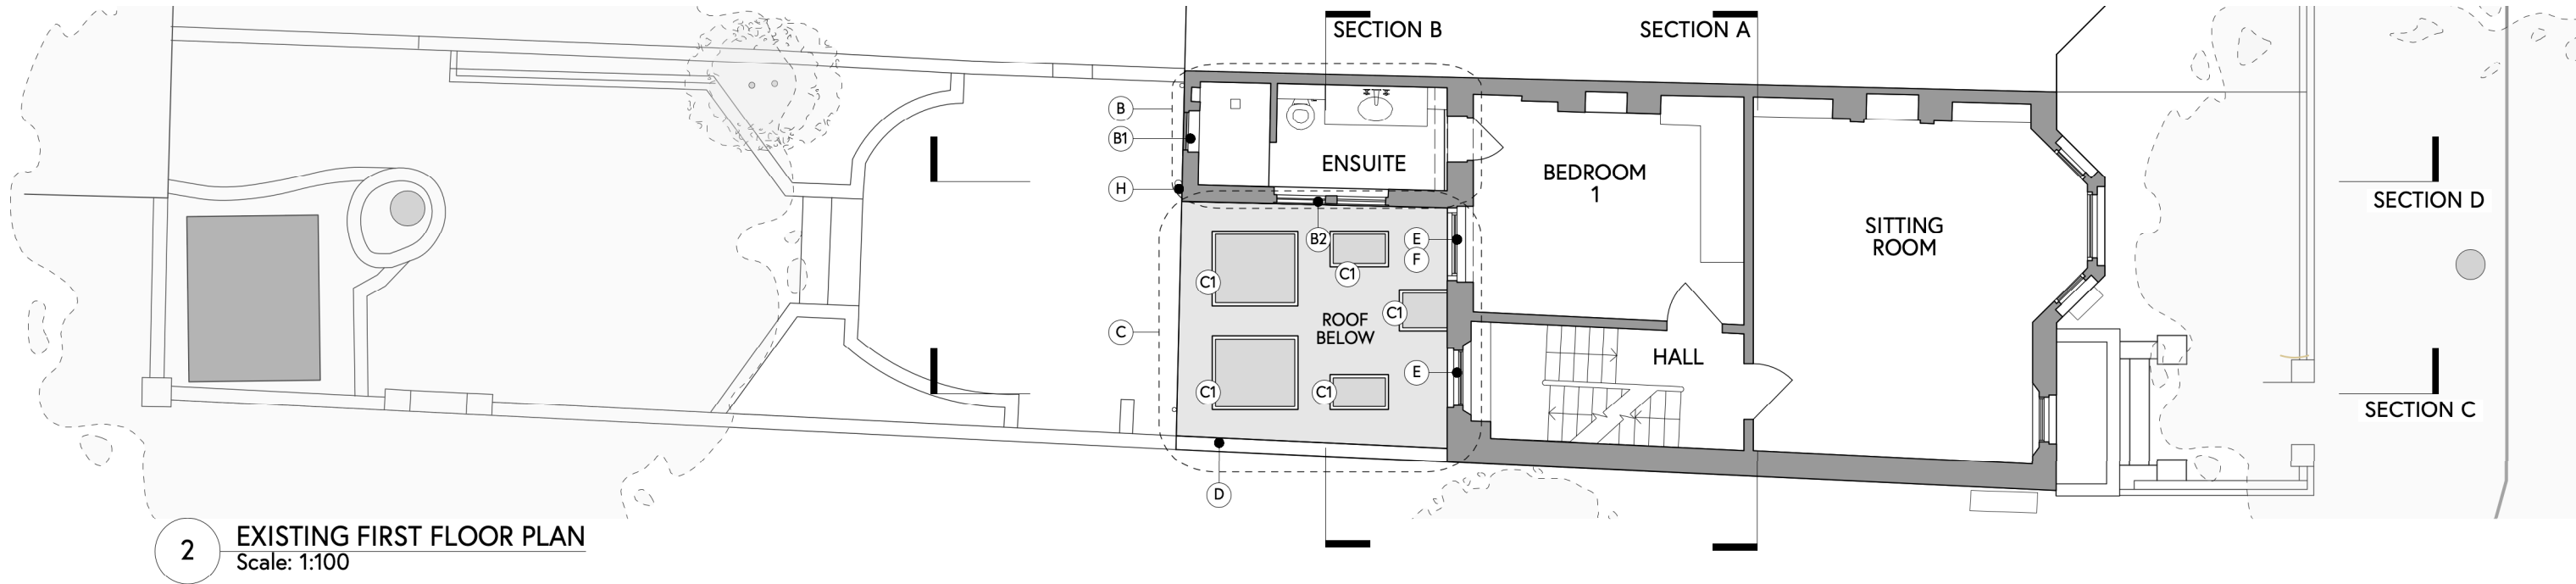
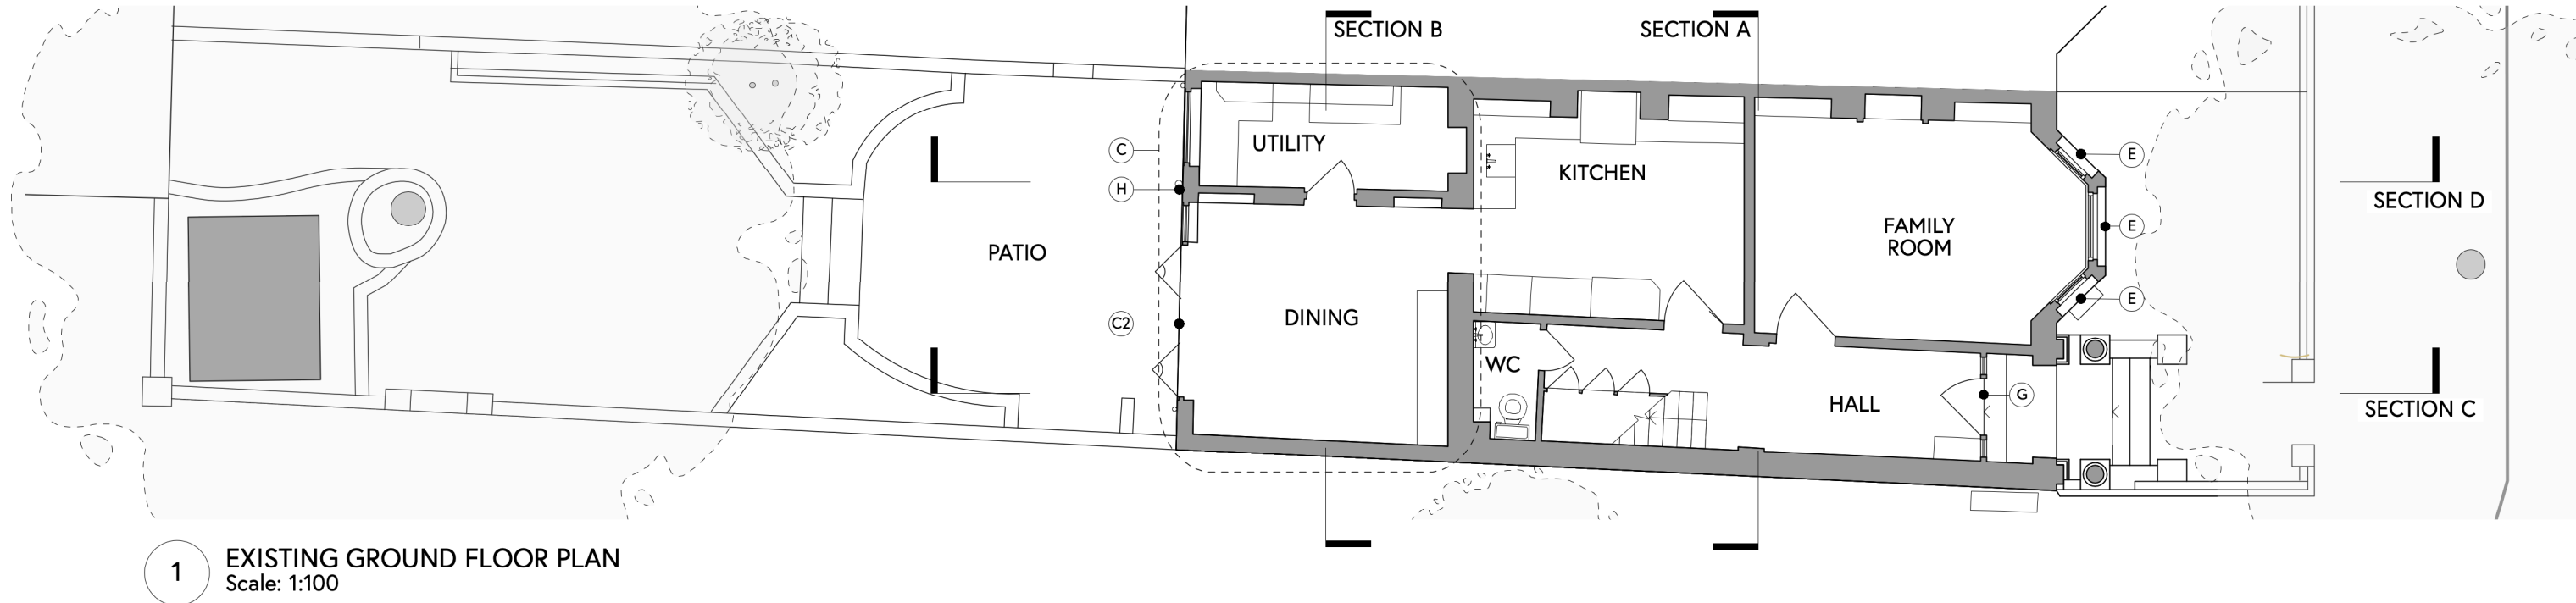
- A** Existing interlocking tile roof:
-Modern interlocking tile to entire existing pitched roof area

A1 Existing pitched-roof side dormer with modern tile cladding to roof and cheeks and painted timber gable infill with two-panel casement window

A2 Existing Velux-style pitched rooflight
- B** Existing first floor rear extension:
-Modern brick extension with side parapet only, concrete coping
-Bitumen flat roof

B1 Modern rear-facing timber-frame casement window with expressed concrete lintel

B2 Modern street-facing timber-frame sliding sash windows with expressed concrete lintel
- C** Existing ground floor rear extension:
-Stock brick rear wall; no parapet to rear elevation
-Bitumen monopitched flat roof slopes down from main elevation towards garden, visible from garden and street

C1 Modern rooflights visible from garden and street

C2 Painted timber French doors and casement window opening to garden

C3 Modern rear-facing timber-frame casement window with fixed glazed panel and concrete lintel
- D** Stock brick side wall to street; profile follows sloping line of existing rear extension with concrete coping in this area

E Single-glazed painted timber sash window
- F** Modern painted timber sash window in altered original opening with expressed concrete lintel

G Existing painted timber half-glazed front door in poor condition with glazed side lights and transom
- H** Existing SVP position
