1 EXISTING FRONT ELEVATION
Scale: 1:100

2 EXISTING FRONT WALL ELEVATION
Scale: 1:100

3 EXISTING REAR ELEVATION
Scale: 1:100

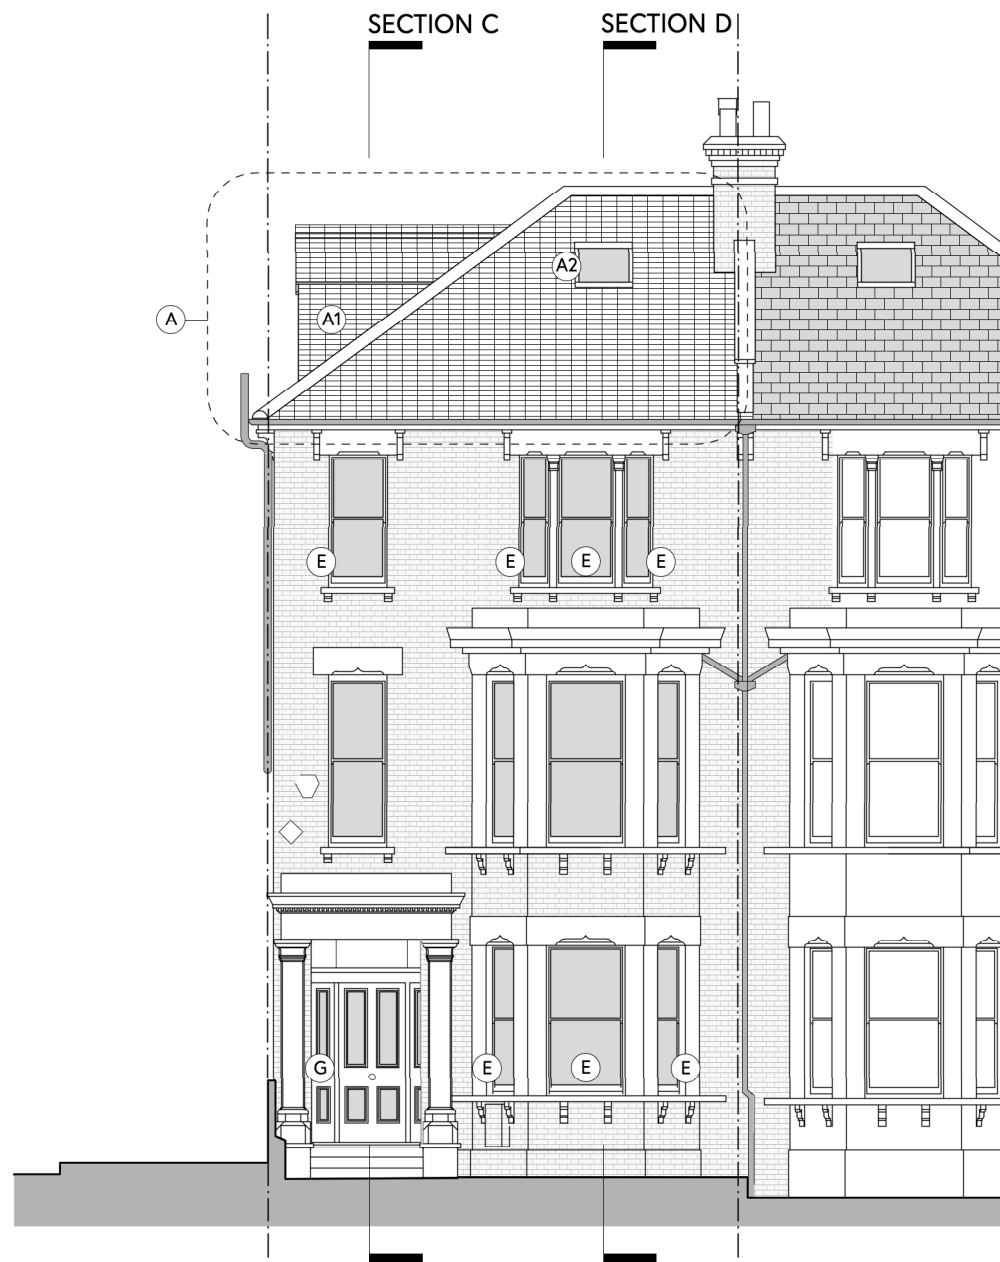
- A** Existing interlocking tile roof:
-Modern interlocking tile to entire existing pitched roof area
- A1** Existing pitched-roof side dormer with modern tile cladding to roof and cheeks and painted timber gable infill with two-panel casement window

- A2** Existing Velux-style pitched rooflight
- B** Existing first floor rear extension:
-Modern brick extension with side parapet only, concrete coping
-Bitumen flat roof

- D** Stock brick side wall to street; profile follows sloping line of existing rear extension with concrete coping in this area
- E** Single-glazed painted timber sash window

- F** Modern painted timber sash window in altered original opening with expressed concrete lintel
- G** Existing painted timber half-glazed front door in poor condition with glazed side lights and transom

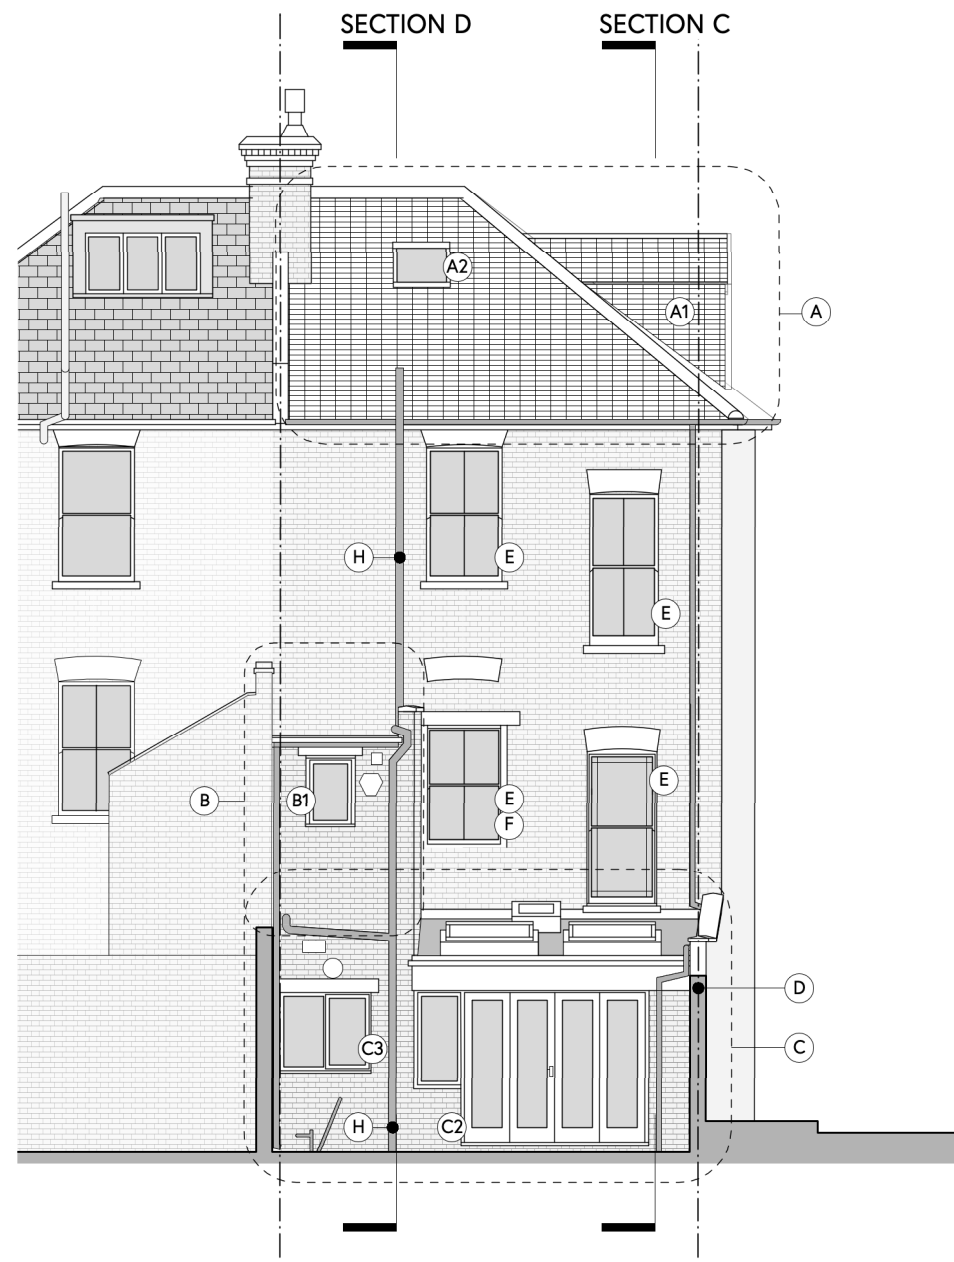
- B1** Modern rear-facing timber-frame casement window with expressed concrete lintel
- B2** Modern street-facing timber-frame sliding sash windows with expressed concrete lintel

- C** Existing ground floor rear extension:
-Stock brick rear wall; no parapet to rear elevation
-Bitumen monopitched flat roof slopes down from main elevation towards garden, visible from garden and street

- C1** Modern rooflights visible from garden and street
- C2** Painted timber French doors and casement window opening to garden
- C3** Modern rear-facing timber-frame casement window with fixed glazed panel and concrete lintel

- H** Existing SVP position
