DRAWING NOTES: EXISTING

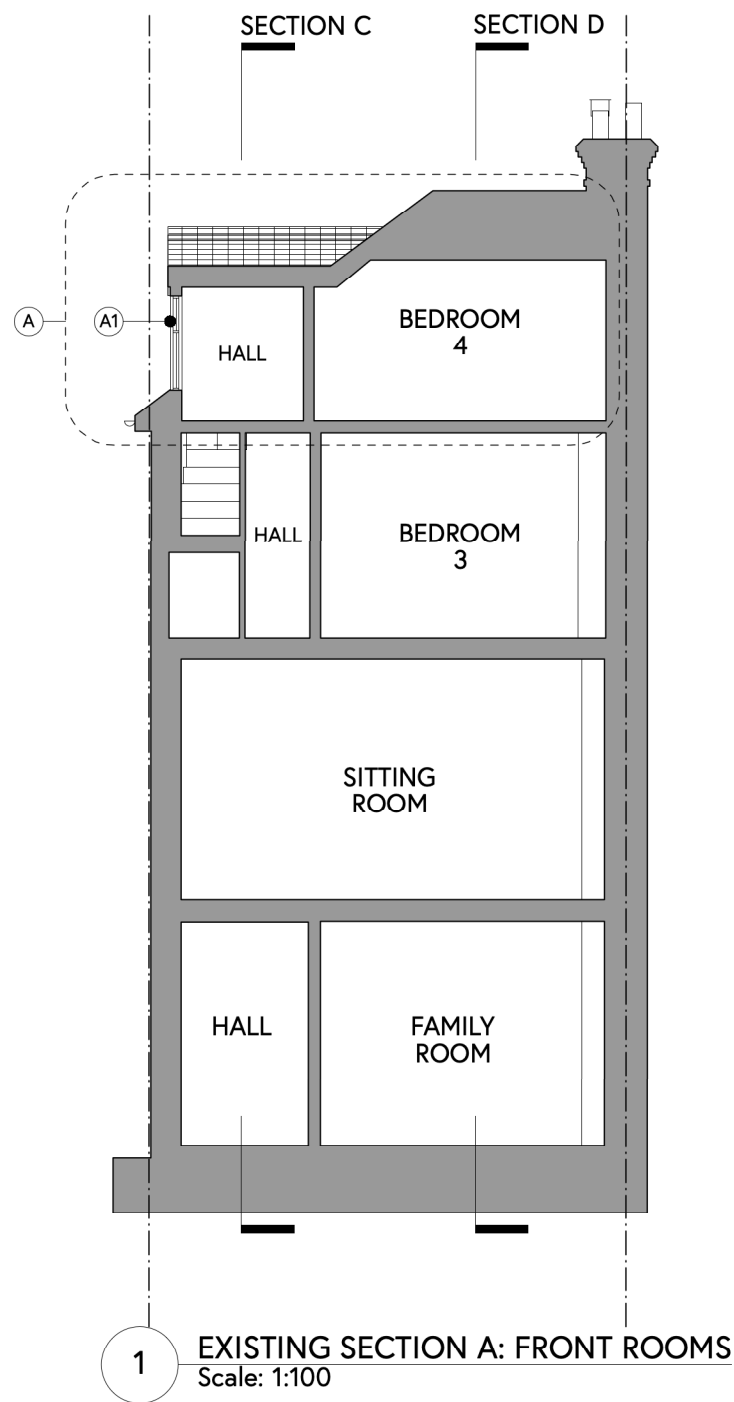
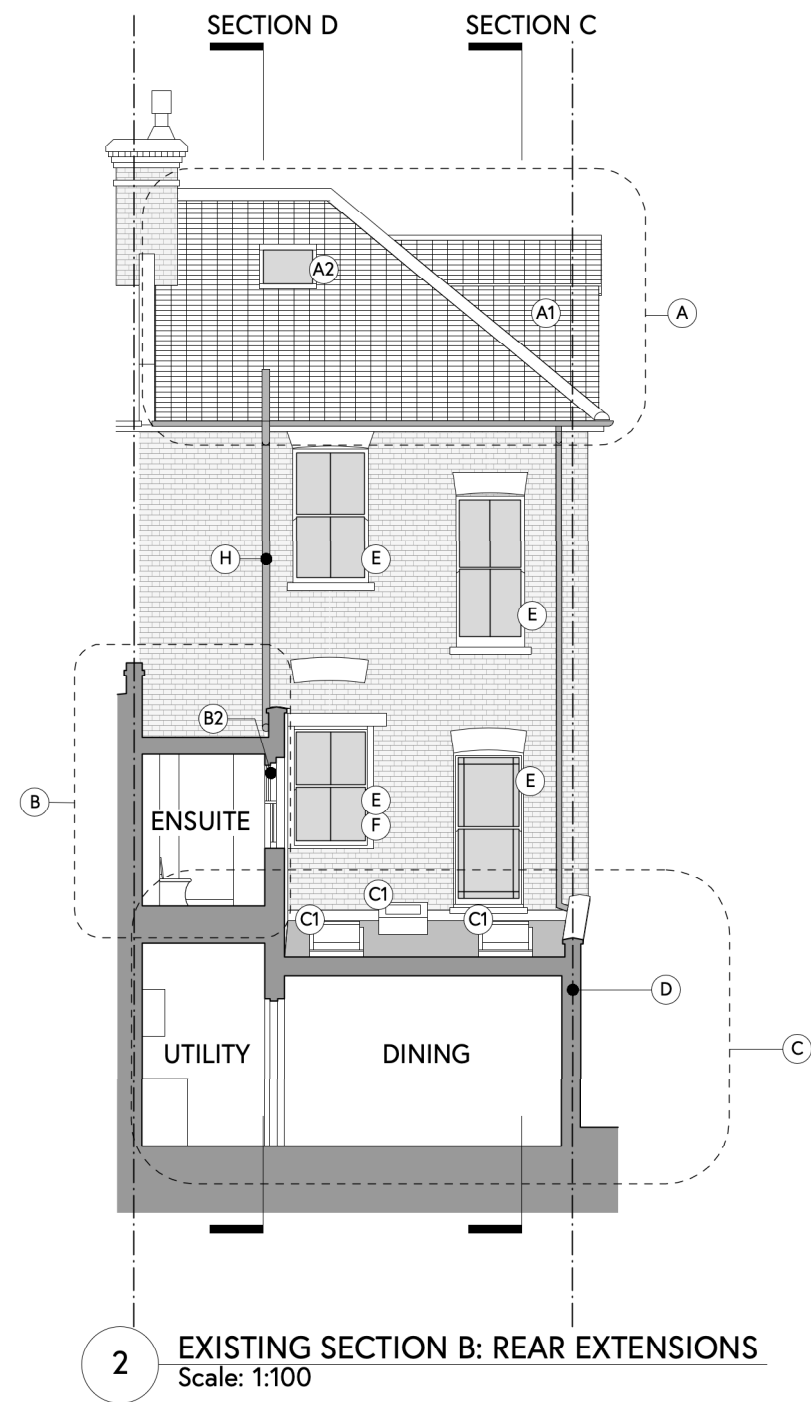
- A** Existing interlocking tile roof:
-Modern interlocking tile to entire existing pitched roof area
- A1** Existing pitched-roof side dormer with modern tile cladding to roof and cheeks and painted timber gable infill with two-panel casement window

- A2** Existing Velux-style pitched rooflight
- B** Existing first floor rear extension:
-Modern brick extension with side parapet only, concrete coping
-Bitumen flat roof

- B1** Modern rear-facing timber-frame casement window with expressed concrete lintel
- B2** Modern street-facing timber-frame sliding sash windows with expressed concrete lintel

- C** Existing ground floor rear extension:
-Stock brick rear wall; no parapet to rear elevation
-Bitumen monopitched flat roof slopes down from main elevation towards garden, visible from garden and street

- C1** Modern rooflights visible from garden and street
- C2** Painted timber French doors and casement window opening to garden
- C3** Modern rear-facing timber-frame casement window with fixed glazed panel and concrete lintel

- D** Stock brick side wall to street; profile follows sloping line of existing rear extension with concrete coping in this area
- E** Single-glazed painted timber sash window

- F** Modern painted timber sash window in altered original opening with expressed concrete lintel
- G** Existing painted timber half-glazed front door in poor condition with glazed side lights and transom

- H** Existing SVP position
