the tree bureau

Arboricultural Impact Assessment
16 Provost Road
London NW3 4ST

Report date: 11 04 25
Report reference: AIA 7812
© The Tree Bureau 2025

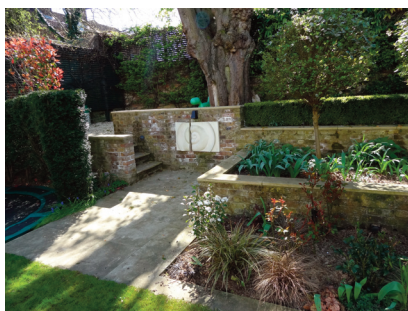
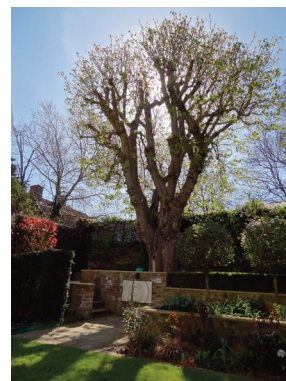
- 2.3 Ground levels have been raised in several parts of the garden to create raised beds. The rear section rises by some 0.5m to 0.8m above the rest of the garden, above the land at the rear of 15 Provost Road and the land at the back of the site (which appears to be a car park). Soil around the horse chestnut's trunk base may be 0.5m deeper than originally.
