Client
UCL

Project Title
Wilkins Building Library Entrance

Sheet Title
Wilkins Building Library Entrance - Existing Floor Plan

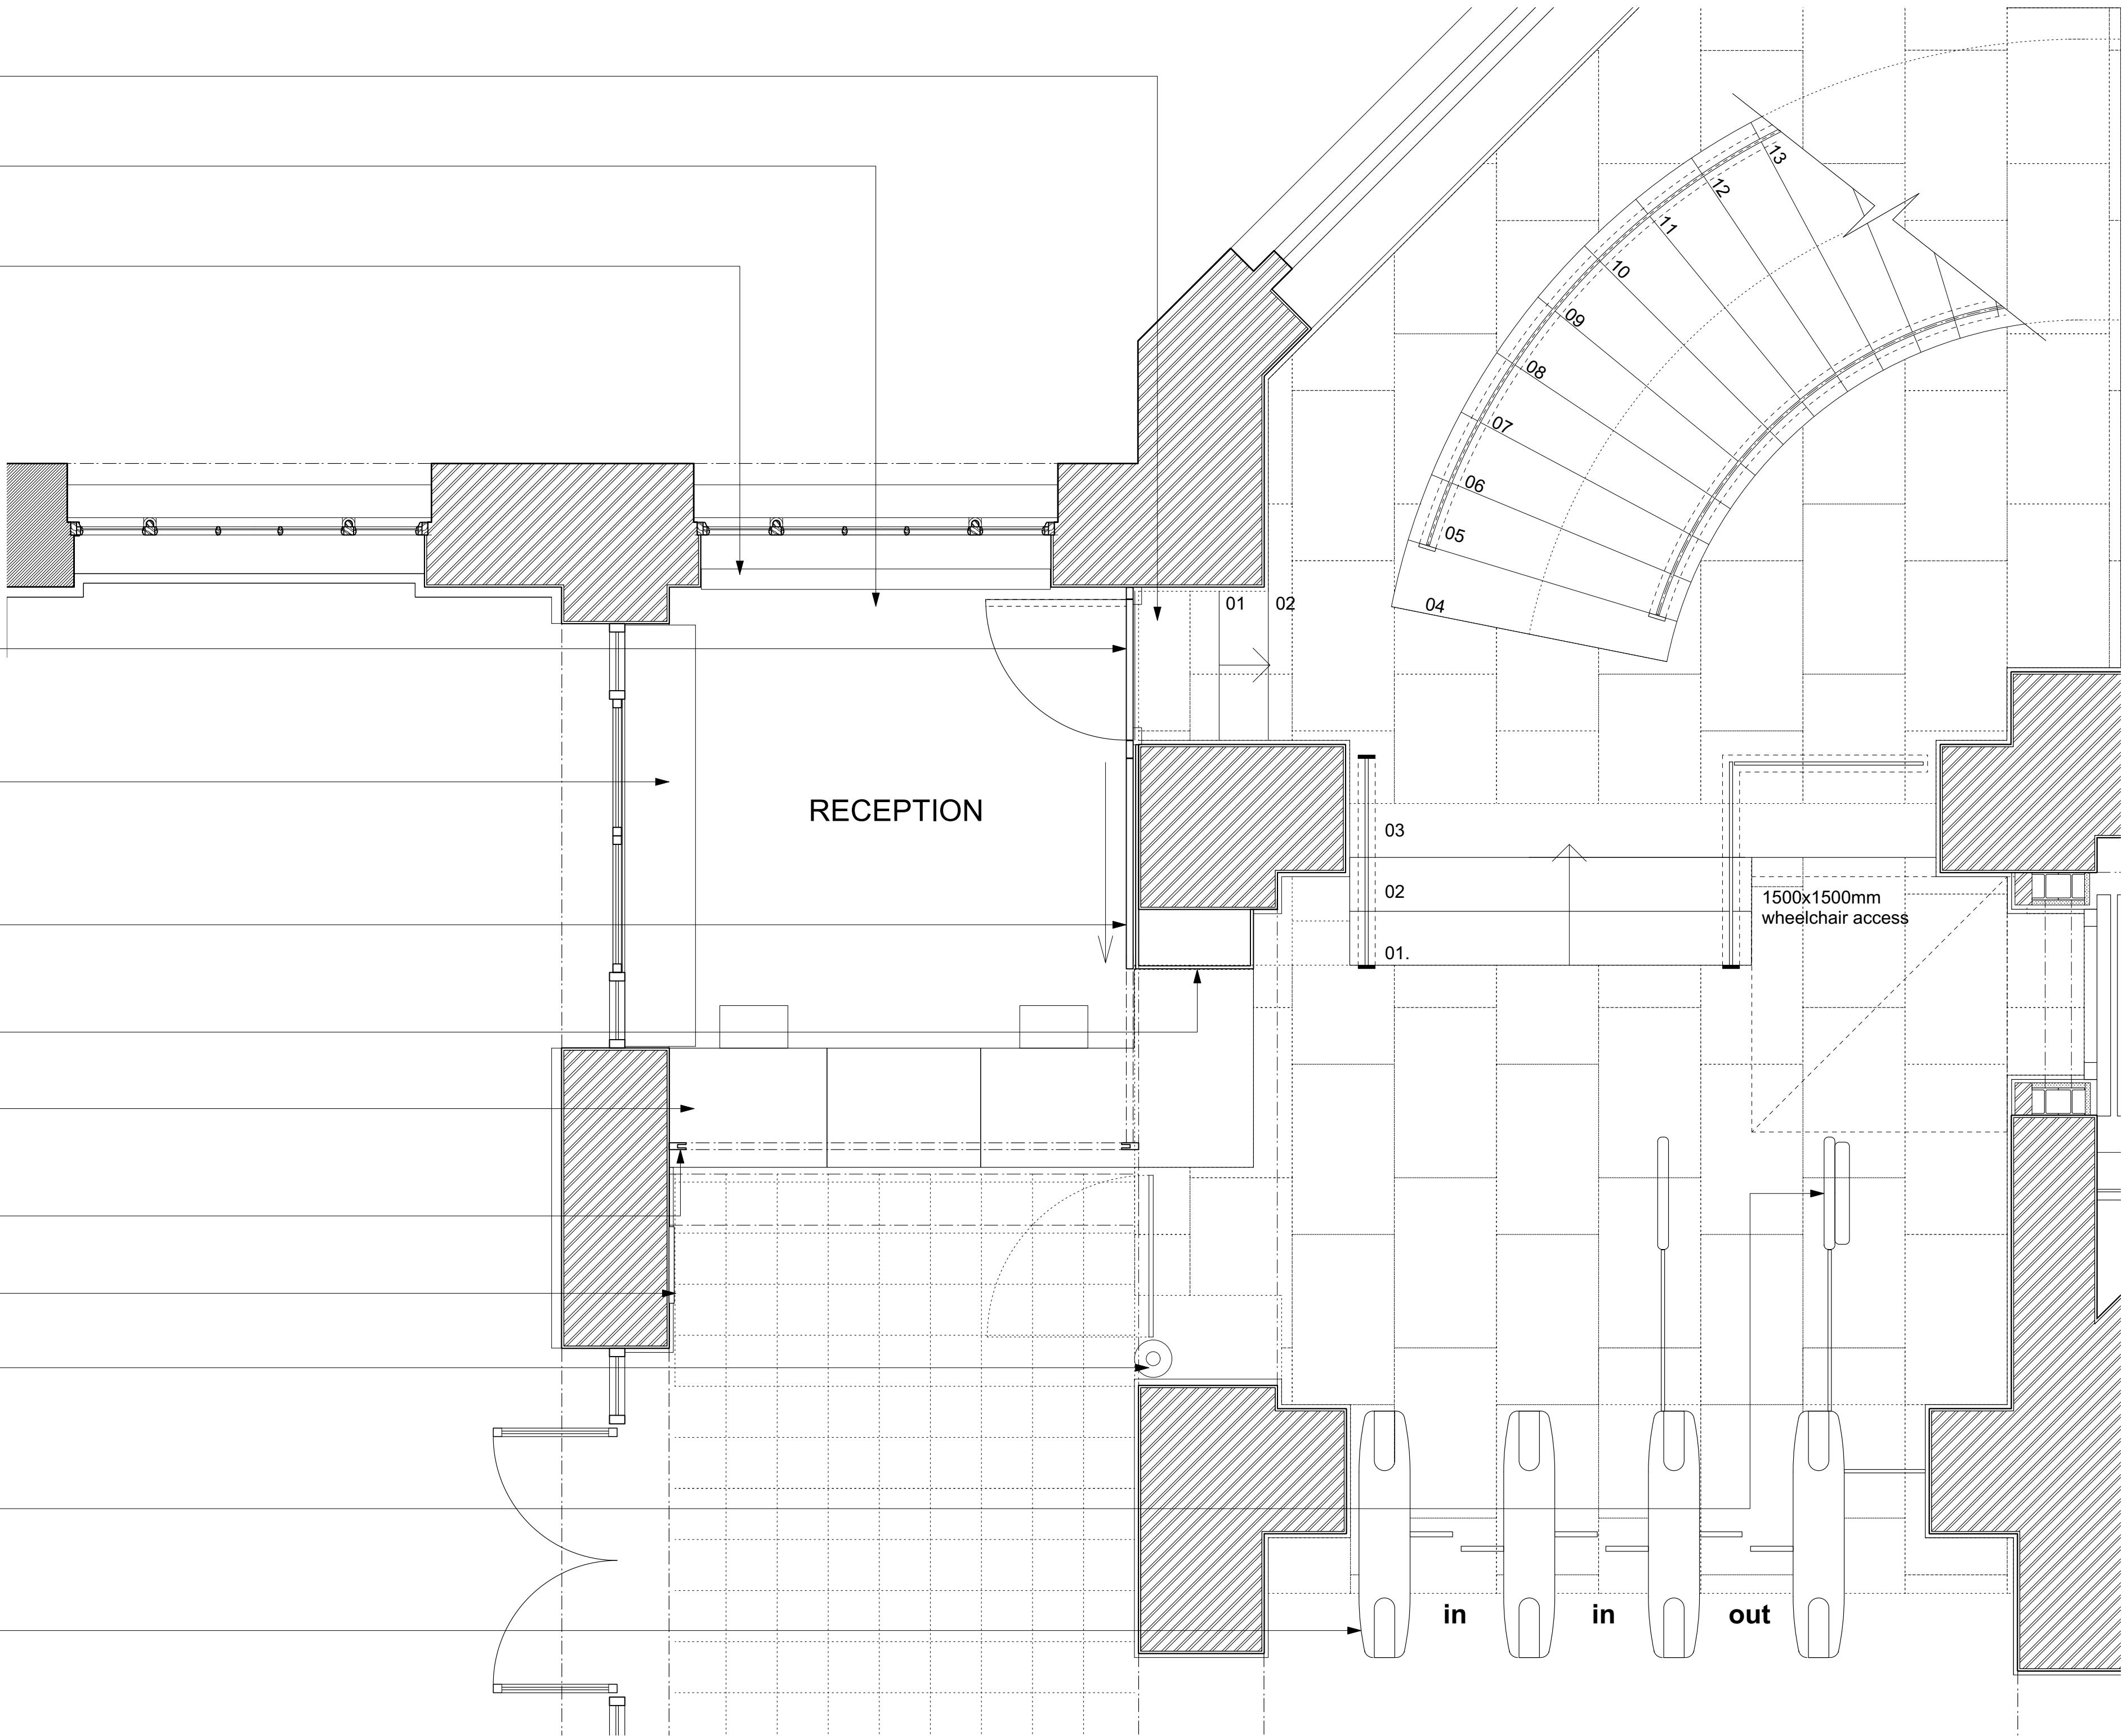
1 Existing Floor Plan
1:25 @ A1 / 150 @ A3

- Access to library reception for staff via step immediately behind door.
- Existing raised floor behind desk means staff are at a higher level
- Timber joinery unit houses control equipment for entrance gates.
- Existing hardwood veneer timber panelling and door
- Existing timber shelving
- Existing hardwood veneer timber panel. (Note that the end panel slides to secure the reception area.)
- Existing hardwood veneer timber panels.
- Existing hardwood timber desk joinery with built in storage shelves.
- Existing roller shutter and hardwood vertical guide rail.
- Existing distribution boards recessed into wall at high level
- Existing DDA access pass gate currently opens in the wrong direction, impeding access in front of the reception desk.
- Existing library anti-theft detector gates.
- Existing entrance control speed gates. (Not DDA Compliant)
