DRAWING TO BE READ IN CONJUNCTION WITH 109- ROOF REPAIRS

PROJECT: 8 HOLLY TERRACE, HIGHGATE  
LONDON, N6 6LX  
CLIENT: MR RICHARD ORMOND  
DRAWING: EXISTING AND PROPOSED ROOF PLANS

DATE: JUNE 2024 SCALE: 1:100 @ A3  
DWG. NO: 5349-105 REVISION: P1

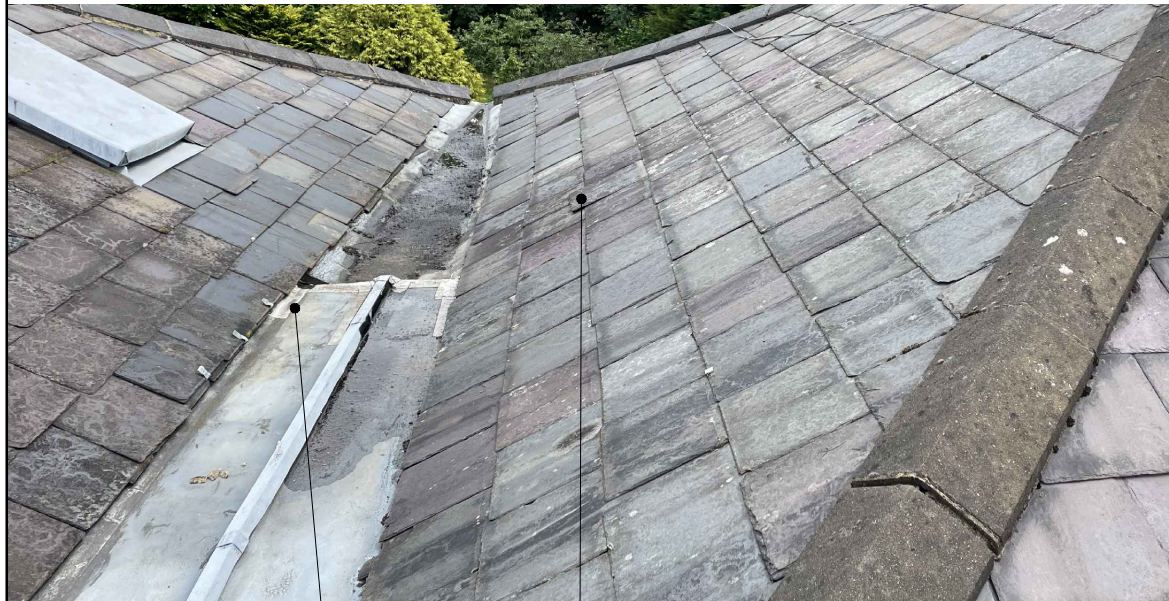
slates slipped and coming loose

Previous flash band repairs to lead

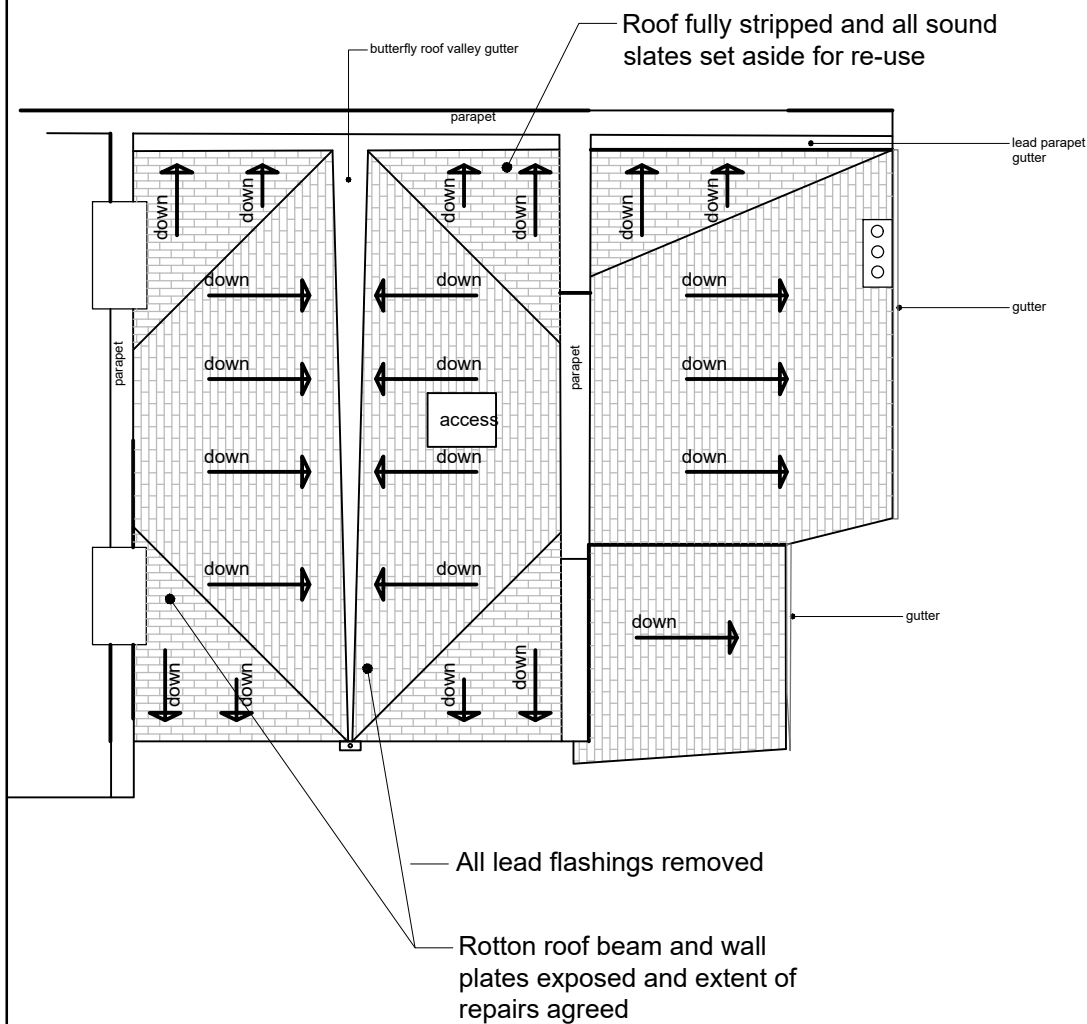
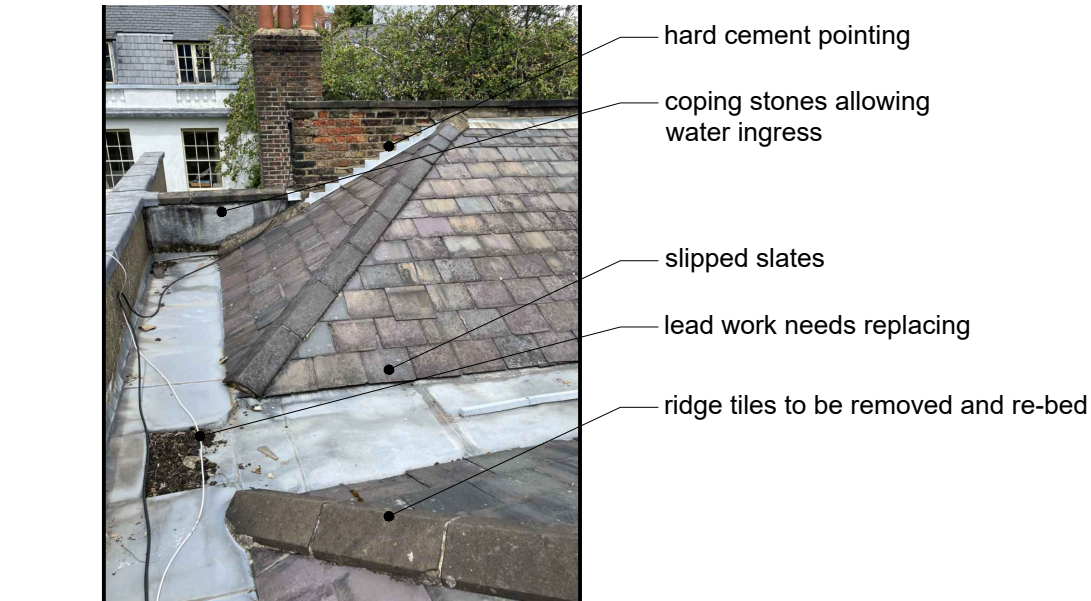
hard cement pointing

coping stones allowing water ingress

slipped slates

lead work needs replacing

ridge tiles to be removed and re-bed
