## **Fire Doors Report**

### **Element Passive Fire Protection Ltd**

South Hampstead High School (GDST)

EL1171 - South Hampstead High School - All Floors

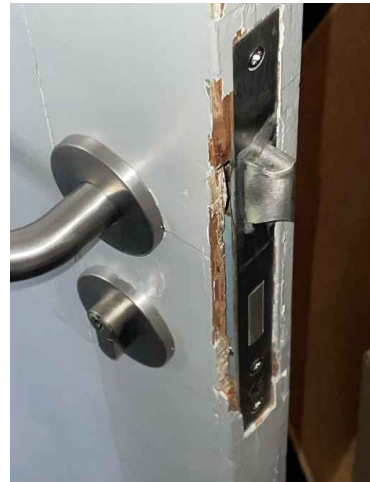
Photo(s)  
Photo 1 of 4

<b>Door Label</b>	
<b>Floor /Level:</b>	3
<b>Door Reference:</b>	0501 records
<b>Current FR:</b>	30
<b>Required FR:</b>	30
<b>Has the fire door got a third party fire door scheme label or plug fitted?:</b>	No
<b>Can you confirm that the door is in fact a fire door and has been proven as such?:</b>	Nominal fd30
<b>Door type</b>	
<b>Door set type:</b>	Single Leaf - Single Action
<b>Door Aesthetics :</b>	Painted
<b>Architrave type:</b>	Bullnose
<b>Door leaf handing:</b>	Right-handed
<b>Door set condition</b>	
<b>Is the door set free from damage?:</b>	No
<b>Door leaf or door set replacement?:</b>	Replacement door set
<b>Door Leaf</b>	
<b>Does the door leaf sit against the door stop and is it free from distortion?:</b>	N/A
<b>If the door is veneered or lipped, is the glue still holding these products firmly in place?:</b>	N/A
<b>Is the door leaf free from damage affecting its fire integrity?:</b>	N/A
<b>Does the door have the correct signage?:</b>	N/A

Does the door have an electronically powered hold open device?:	N/A
Lock And Latch	
Does the door have a lock and/or latch? :	N/A
Glazing And Glass	
Does the door leaf contain a vision panel(s)?:	N/A
Side And Overpanels	
Are there side and overpanels installed?:	N/A
Replacement door leaf/ Replacement door set	
Replacement door set (structural opening) width:	810
Replacement door set (structural opening) height:	2005
Replacement door set (structural opening) wall depth:	150
Architrave width:	70
Summary	
Summary / Recommendations:	
Due to excessive damage on door leaf all door set need to be replaced inclusive of following:	
3x grade 13 hinges	
2x FDKS fixed signage	
1x overhead closer	
15mm intumescent brush strips	
Full lock and latch including handles	
Thumb turn euro cylinder	
Priority	
Priority:	2

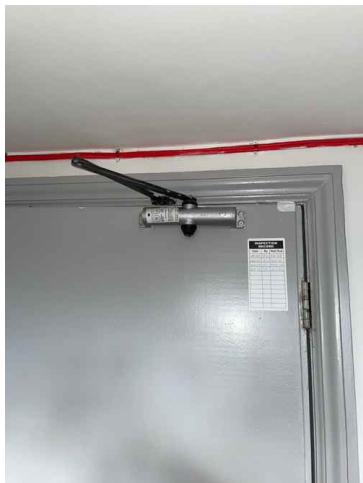
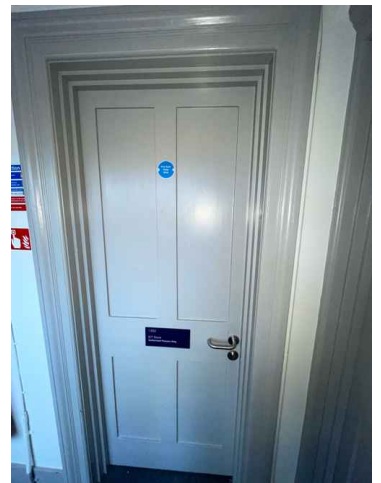
Photo(s)  
Photo 1 of 4

<b>Door Label</b>	
<b>Floor /Level:</b>	3
<b>Door Reference:</b>	ICT store 0502
<b>Current FR:</b>	30
<b>Required FR:</b>	30
<b>Has the fire door got a third party fire door scheme label or plug fitted?:</b>	No
<b>Can you confirm that the door is in fact a fire door and has been proven as such?:</b>	Nominal fd30
<b>Door type</b>	
<b>Door set type:</b>	Single Leaf - Single Action
<b>Door Aesthetics :</b>	Painted
<b>Architrave type:</b>	Bullnose
<b>Door leaf handing:</b>	Right-handed
<b>Door set condition</b>	
<b>Is the door set free from damage?:</b>	Yes
<b>Maintenance or no action?:</b>	Maintenance
<b>Door Leaf</b>	
<b>Does the door leaf sit against the door stop and is it free from distortion?:</b>	N/A
<b>If the door is veneered or lipped, is the glue still holding these products firmly in place?:</b>	Yes
<b>Is the door leaf free from damage affecting its fire integrity?:</b>	Yes
<b>Does the door have the correct signage?:</b>	No

<b>Door Frame</b>	
<b>Is the door frame firmly attached to the wall?:</b>	Yes
<b>If a planted door stop is present, is it firmly attached?:</b>	Yes
<b>Are the frame to door leaf gaps in line with the manufacturers installation instructions/testing? :</b>	Yes
<b>Is the door frame free from damage affecting its fire integrity?:</b>	Yes
<b>Is there a consistent gap under the door that allows it to swing without touching floor covering?:</b>	Yes
<b>Is the door to floor covering gap in line with the manufacturer's installation instructions / testing?:</b>	No
<b>Intumescent/Smoke/Acoust Seals</b>	
<b>Are intumescent seals in place?:</b>	No
<b>Hinges</b>	
<b>Is there a minimum of three hinges with all of the screws fitted?:</b>	No
<b>Are all the ironmongery screws secure and the correct size?:</b>	No
<b>Are the hinges free of metal fragment and oil leakage, which show signs of wear?:</b>	Yes
<b>Are intumescent packers installed behind hinge?:</b>	Unable to Verify

<b>Is all the ironmongery marked with CE stamp or BSEN 1935 grade 13 (or international equivalent)?:</b>	No
<b>Is all ironmongery free from damage and operating correctly?:</b>	No
<b>Door Closers</b>	
<b>Does the door have a closer?:</b>	Yes
<b>Open the door to 5 degrees or 75mm. Does it close and engage with the latch?:</b>	No

Other:	FDKS
<b>Summary</b>	
<b>Summary / Recommendations:</b>	
Ease and adjustment	
Rebate and install 15mm intumescent brush strips	
3x grade 13 hinges	
1x FDKS fixed signage ( only 1 in place at the moment)	
1x overhead closer	
<b>Priority</b>	
Priority:	2

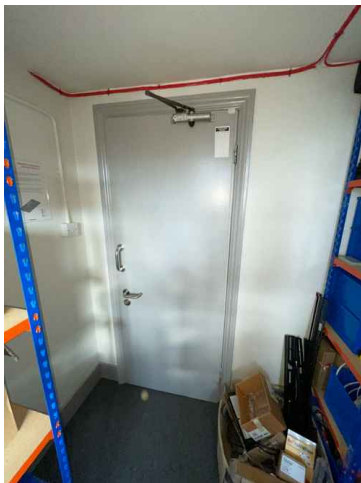
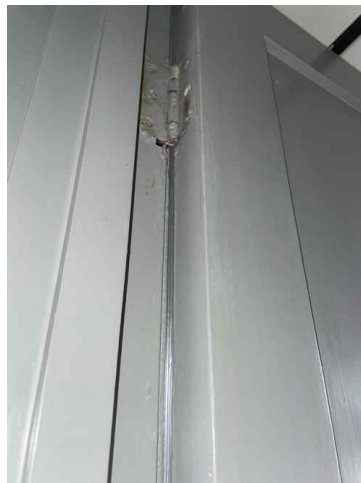
Is the closer correctly attached to the door and frame?:	Yes
Is the closer free from damage and not leaking?:	Yes
If unlatched, does the closer hold the door in line with the frame and intumescent seal?:	Yes
If hung in pairs, do they close in line if both opened and released together? (optional):	N/A
Does the door close within the specified time required?:	No
<b>Hold Open Devices</b>	
Does the door have an electronically powered hold open device?:	No
<b>Lock And Latch</b>	
Does the door have a lock and/or latch? :	Yes
Does the latch hold the door firmly in place without rattling?:	Yes
<b>Glazing And Glass</b>	
Does the door leaf contain a vision panel(s)?:	No
<b>Side And Overpanels</b>	
Are there side and overpanels installed?:	No
<b>Maintenance Remedial Works Required</b>	
Door gaps:	Ease and Adjustment
Door seals:	15mm intumescent/brush seals
Ironmongery:	3x Grade 13 hinges, Closer replacement/installation

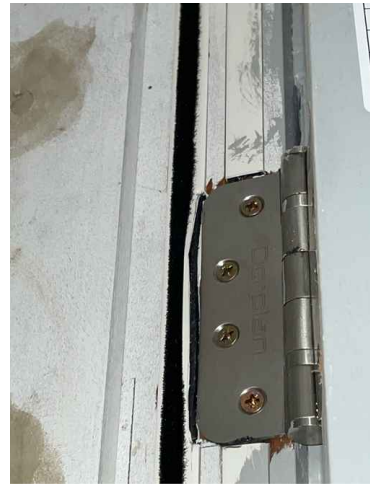
Photo(s)  
Photo 1 of 3

Door Label	
Floor /Level:	3
Door Reference:	Tank room
Current FR:	60s
Required FR:	60s
Has the fire door got a third party fire door scheme label or plug fitted?:	No
Door type	
Door set type:	Single Leaf - Single Action
Door Aesthetics :	Painted
Architrave type:	Bullnose
Door leaf handing:	Right-handed
Door set condition	
Is the door set free from damage?:	Yes
Maintenance or no action?:	Maintenance
Door Leaf	
Does the door leaf sit against the door stop and is it free from distortion?:	Yes
If the door is veneered or lipped, is the glue still holding these products firmly in place?:	Yes
Is the door leaf free from damage affecting its fire integrity?:	Yes
Does the door have the correct signage?:	No
Door Frame	
Is the door frame firmly attached to the wall?:	Yes
If a planted door stop is present, is it firmly attached?:	Yes
Are the frame to door leaf gaps in line with the manufacturers installation instructions/testing? :	Yes

Is the door frame free from damage affecting its fire integrity?:	Yes
Is there a consistent gap under the door that allows it to swing without touching floor covering?:	Yes
Is the door to floor covering gap in line with the manufacturer's installation instructions / testing?:	Yes
Intumescent/Smoke/Acoust Seals	
Are intumescent seals in place?:	Yes
Are the seals free from damage?:	No
Are the smoke seals free from paint or varnish?:	No
Are the seals well attached inside the groove in the frame or door leaf?:	Yes
Are the seals continuous around the frame or door leaf?:	Yes
Is the smoke seal in full contact with the door giving an effective seal?:	No
Hinges	
Is there a minimum of three hinges with all of the screws fitted?:	No
Are all the ironmongery screws secure and the correct size?:	Yes
Are the hinges free of metal fragment and oil leakage, which show signs of wear?:	Yes
Are intumescent packers installed behind hinge?:	Unable to Verify

Is all ironmongery free from damage and operating correctly?:	Yes
<b>Door Closers</b>	
Does the door have a closer?:	No
<b>Hold Open Devices</b>	
Does the door have an electronically powered hold open device?:	No
<b>Lock And Latch</b>	
Does the door have a lock and/or latch? :	Yes
Does the latch hold the door firmly in place without rattling?:	Yes
<b>Glazing And Glass</b>	
Does the door leaf contain a vision panel(s)?:	No
<b>Side And Overpanels</b>	
Are there side and overpanels installed?:	No
<b>Maintenance Remedial Works Required</b>	
Door seals:	15mm intumescent/brush seals, 15mm intumescent seals
Ironmongery:	3x Grade 13 hinges
Other:	FDKL
<b>Summary</b>	
<b>Summary / Recomendations:</b>	
3x grade 13 hinges	
15mm intumescent brush strips	
15mm intumescent seals	
1x FDKL fixed signage	
<b>Priority</b>	
Priority:	1

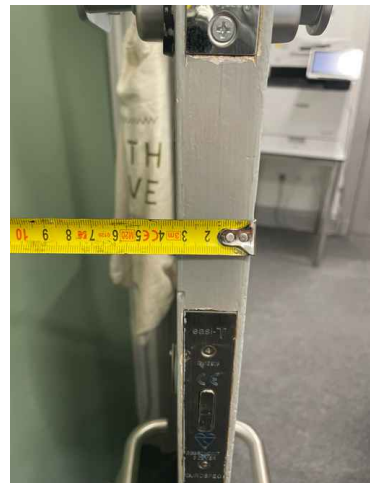
Photo(s)  
Photo 1 of 4

<b>Door Label</b>	
<b>Floor /Level:</b>	4
<b>Door Reference:</b>	0401 director of philanthropy & alumnae
<b>Current FR:</b>	NR
<b>Required FR:</b>	30
<b>Has the fire door got a third party fire door scheme label or plug fitted?:</b>	No
<b>Can you confirm that the door is in fact a fire door and has been proven as such?:</b>	Non fire rated door set
<b>Door type</b>	
<b>Door set type:</b>	Single Leaf - Single Action
<b>Door Aesthetics :</b>	Painted
<b>Architrave type:</b>	Bullnose
<b>Door leaf handing:</b>	Left-handed
<b>Door set condition</b>	
<b>Is the door set free from damage?:</b>	No
<b>Door leaf or door set replacement?:</b>	Replacement door set
<b>Door Leaf</b>	
<b>Does the door leaf sit against the door stop and is it free from distortion?:</b>	N/A
<b>If the door is veneered or lipped, is the glue still holding these products firmly in place?:</b>	N/A
<b>Is the door leaf free from damage affecting its fire integrity?:</b>	N/A

Does the door have an electronically powered hold open device?:	N/A
Lock And Latch	
Does the door have a lock and/or latch? :	N/A
Glazing And Glass	
Does the door leaf contain a vision panel(s)?:	N/A
Side And Overpanels	
Are there side and overpanels installed?:	N/A
Replacement door leaf/ Replacement door set	
Replacement door set (structural opening) width:	810
Replacement door set (structural opening) height:	2085
Replacement door set (structural opening) wall depth:	150
Architrave width:	120
Summary	
Summary / Recomendations:	
No fire rated on existing door set , recommended to replace all door set with a timber fd30 door set inclusive of following:	
3x grade 13 hinges	
15mm intumescent brush strips	
1x overhead closer	
2x FDKS fixed signage	
Full lock and latch	
2x vp ( 170x510mm )	
Digi lock	
Priority	
Priority:	2

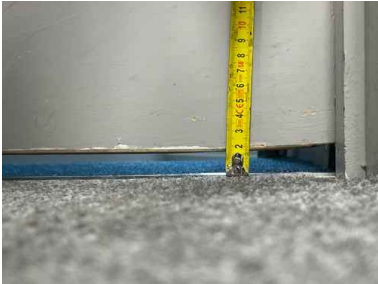
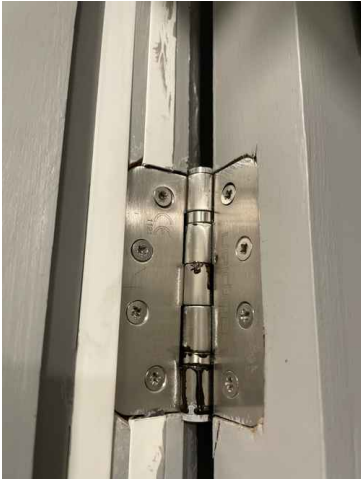
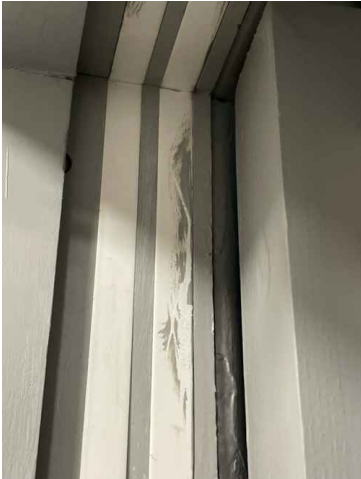
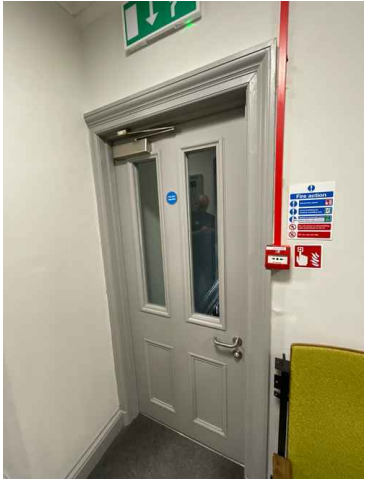
Door Label	
Floor /Level:	4
Door Reference:	Staircase
Current FR:	60s
Required FR:	60s
Has the fire door got a third party fire door scheme label or plug fitted?:	No
Can you confirm that the door is in fact a fire door and has been proven as such?:	Nominal fd60s
Door type	
Door set type:	Single Leaf - Single Action
Door Aesthetics :	Painted
Architrave type:	Bullnose
Door leaf handing:	Right-handed
Door set condition	
Is the door set free from damage?:	Yes
Maintenance or no action?:	Maintenance
Door Leaf	
Does the door leaf sit against the door stop and is it free from distortion?:	Yes
If the door is veneered or lipped, is the glue still holding these products firmly in place?:	Yes
Is the door leaf free from damage affecting its fire integrity?:	Yes
Does the door have the correct signage?:	No
Door Frame	
Is the door frame firmly attached to the wall?:	Yes
If a planted door stop is present, is it firmly attached?:	Yes

Are the frame to door leaf gaps in line with the manufacturers installation instructions/testing? :	Yes
Meeting Edge Gap:	5
Leading Edge Gap:	3
Top Edge Gap:	5
Is the door frame free from damage affecting its fire integrity?:	Yes
Is there a consistent gap under the door that allows it to swing without touching floor covering?:	Yes
Is the door to floor covering gap in line with the manufacturer's installation instructions / testing?:	No
Threshold Gap:	18
Intumescent/Smoke/Acoust Seals	
Are intumescent seals in place?:	Yes
Are the seals free from damage?:	No
Are the smoke seals free from paint or varnish?:	No
Are the seals well attached inside the groove in the frame or door leaf?:	Yes
Are the seals continuous around the frame or door leaf?:	Yes
Is the smoke seal in full contact with the door giving an effective seal?:	No
Hinges

Is there a minimum of three hinges with all of the screws fitted?:	Yes
Are all the ironmongery screws secure and the correct size?:	Yes
Are the hinges free of metal fragment and oil leakage, which show signs of wear?:	No
Are intumescent packers installed behind hinge?:	Unable to Verify
Is all the ironmongery marked with CE stamp or BSEN 1935 grade 13 (or international equivalent)?:	Yes
Is all ironmongery free from damage and operating correctly?:	No
<b>Door Closers</b>	
Does the door have a closer?:	Yes
Open the door to 5 degrees or 75mm. Does it close and engage with the latch?:	Yes
Is the closer correctly attached to the door and frame?:	No
Is the closer free from damage and not leaking?:	Yes
If unlatched, does the closer hold the door in line with the frame and intumescent seal?:	Yes
If hung in pairs, do they close in line if both opened and released together? (optional):	N/A
Does the door close within the specified time required?:	Yes

Ironmongery:	3x Grade 13 hinges, Closer Adjustment
Other:	FDKS
<b>Summary</b>	
<b>Summary / Recomendations:</b>	
Ease and adjustment	
15mm intumescent brush strips	
15mm intumescent seals	
Closer adjustment	
3x grade 13 hinges	
1x FDKS fixed signage ( only 1 in place at the moment )	
BE lipping, BE gap 18mm	
Face mounted drop down seal ( leaf 830mm)	
<b>Priority</b>

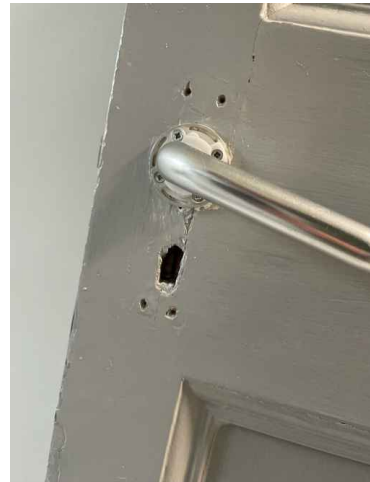
Photo(s)  
Photo 1 of 4

<b>Door Label</b>	
<b>Floor /Level:</b>	4
<b>Door Reference:</b>	Kitchen
<b>Current FR:</b>	30
<b>Required FR:</b>	30
<b>Has the fire door got a third party fire door scheme label or plug fitted?:</b>	No
<b>Can you confirm that the door is in fact a fire door and has been proven as such?:</b>	Nominal fd30
<b>Door type</b>	
<b>Door set type:</b>	Single Leaf - Single Action
<b>Door Aesthetics :</b>	Painted
<b>Architrave type:</b>	Bullnose
<b>Door leaf handing:</b>	Left-handed
<b>Door set condition</b>	
<b>Is the door set free from damage?:</b>	No
<b>Door leaf or door set replacement?:</b>	Replacement door set
<b>Door Leaf</b>	
<b>Does the door leaf sit against the door stop and is it free from distortion?:</b>	N/A
<b>If the door is veneered or lipped, is the glue still holding these products firmly in place?:</b>	N/A
<b>Is the door leaf free from damage affecting its fire integrity?:</b>	N/A
<b>Does the door have the correct signage?:</b>	N/A

Does the door have an electronically powered hold open device?:	N/A
Lock And Latch	
Does the door have a lock and/or latch? :	N/A
Glazing And Glass	
Does the door leaf contain a vision panel(s)?:	N/A
Side And Overpanels	
Are there side and overpanels installed?:	N/A
Replacement door leaf/ Replacement door set	
Replacement door set (structural opening) width:	875
Replacement door set (structural opening) height:	2065
Replacement door set (structural opening) wall depth:	150
Architrave width:	120
Summary	
Summary / Recommendations:	
Due to excessive damage on door leaf all door set need to be replaced inclusive of following:	
3x grade 13 hinges	
2x FDKS fixed signage	
1x overhead closer	
15mm intumescent brush strips	
Full lock and latch including handles	
Over glass panel (830x300mm)	
Priority	
Priority:	1

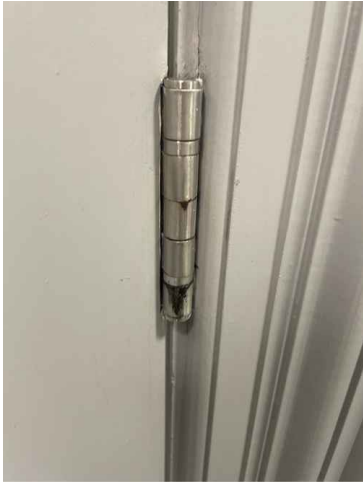
Photo(s)  
Photo 1 of 4

Door Label	
Floor /Level:	4
Door Reference:	Corridor
Current FR:	60s
Required FR:	60s
Has the fire door got a third party fire door scheme label or plug fitted?:	No
Can you confirm that the door is in fact a fire door and has been proven as such?:	Nominal fd60s
Door type	
Door set type:	Single Leaf - Single Action
Door Aesthetics :	Painted
Architrave type:	Bullnose
Door leaf handing:	Right-handed
Door set condition	
Is the door set free from damage?:	Yes
Maintenance or no action?:	Maintenance
Door Leaf	
Does the door leaf sit against the door stop and is it free from distortion?:	Yes
If the door is veneered or lipped, is the glue still holding these products firmly in place?:	Yes
Is the door leaf free from damage affecting its fire integrity?:	Yes
Does the door have the correct signage?:	No
Door Frame	
Is the door frame firmly attached to the wall?:	Yes
If a planted door stop is present, is it firmly attached?:	Yes

Are the frame to door leaf gaps in line with the manufacturers installation instructions/testing? :	Yes
Meeting Edge Gap:	4
Leading Edge Gap:	2
Top Edge Gap:	5
Is the door frame free from damage affecting its fire integrity?:	No
Is there a consistent gap under the door that allows it to swing without touching floor covering?:	Yes
Is the door to floor covering gap in line with the manufacturer's installation instructions / testing?:	No
Threshold Gap:	7
Intumescent/Smoke/Acoust Seals	
Are intumescent seals in place?:	Yes
Are the seals free from damage?:	Yes
Are the smoke seals free from paint or varnish?:	No
Are the seals well attached inside the groove in the frame or door leaf?:	Yes
Are the seals continuous around the frame or door leaf?:	Yes
Is the smoke seal in full contact with the door giving an effective seal?:	No
Hinges

Is there a minimum of three hinges with all of the screws fitted?:	Yes
Are all the ironmongery screws secure and the correct size?:	Yes
Are the hinges free of metal fragment and oil leakage, which show signs of wear?:	No
Are intumescent packers installed behind hinge?:	Unable to Verify
Is all the ironmongery marked with CE stamp or BSEN 1935 grade 13 (or international equivalent)?:	Yes
Is all ironmongery free from damage and operating correctly?:	No
<b>Door Closers</b>	
Does the door have a closer?:	Yes
Open the door to 5 degrees or 75mm. Does it close and engage with the latch?:	Yes
Is the closer correctly attached to the door and frame?:	Yes
Is the closer free from damage and not leaking?:	Yes
If unlatched, does the closer hold the door in line with the frame and intumescent seal?:	Yes
If hung in pairs, do they close in line if both opened and released together? (optional):	N/A
Does the door close within the specified time required?:	Yes

Other:	FDKS
<b>Summary</b>	
<b>Summary / Recommendations:</b>	
Ease and adjustment	
3x grade 13 hinges	
2x FDKS fixed signage	
Face mounted drop down seal ( leaf 830mm)	
<b>Priority</b>	
Priority:	2

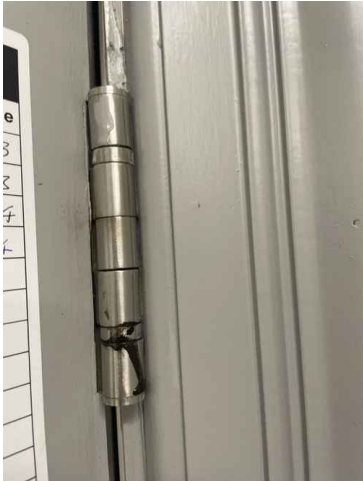
Photo(s)  
Photo 1 of 4

<b>Door Label</b>	
<b>Floor /Level:</b>	4
<b>Door Reference:</b>	0412 finance office
<b>Current FR:</b>	60s
<b>Required FR:</b>	60s
<b>Has the fire door got a third party fire door scheme label or plug fitted?:</b>	No
<b>Can you confirm that the door is in fact a fire door and has been proven as such?:</b>	Nominal fd60s
<b>Door type</b>	
<b>Door set type:</b>	Single Leaf - Single Action
<b>Door Aesthetics :</b>	Painted
<b>Architrave type:</b>	Bullnose
<b>Door leaf handing:</b>	Right-handed
<b>Door set condition</b>	
<b>Is the door set free from damage?:</b>	Yes
<b>Maintenance or no action?:</b>	Maintenance
<b>Door Leaf</b>	
<b>Does the door leaf sit against the door stop and is it free from distortion?:</b>	Yes
<b>If the door is veneered or lipped, is the glue still holding these products firmly in place?:</b>	Yes
<b>Is the door leaf free from damage affecting its fire integrity?:</b>	Yes
<b>Does the door have the correct signage?:</b>	No

Is there a minimum of three hinges with all of the screws fitted?:	Yes
Are all the ironmongery screws secure and the correct size?:	Yes
Are the hinges free of metal fragment and oil leakage, which show signs of wear?:	No
Are intumescent packers installed behind hinge?:	Unable to Verify
Is all the ironmongery marked with CE stamp or BSEN 1935 grade 13 (or international equivalent)?:	Yes
Is all ironmongery free from damage and operating correctly?:	Yes
<b>Door Closers</b>	
Does the door have a closer?:	Yes
Open the door to 5 degrees or 75mm. Does it close and engage with the latch?:	N/A
Is the closer correctly attached to the door and frame?:	Yes
Is the closer free from damage and not leaking?:	No
If unlatched, does the closer hold the door in line with the frame and intumescent seal?:	Yes
If hung in pairs, do they close in line if both opened and released together? (optional):	N/A
Does the door close within the specified time required?:	No

Ironmongery:	3x Grade 13 hinges, Closer replacement/installation
Other:	FDKS
<b>Summary</b>	
<b>Summary / Recommendations:</b>	
Ease and adjustment	
3x grade 13 hinges	
2x FDKS fixed signage	
Face mounted drop down seal ( leaf 830mm)	
1x overhead closer	
<b>Priority</b>	
Priority:	2

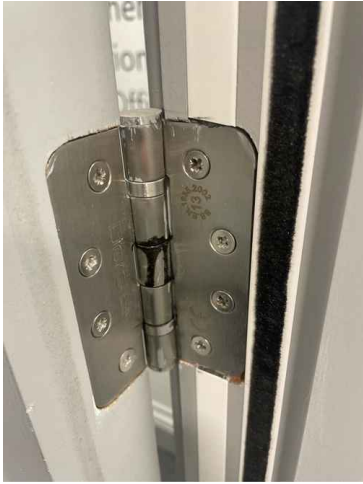
Photo(s)  
Photo 1 of 4

<b>Door Label</b>	
<b>Floor /Level:</b>	4
<b>Door Reference:</b>	Corridor
<b>Current FR:</b>	60s
<b>Required FR:</b>	60s
<b>Has the fire door got a third party fire door scheme label or plug fitted?:</b>	No
<b>Can you confirm that the door is in fact a fire door and has been proven as such?:</b>	Nominal fd60s
<b>Door type</b>	
<b>Door set type:</b>	Single Leaf - Single Action
<b>Door Aesthetics :</b>	Painted
<b>Architrave type:</b>	Bullnose
<b>Door leaf handing:</b>	Left-handed
<b>Door set condition</b>	
<b>Is the door set free from damage?:</b>	Yes
<b>Maintenance or no action?:</b>	Maintenance
<b>Door Leaf</b>	
<b>Does the door leaf sit against the door stop and is it free from distortion?:</b>	Yes
<b>If the door is veneered or lipped, is the glue still holding these products firmly in place?:</b>	Yes
<b>Is the door leaf free from damage affecting its fire integrity?:</b>	Yes
<b>Does the door have the correct signage?:</b>	No

Is there a minimum of three hinges with all of the screws fitted?:	Yes
Are all the ironmongery screws secure and the correct size?:	Yes
Are the hinges free of metal fragment and oil leakage, which show signs of wear?:	No
Are intumescent packers installed behind hinge?:	Unable to Verify
Is all the ironmongery marked with CE stamp or BSEN 1935 grade 13 (or international equivalent)?:	Yes
Is all ironmongery free from damage and operating correctly?:	Yes
<b>Door Closers</b>	
Does the door have a closer?:	Yes
Open the door to 5 degrees or 75mm. Does it close and engage with the latch?:	Yes
Is the closer correctly attached to the door and frame?:	Yes
Is the closer free from damage and not leaking?:	Yes
If unlatched, does the closer hold the door in line with the frame and intumescent seal?:	Yes
If hung in pairs, do they close in line if both opened and released together? (optional):	N/A
Does the door close within the specified time required?:	No

<b>Summary / Recommendations:</b>	
Ease and adjustment	
3x grade 13 hinges	
2x FDKS fixed signage	
Closer adjustment	
<b>Priority</b>	
Priority:	2

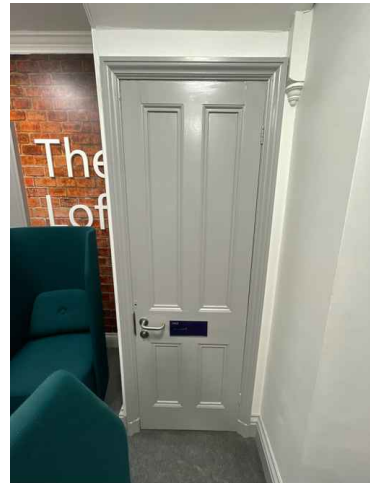
Photo(s)  
Photo 1 of 1

Does the door have an electronically powered hold open device?:	N/A
Lock And Latch	
Does the door have a lock and/or latch? :	N/A
Glazing And Glass	
Does the door leaf contain a vision panel(s)?:	N/A
Side And Overpanels	
Are there side and overpanels installed?:	N/A
Summary	
Summary / Recomendations:	
No access during the time of survey

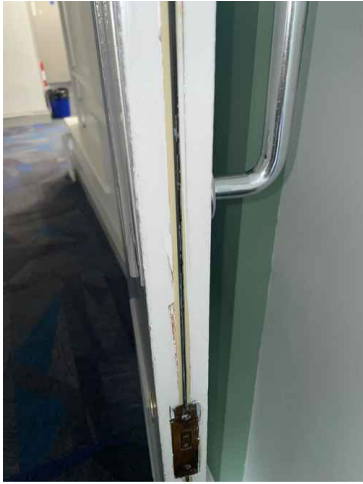
Photo(s)  
Photo 1 of 3

<b>Glazing And Glass</b>	
Does the door leaf contain a vision panel(s)?:	Yes
Is the intumescent seal continuous and attached to the glass and bead?:	Yes
Are the glazing beads correctly attached to the frame from both sides and free from damage?:	Yes
Is the glass free from damage and cracking?:	Yes
Is the glass identified as fire rated?:	Yes
If glazing panels are below 1500mm from bottom of door, is the glass safety glass?:	N/A
<b>Side And Overpanels</b>	
Are there side and overpanels installed?:	No
<b>Maintenance Remedial Works Required</b>	
Door gaps:	Ease and Adjustment
Door seals:	10mm intumescent/brush seals
Ironmongery:	6x Grade 13 hinges, Closer replacement/installation
Other:	AFDCK
<b>Summary</b>	
<b>Summary / Recomendations:</b>	
Ease and adjustment	
10mm intumescent brush strips	
6x grade 13 hinges	
2x AFDCK fixed signage ( only 2 in place at the moment)	
2x overhead closers	
<b>Priority</b>	
Priority:	2

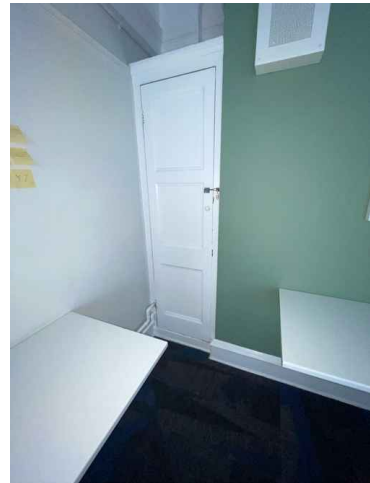
Photo(s)  
Photo 1 of 1

Does the door have an electronically powered hold open device?:	N/A
Lock And Latch	
Does the door have a lock and/or latch? :	N/A
Glazing And Glass	
Does the door leaf contain a vision panel(s)?:	N/A
Side And Overpanels	
Are there side and overpanels installed?:	N/A
Summary	
Summary / Recomendations:	
No access during the time of survey

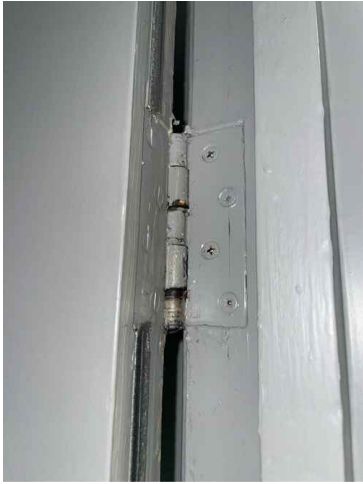
Photo(s)  
Photo 1 of 4

Are the glazing beads correctly attached to the frame from both sides and free from damage?:	Yes
Is the glass free from damage and cracking?:	N/A
Is the glass identified as fire rated?:	Yes
If glazing panels are below 1500mm from bottom of door, is the glass safety glass?:	N/A
<b>Side And Overpanels</b>	
Are there side and overpanels installed?:	No
<b>Maintenance Remedial Works Required</b>	
Door gaps:	Ease and Adjustment, Install Lipping (BE), Install face-mounted drop-down seal
Door seals:	10mm intumescent/brush seals
Ironmongery:	3x Grade 13 hinges
Other:	FDKS
<b>Summary</b>	
<b>Summary / Recomendations:</b>	
Ease and adjustment	
10mm intumescent brush strips	
3x grade 13 hinges	
BE lipping , BE gap 20mm	
Face mounted drop down seal ( leaf 810mm)	
<b>Priority</b>	
Priority:	2

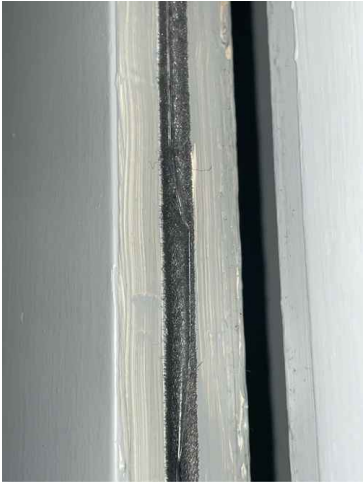
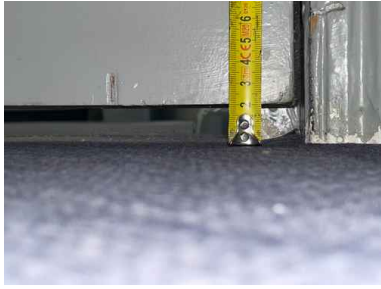
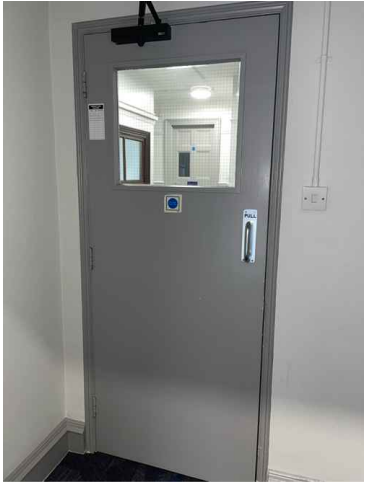
<b>Door Label</b>	
<b>Floor /Level:</b>	3
<b>Door Reference:</b>	Cross corridor
<b>Current FR:</b>	30
<b>Required FR:</b>	30
<b>Has the fire door got a third party fire door scheme label or plug fitted?:</b>	No
<b>Can you confirm that the door is in fact a fire door and has been proven as such?:</b>	Nominal fd30
<b>Door type</b>	
<b>Door set type:</b>	Single Leaf - Single Action
<b>Door Aesthetics :</b>	Painted
<b>Architrave type:</b>	Bullnose
<b>Door leaf handing:</b>	Left-handed
<b>Door set condition</b>	
<b>Is the door set free from damage?:</b>	Yes
<b>Maintenance or no action?:</b>	Maintenance
<b>Door Leaf</b>	
<b>Does the door leaf sit against the door stop and is it free from distortion?:</b>	Yes
<b>If the door is veneered or lipped, is the glue still holding these products firmly in place?:</b>	Yes
<b>Is the door leaf free from damage affecting its fire integrity?:</b>	Yes
<b>Does the door have the correct signage?:</b>	No

<b>Door Frame</b>	
<b>Is the door frame firmly attached to the wall?:</b>	Yes
<b>If a planted door stop is present, is it firmly attached?:</b>	Yes
<b>Are the frame to door leaf gaps in line with the manufacturers installation instructions/testing? :</b>	Yes
<b>Is the door frame free from damage affecting its fire integrity?:</b>	Yes
<b>Is there a consistent gap under the door that allows it to swing without touching floor covering?:</b>	Yes
<b>Is the door to floor covering gap in line with the manufacturer's installation instructions / testing?:</b>	No
<b>Intumescent/Smoke/Acoust Seals</b>	
<b>Are intumescent seals in place?:</b>	Yes
<b>Are the seals free from damage?:</b>	No
<b>Are the smoke seals free from paint or varnish?:</b>	No
<b>Are the seals well attached inside the groove in the frame or door leaf?:</b>	Yes
<b>Are the seals continuous around the frame or door leaf?:</b>	Yes
<b>Is the smoke seal in full contact with the door giving an effective seal?:</b>	No

<b>Hinges</b>	
<b>Is there a minimum of three hinges with all of the screws fitted?:</b>	Yes
<b>Are all the ironmongery screws secure and the correct size?:</b>	No
<b>Are the hinges free of metal fragment and oil leakage, which show signs of wear?:</b>	No
<b>Are intumescent packers installed behind hinge?:</b>	Unable to Verify

Is all the ironmongery marked with CE stamp or BSEN 1935 grade 13 (or international equivalent)?:	No
Is all ironmongery free from damage and operating correctly?:	No
<b>Door Closers</b>	
Does the door have a closer?:	Yes
Open the door to 5 degrees or 75mm. Does it close and engage with the latch?:	Yes
Is the closer correctly attached to the door and frame?:	Yes
Is the closer free from damage and not leaking?:	Yes
If unlatched, does the closer hold the door in line with the frame and intumescent seal?:	Yes
If hung in pairs, do they close in line if both opened and released together? (optional):	N/A
Does the door close within the specified time required?:	Yes
<b>Hold Open Devices</b>	
Does the door have an electronically powered hold open device?:	No
<b>Lock And Latch</b>	
Does the door have a lock and/or latch? :	No
<b>Glazing And Glass</b>	
Does the door leaf contain a vision panel(s)?:	Yes
Is the intumescent seal continuous and attached to the glass and bead?:	Yes

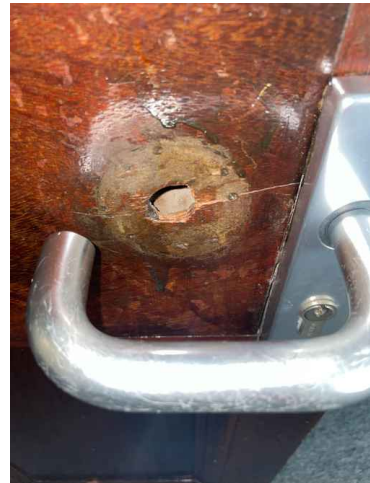
Photo(s)  
Photo 1 of 4

Does the door have an electronically powered hold open device?:	N/A
Lock And Latch	
Does the door have a lock and/or latch? :	N/A
Glazing And Glass	
Does the door leaf contain a vision panel(s)?:	N/A
Side And Overpanels	
Are there side and overpanels installed?:	N/A
Replacement door leaf/ Replacement door set	
Replacement door set (structural opening) width:	950
Replacement door set (structural opening) height:	2065
Replacement door set (structural opening) wall depth:	270
Architrave width:	130
Summary	
Summary / Recomendations:	
Due to excessive damage on door leaf all door set need to be replaced inclusive of following:	
3x grade 13 hinges	
2x FDKS fixed signage	
1x overhead closer	
15mm intumescent brush strips	
Full lock and latch including handles	
Thumb turn euro cylinder	
1x vp ( 250x510mm )	
Aesthetic See picture	
Priority	
Priority:	2

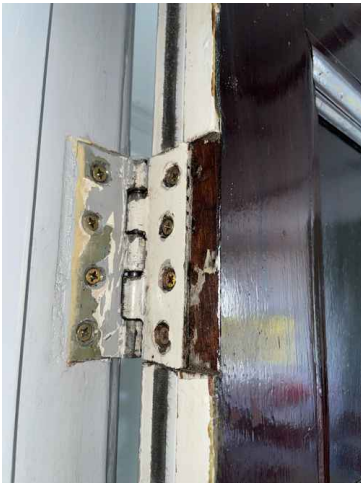
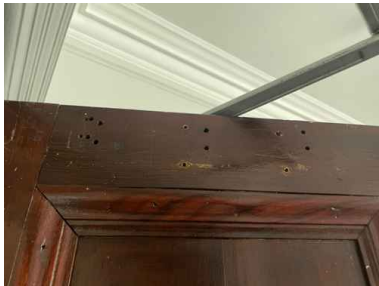
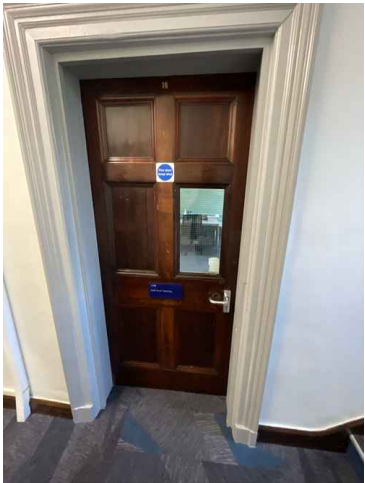
<b>Door Label</b>	
<b>Floor /Level:</b>	3
<b>Door Reference:</b>	Cross corridor
<b>Current FR:</b>	30
<b>Required FR:</b>	30
<b>Has the fire door got a third party fire door scheme label or plug fitted?:</b>	No
<b>Can you confirm that the door is in fact a fire door and has been proven as such?:</b>	Nominal fd30
<b>Door type</b>	
<b>Door set type:</b>	Single Leaf - Single Action
<b>Door Aesthetics :</b>	Painted
<b>Architrave type:</b>	Bullnose
<b>Door leaf handing:</b>	Right-handed
<b>Door set condition</b>	
<b>Is the door set free from damage?:</b>	Yes
<b>Maintenance or no action?:</b>	Maintenance
<b>Door Leaf</b>	
<b>Does the door leaf sit against the door stop and is it free from distortion?:</b>	Yes
<b>If the door is veneered or lipped, is the glue still holding these products firmly in place?:</b>	Yes
<b>Is the door leaf free from damage affecting its fire integrity?:</b>	Yes
<b>Does the door have the correct signage?:</b>	N/A

<b>Door Frame</b>	
<b>Is the door frame firmly attached to the wall?:</b>	Yes
<b>If a planted door stop is present, is it firmly attached?:</b>	Yes
<b>Are the frame to door leaf gaps in line with the manufacturers installation instructions/testing? :</b>	Yes
<b>Is the door frame free from damage affecting its fire integrity?:</b>	Yes
<b>Is there a consistent gap under the door that allows it to swing without touching floor covering?:</b>	Yes
<b>Is the door to floor covering gap in line with the manufacturer's installation instructions / testing?:</b>	No
<b>Intumescent/Smoke/Acoust Seals</b>	
<b>Are intumescent seals in place?:</b>	Yes
<b>Are the seals free from damage?:</b>	No
<b>Are the smoke seals free from paint or varnish?:</b>	No
<b>Are the seals well attached inside the groove in the frame or door leaf?:</b>	Yes
<b>Are the seals continuous around the frame or door leaf?:</b>	Yes
<b>Is the smoke seal in full contact with the door giving an effective seal?:</b>	No

<b>Hinges</b>	
<b>Is there a minimum of three hinges with all of the screws fitted?:</b>	Yes
<b>Are all the ironmongery screws secure and the correct size?:</b>	Yes
<b>Are the hinges free of metal fragment and oil leakage, which show signs of wear?:</b>	No
<b>Are intumescent packers installed behind hinge?:</b>	Unable to Verify

Is all the ironmongery marked with CE stamp or BSEN 1935 grade 13 (or international equivalent)?:	No
Is all ironmongery free from damage and operating correctly?:	Yes
<b>Door Closers</b>	
Does the door have a closer?:	Yes
Open the door to 5 degrees or 75mm. Does it close and engage with the latch?:	Yes
Is the closer correctly attached to the door and frame?:	Yes
Is the closer free from damage and not leaking?:	Yes
If unlatched, does the closer hold the door in line with the frame and intumescent seal?:	Yes
If hung in pairs, do they close in line if both opened and released together? (optional):	N/A
Does the door close within the specified time required?:	Yes
<b>Hold Open Devices</b>	
Does the door have an electronically powered hold open device?:	No
<b>Lock And Latch</b>	
Does the door have a lock and/or latch? :	No
<b>Glazing And Glass</b>	
Does the door leaf contain a vision panel(s)?:	Yes
Is the intumescent seal continuous and attached to the glass and bead?:	Yes

Are the glazing beads correctly attached to the frame from both sides and free from damage?:	Yes
Is the glass free from damage and cracking?:	Yes
Is the glass identified as fire rated?:	Yes
If glazing panels are below 1500mm from bottom of door, is the glass safety glass?:	N/A
<b>Side And Overpanels</b>	
Are there side and overpanels installed?:	No
<b>Maintenance Remedial Works Required</b>	
Door gaps:	Ease and Adjustment, Install face-mounted drop-down seal
Door seals:	10mm intumescent/brush seals
Ironmongery:	3x Grade 13 hinges
<b>Summary</b>	
<b>Summary / Recommendations:</b>	
Ease and adjustment	
10mm intumescent brush strips	
3x grade 13 hinges	
Face mounted drop down seal ( leaf 910mm)	
<b>Priority</b>	
Priority:	2

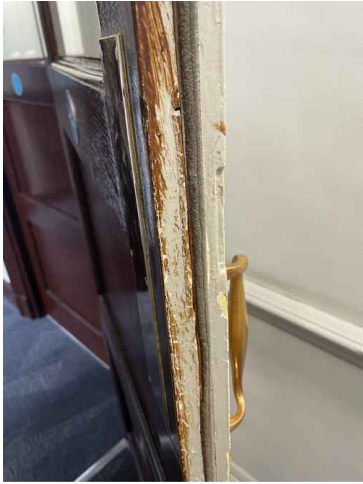
Photo(s)  
Photo 1 of 4

Are the glazing beads correctly attached to the frame from both sides and free from damage?:	Yes
Is the glass free from damage and cracking?:	Yes
Is the glass identified as fire rated?:	Yes
If glazing panels are below 1500mm from bottom of door, is the glass safety glass?:	N/A
<b>Side And Overpanels</b>	
Are there side and overpanels installed?:	No
<b>Maintenance Remedial Works Required</b>	
Door gaps:	Ease and Adjustment, Install face-mounted drop-down seal
Door seals:	10mm intumescent/brush seals
Ironmongery:	3x Grade 13 hinges, Closer replacement/installation
<b>Summary</b>	
<b>Summary / Recommendations:</b>	
Ease and adjustment	
10mm intumescent brush strips	
3x grade 13 hinges	
1x overhead closer	
Face mounted drop down seal ( leaf 790mm)	
<b>Priority</b>	
Priority:	2

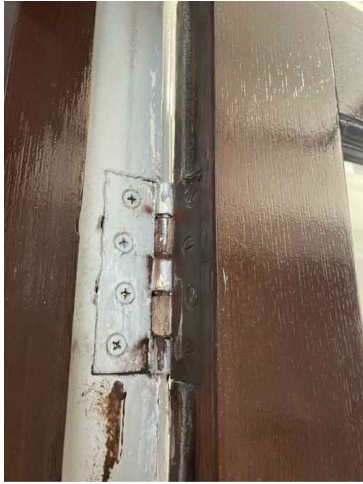
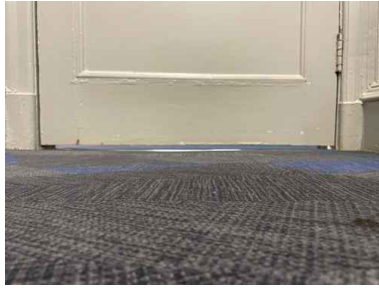
<b>Door Label</b>	
<b>Floor /Level:</b>	3
<b>Door Reference:</b>	Staircase
<b>Current FR:</b>	30
<b>Required FR:</b>	30
<b>Has the fire door got a third party fire door scheme label or plug fitted?:</b>	No
<b>Can you confirm that the door is in fact a fire door and has been proven as such?:</b>	Nominal fd30
<b>Door type</b>	
<b>Door set type:</b>	Single Leaf - Single Action
<b>Door Aesthetics :</b>	Painted
<b>Architrave type:</b>	Bullnose
<b>Door leaf handing:</b>	Right-handed
<b>Door set condition</b>	
<b>Is the door set free from damage?:</b>	Yes
<b>Maintenance or no action?:</b>	Maintenance
<b>Door Leaf</b>	
<b>Does the door leaf sit against the door stop and is it free from distortion?:</b>	Yes
<b>If the door is veneered or lipped, is the glue still holding these products firmly in place?:</b>	Yes
<b>Is the door leaf free from damage affecting its fire integrity?:</b>	Yes
<b>Does the door have the correct signage?:</b>	Yes

<b>Door Frame</b>	
<b>Is the door frame firmly attached to the wall?:</b>	Yes
<b>If a planted door stop is present, is it firmly attached?:</b>	Yes
<b>Are the frame to door leaf gaps in line with the manufacturers installation instructions/testing? :</b>	Yes
<b>Is the door frame free from damage affecting its fire integrity?:</b>	Yes
<b>Is there a consistent gap under the door that allows it to swing without touching floor covering?:</b>	Yes
<b>Is the door to floor covering gap in line with the manufacturer's installation instructions / testing?:</b>	No
<b>Intumescent/Smoke/Acoust Seals</b>	
<b>Are intumescent seals in place?:</b>	Yes
<b>Are the seals free from damage?:</b>	No
<b>Are the smoke seals free from paint or varnish?:</b>	No
<b>Are the seals well attached inside the groove in the frame or door leaf?:</b>	Yes
<b>Are the seals continuous around the frame or door leaf?:</b>	Yes
<b>Is the smoke seal in full contact with the door giving an effective seal?:</b>	No

<b>Hinges</b>	
<b>Is there a minimum of three hinges with all of the screws fitted?:</b>	No
<b>Are all the ironmongery screws secure and the correct size?:</b>	Yes
<b>Are the hinges free of metal fragment and oil leakage, which show signs of wear?:</b>	Yes
<b>Are intumescent packers installed behind hinge?:</b>	Unable to Verify

Is all the ironmongery marked with CE stamp or BSEN 1935 grade 13 (or international equivalent)?:	No
Is all ironmongery free from damage and operating correctly?:	No
<b>Door Closers</b>	
Does the door have a closer?:	Yes
Open the door to 5 degrees or 75mm. Does it close and engage with the latch?:	No
Is the closer correctly attached to the door and frame?:	Yes
Is the closer free from damage and not leaking?:	No
If unlatched, does the closer hold the door in line with the frame and intumescent seal?:	Yes
If hung in pairs, do they close in line if both opened and released together? (optional):	N/A
Does the door close within the specified time required?:	No
<b>Hold Open Devices</b>	
Does the door have an electronically powered hold open device?:	No
<b>Lock And Latch</b>	
Does the door have a lock and/or latch? :	No
<b>Glazing And Glass</b>	
Does the door leaf contain a vision panel(s)?:	Yes
Is the intumescent seal continuous and attached to the glass and bead?:	Yes

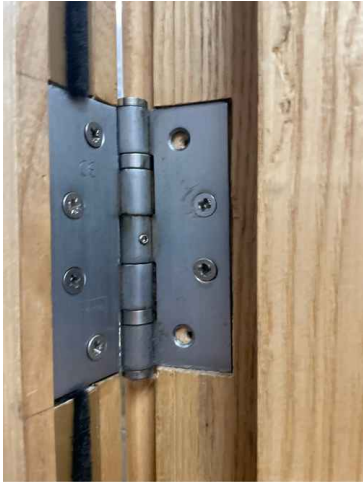
Photo(s)  
Photo 1 of 4

<b>Glazing And Glass</b>	
Does the door leaf contain a vision panel(s)?:	Yes
Is the intumescent seal continuous and attached to the glass and bead?:	Yes
Are the glazing beads correctly attached to the frame from both sides and free from damage?:	Yes
Is the glass free from damage and cracking?:	Yes
Is the glass identified as fire rated?:	Yes
If glazing panels are below 1500mm from bottom of door, is the glass safety glass?:	N/A
<b>Side And Overpanels</b>	
Are there side and overpanels installed?:	No
<b>Maintenance Remedial Works Required</b>	
Door gaps:	Ease and Adjustment
Door seals:	15mm intumescent/brush seals
Ironmongery:	Replacement screws
Other:	AFDCK
<b>Summary</b>	
<b>Summary / Recomendations:</b>	
Ease and adjustment	
Screws missing from hinges	
20mm intumescent brush strips	
Escutcheon	
2x AFDCK fixed signage	
<b>Priority</b>	
Priority:	2

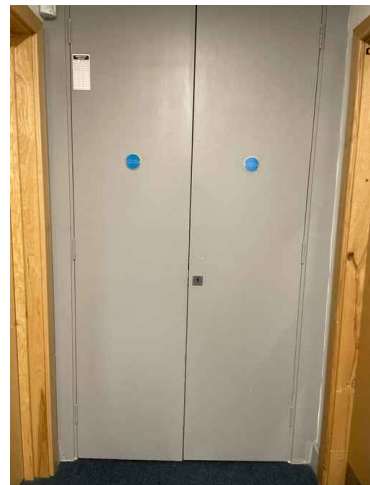
Photo(s)  
Photo 1 of 1

Does the door have an electronically powered hold open device?:	N/A
Lock And Latch	
Does the door have a lock and/or latch? :	N/A
Glazing And Glass	
Does the door leaf contain a vision panel(s)?:	N/A
Side And Overpanels	
Are there side and overpanels installed?:	N/A
Summary	
Summary / Recomendations:	
No access during the time of survey

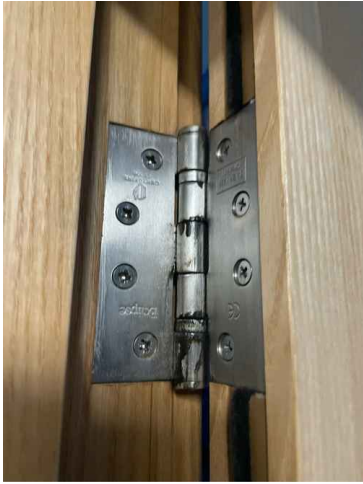
Photo(s)  
Photo 1 of 4

<b>Glazing And Glass</b>	
Does the door leaf contain a vision panel(s)?:	Yes
Is the intumescent seal continuous and attached to the glass and bead?:	Yes
Are the glazing beads correctly attached to the frame from both sides and free from damage?:	Yes
Is the glass free from damage and cracking?:	Yes
Is the glass identified as fire rated?:	Yes
If glazing panels are below 1500mm from bottom of door, is the glass safety glass?:	N/A
<b>Side And Overpanels</b>	
Are there side and overpanels installed?:	No
<b>Maintenance Remedial Works Required</b>	
Door gaps:	Ease and Adjustment, Install face-mounted drop-down seal
Door seals:	15mm intumescent/brush seals
Ironmongery:	3x Grade 13 hinges
Other:	FDKS
<b>Summary</b>	
<b>Summary / Recommendations:</b>	
Ease and adjustment	
3x grade 13 hinges	
20mm intumescent brush strips	
2x FDKS fixed signage	
Face mounted drop down seal ( leaf 810mm)	
<b>Priority</b>	
Priority:	2

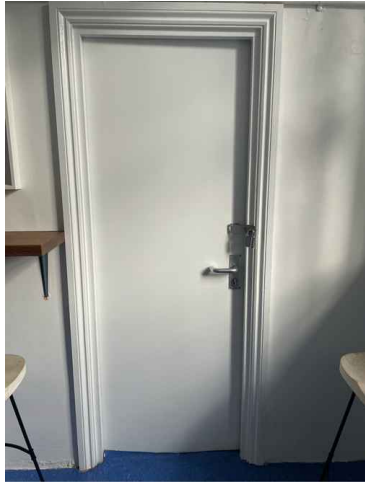
Photo(s)  
Photo 1 of 1

Does the door have an electronically powered hold open device?:	N/A
Lock And Latch	
Does the door have a lock and/or latch? :	N/A
Glazing And Glass	
Does the door leaf contain a vision panel(s)?:	N/A
Side And Overpanels	
Are there side and overpanels installed?:	N/A
Summary	
Summary / Recomendations:	
No access during the time of survey	
No keys provided

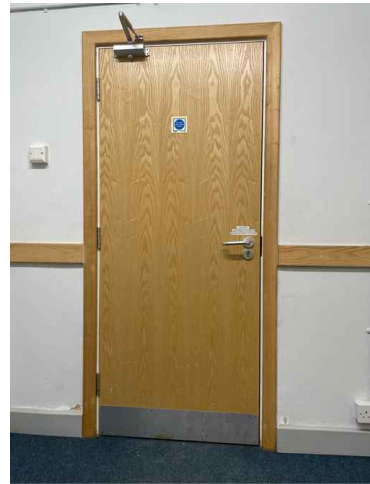
Photo(s)  
Photo 1 of 1

Does the door have an electronically powered hold open device?:	N/A
Lock And Latch	
Does the door have a lock and/or latch? :	N/A
Glazing And Glass	
Does the door leaf contain a vision panel(s)?:	N/A
Side And Overpanels	
Are there side and overpanels installed?:	N/A
Summary	
Summary / Recomendations:	
No access during the time of survey	
No keys provided

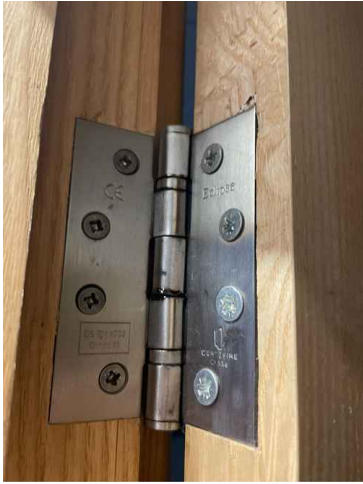
Photo(s)  
Photo 1 of 4

Does the door leaf contain a vision panel(s)?:	Yes
Is the intumescent seal continuous and attached to the glass and bead?:	Yes
Are the glazing beads correctly attached to the frame from both sides and free from damage?:	Yes
Is the glass free from damage and cracking?:	Yes
Is the glass identified as fire rated?:	Yes
If glazing panels are below 1500mm from bottom of door, is the glass safety glass?:	N/A
<b>Side And Overpanels</b>	
Are there side and overpanels installed?:	No
<b>Maintenance Remedial Works Required</b>	
Door gaps:	Ease and Adjustment
Door seals:	15mm intumescent/brush seals
Ironmongery:	3x Grade 13 hinges, Closer replacement/installation
Other:	FDKS
<b>Summary</b>	
<b>Summary / Recommendations:</b>	
Ease and adjustment	
20mm intumescent brush strips	
3x grade 13 hinges	
2x FDKS fixed signage	
<b>Priority</b>	
Priority:	2

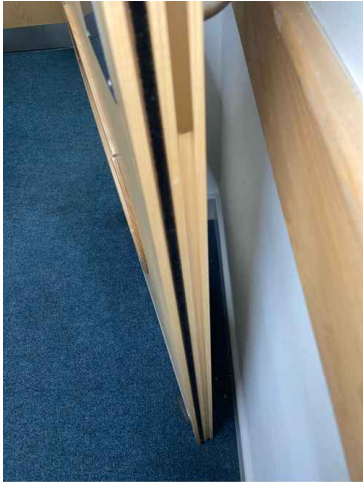
Photo(s)  
Photo 1 of 3

Does the door leaf contain a vision panel(s)?:	Yes
Is the intumescent seal continuous and attached to the glass and bead?:	Yes
Are the glazing beads correctly attached to the frame from both sides and free from damage?:	Yes
Is the glass free from damage and cracking?:	Yes
Is the glass identified as fire rated?:	Yes
If glazing panels are below 1500mm from bottom of door, is the glass safety glass?:	N/A
<b>Side And Overpanels</b>	
Are there side and overpanels installed?:	No
<b>Maintenance Remedial Works Required</b>	
Door seals:	10mm intumescent/brush seals
Ironmongery:	6x Grade 13 hinges
Other:	FDKS
<b>Summary</b>	
<b>Summary / Recommendations:</b>	
10mm intumescent brush strips	
6x grade 13 hinges	
4x FDKS fixed signage	
<b>Priority</b>	
Priority:	2

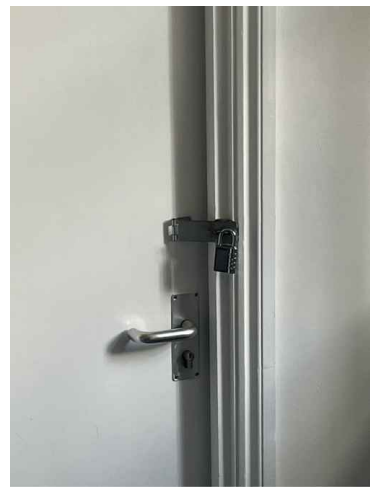
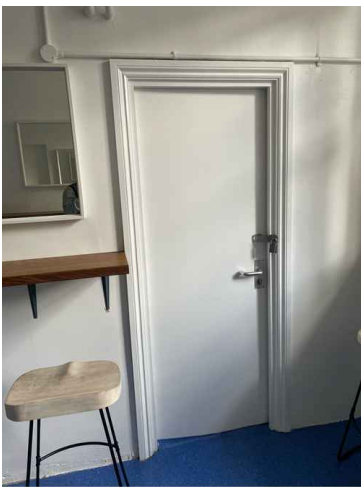
Does the door have an electronically powered hold open device?:	N/A
Lock And Latch	
Does the door have a lock and/or latch? :	N/A
Glazing And Glass	
Does the door leaf contain a vision panel(s)?:	N/A
Side And Overpanels	
Are there side and overpanels installed?:	N/A
Summary	
Summary / Recomendations:	
No access during the time of survey	
No keys provided	
Access from locker room

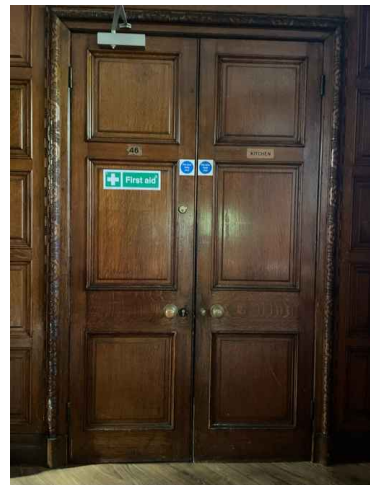
Photo(s)  
Photo 1 of 1

Does the door have an electronically powered hold open device?:	N/A
Lock And Latch	
Does the door have a lock and/or latch? :	N/A
Glazing And Glass	
Does the door leaf contain a vision panel(s)?:	N/A
Side And Overpanels	
Are there side and overpanels installed?:	N/A
Summary	
Summary / Recomendations:	
No access during the time of survey

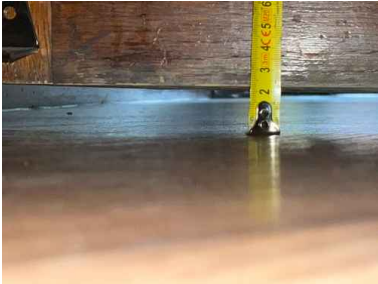
Photo(s)  
Photo 1 of 4

Door gaps:	Ease and Adjustment, Install Lipping (BE), Install face-mounted drop-down seal
Door seals:	15mm intumescent/brush seals
Ironmongery:	3x Grade 13 hinges
Other:	FDKS
<b>Summary</b>	
<b>Summary / Recommendations:</b>	
Due to listed doorset in situ, remedial works limited to:	
Surface mount brush strips(15mm )	
4 grade 13 hinges	
FDKS Sticker signage	
BE lipping, BE gap 23mm	
Face mounted drop down seal ( leaf 940mm)

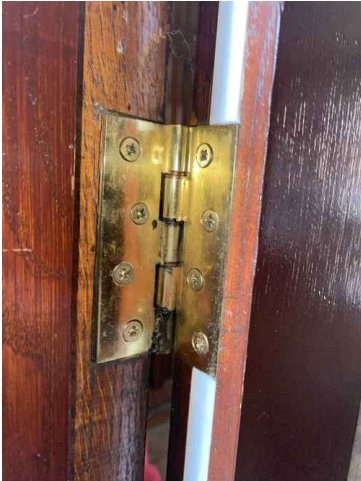
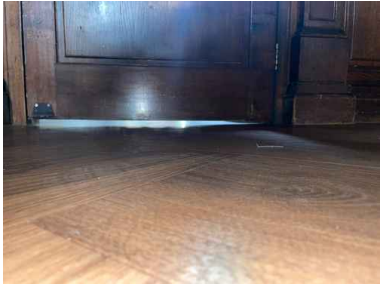
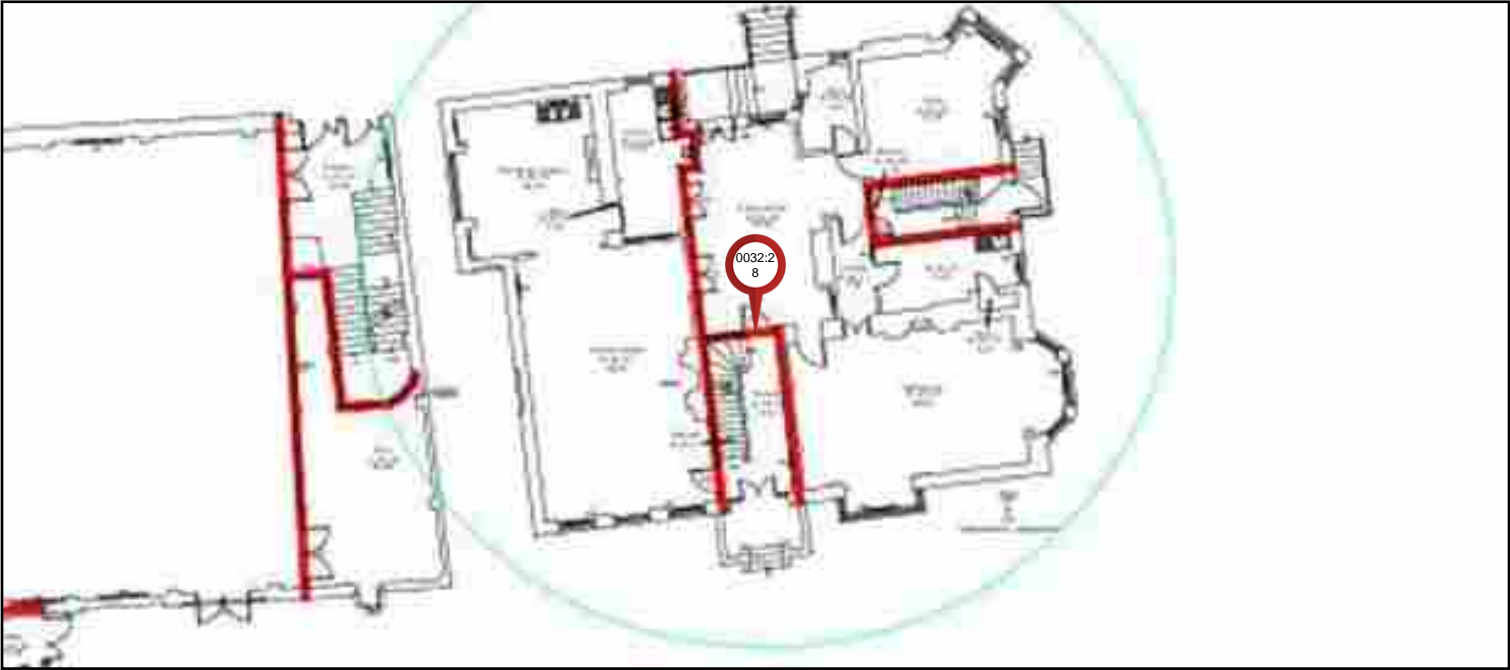
<b>Is all the ironmongery marked with CE stamp or BSEN 1935 grade 13 (or international equivalent)?:</b>	N/A
<b>Is all ironmongery free from damage and operating correctly?:</b>	N/A
<b>Door Closers</b>	
<b>Does the door have a closer?:</b>	N/A
<b>Hold Open Devices</b>

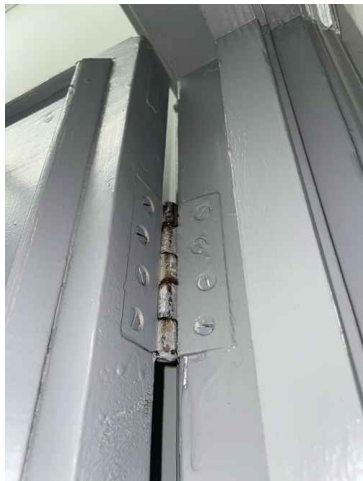
Photo(s)  
Photo 1 of 4

Door seals:	15mm intumescent/brush seals
Ironmongery:	3x Grade 13 hinges, Closer Adjustment
Other:	FDKS
<b>Summary</b>	
<b>Summary / Recomendations:</b>	
Due to listed doorset in situ, remedial works limited to:	
Surface mount brush strips(15mm )	
3 grade 13 hinges	
FDKS Sticker signage	
Face mounted drop down seal (leaf 680mm)	
Closer adjustment	
<b>Priority</b>	
Priority:	2
