## **Fire Doors Report**

### **Element Passive Fire Protection Ltd**

South Hampstead High School (GDST)

EL1171 - South Hampstead High School - All Floors

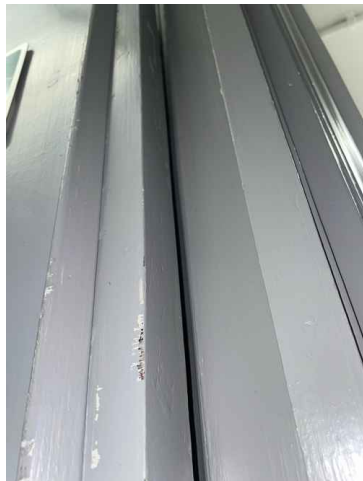
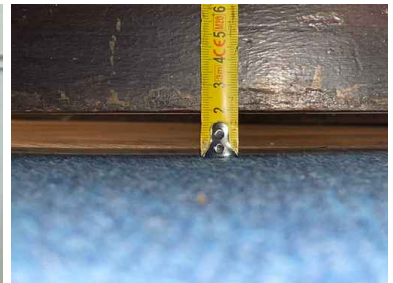
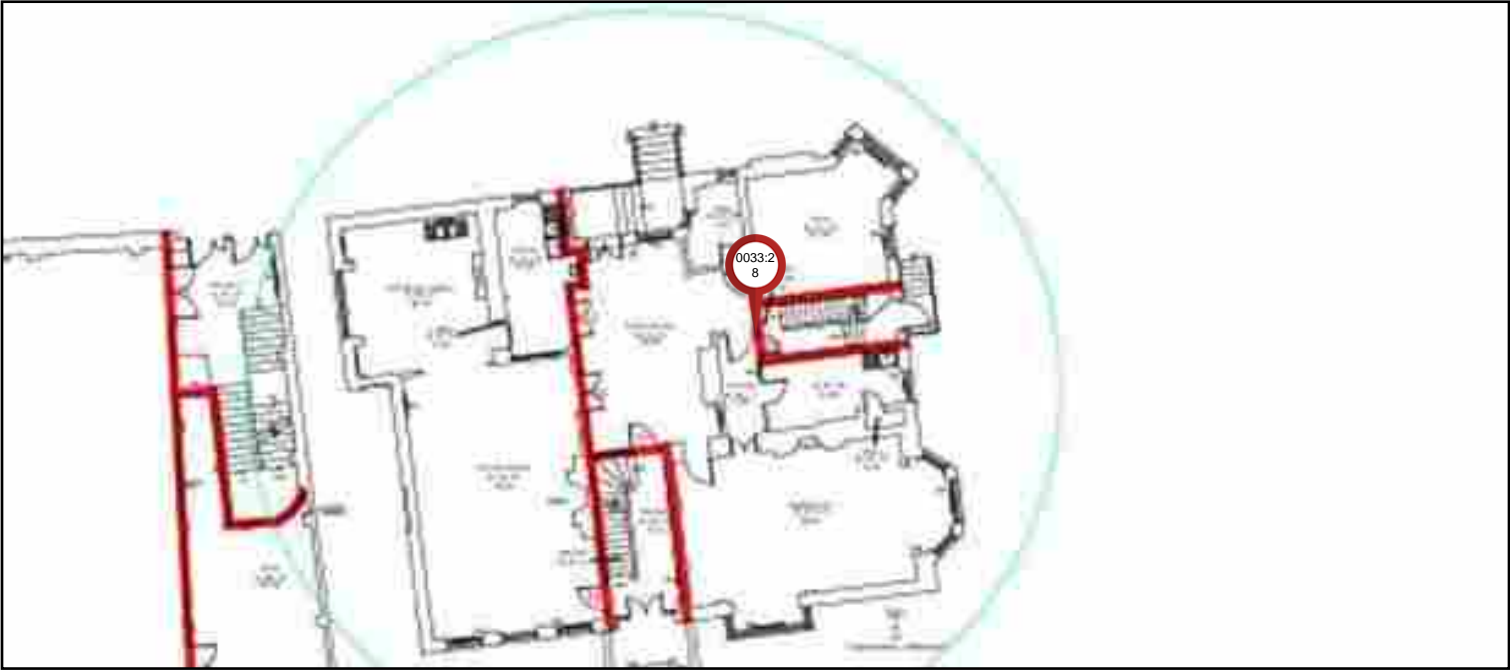
Door Label	
Floor /Level:	G
Door Reference:	Staircase
Current FR:	30
Required FR:	30
Has the fire door got a third party fire door scheme label or plug fitted?:	No
Can you confirm that the door is in fact a fire door and has been proven as such?:	Nominal fd30
Door type	
Door set type:	Single Leaf - Single Action
Door Aesthetics :	Painted, Walnut Veneer
Architrave type:	Bullnose
Door leaf handing:	Left-handed
Door set condition	
Is the door set free from damage?:	Yes
Maintenance or no action?:	Maintenance
Door Leaf	
Does the door leaf sit against the door stop and is it free from distortion?:	Yes
If the door is veneered or lipped, is the glue still holding these products firmly in place?:	Yes
Is the door leaf free from damage affecting its fire integrity?:	Yes
Does the door have the correct signage?:	No
Door Frame	
Is the door frame firmly attached to the wall?:	Yes
If a planted door stop is present, is it firmly attached?:	Yes

Are the frame to door leaf gaps in line with the manufacturers installation instructions/testing? :	Yes
Is the door frame free from damage affecting its fire integrity?:	Yes
Is there a consistent gap under the door that allows it to swing without touching floor covering?:	Yes
Is the door to floor covering gap in line with the manufacturer's installation instructions / testing?:	No
Threshold Gap:	18
Intumescent/Smoke/Acoust Seals	
Are intumescent seals in place?:	No
Hinges	
Is there a minimum of three hinges with all of the screws fitted?:	No
Are all the ironmongery screws secure and the correct size?:	Yes
Are the hinges free of metal fragment and oil leakage, which show signs of wear?:	No
Are intumescent packers installed behind hinge?:	Unable to Verify
Is all the ironmongery marked with CE stamp or BSEN 1935 grade 13 (or international equivalent)?:	No
Is all ironmongery free from damage and operating correctly?:	No

Open the door to 5 degrees or 75mm. Does it close and engage with the latch?:	Yes
Is the closer correctly attached to the door and frame?:	Yes
Is the closer free from damage and not leaking?:	Yes
If unlatched, does the closer hold the door in line with the frame and intumescent seal?:	Yes
If hung in pairs, do they close in line if both opened and released together? (optional):	N/A
Does the door close within the specified time required?:	No
<b>Hold Open Devices</b>	
Does the door have an electronically powered hold open device?:	No
<b>Lock And Latch</b>	
Does the door have a lock and/or latch? :	Yes
Does the latch hold the door firmly in place without rattling?:	Yes
<b>Glazing And Glass</b>	
Does the door leaf contain a vision panel(s)?:	No
<b>Side And Overpanels</b>	
Are there side and overpanels installed?:	No
<b>Maintenance Remedial Works Required</b>	
Door gaps:	Ease and Adjustment, Install face-mounted drop-down seal

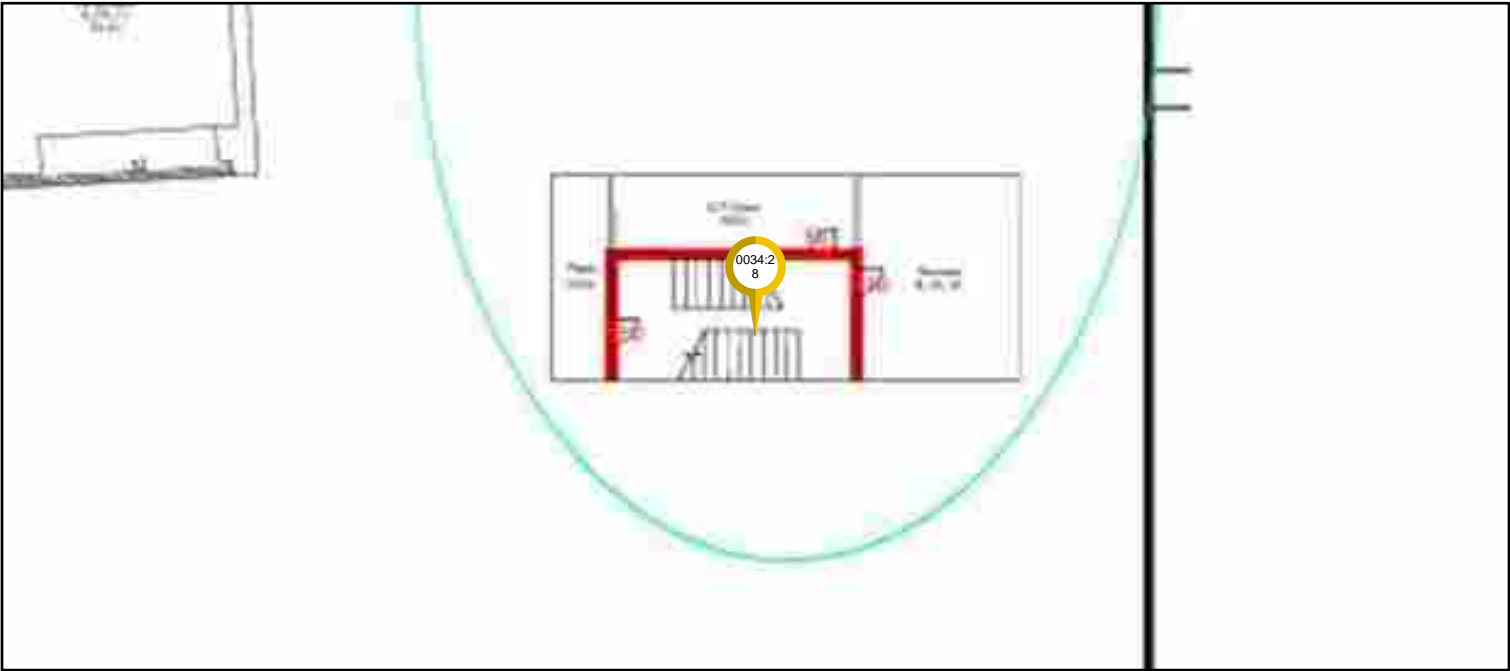
Photo(s)  
Photo 1 of 1

<b>Door Label</b>	
<b>Floor /Level:</b>	5
<b>Door Reference:</b>	Top floor
<b>Current FR:</b>	30
<b>Required FR:</b>	30
<b>Has the fire door got a third party fire door scheme label or plug fitted?:</b>	No
<b>Door type</b>	
<b>Door set type:</b>	Single Leaf - Single Action
<b>Door Aesthetics :</b>	Painted
<b>Architrave type:</b>	Torus
<b>Door leaf handing:</b>	Right-handed
<b>Door set condition</b>	
<b>Is the door set free from damage?:</b>	Yes
<b>Maintenance or no action?:</b>	No action
<b>Door Leaf</b>	
<b>Does the door leaf sit against the door stop and is it free from distortion?:</b>	N/A
<b>If the door is veneered or lipped, is the glue still holding these products firmly in place?:</b>	N/A
<b>Is the door leaf free from damage affecting its fire integrity?:</b>	N/A
<b>Does the door have the correct signage?:</b>	N/A
<b>Door Frame</b>	
<b>Is the door frame firmly attached to the wall?:</b>	N/A
<b>If a planted door stop is present, is it firmly attached?:</b>	N/A
