A-squared Studio

14 Blackburn Road, London, NW6 1RZ

Phase I Desk Study

3749-A2S-XX-XX-RP-Y-0001-02

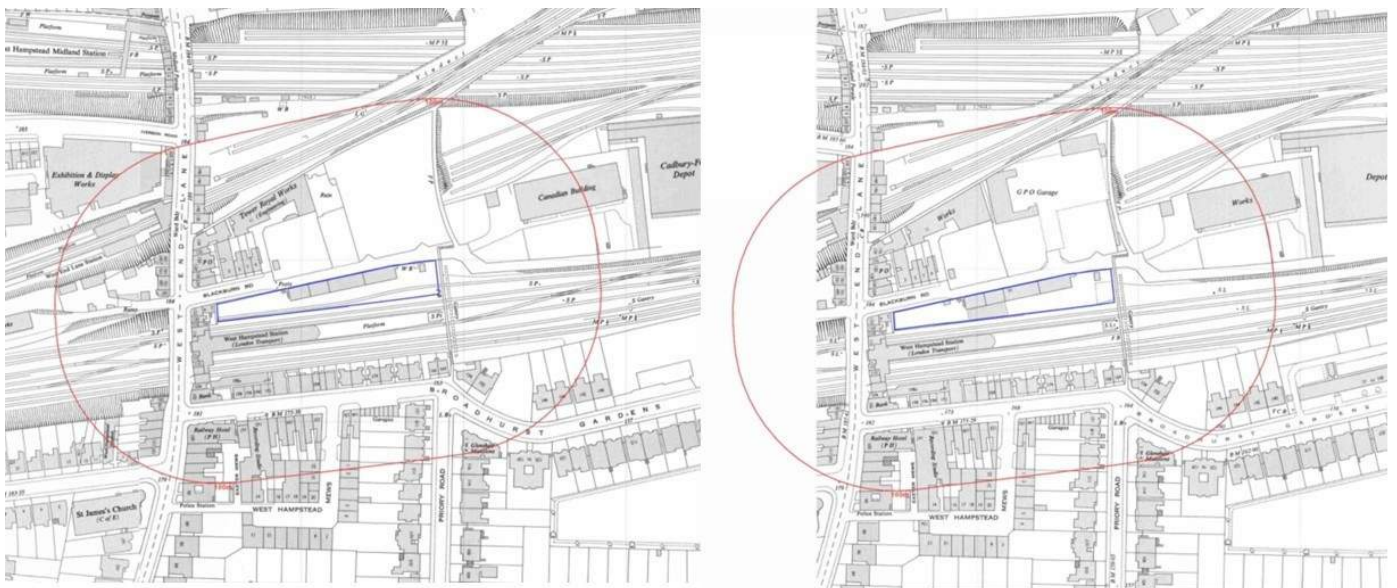
Figure 3.3 Historical maps dated to 1953 (left) and 1960 (right) © Ordnance Survey (1:2,500 scale)

With reference to the map dated 1953 (left image of Figure 3.3), no discernible changes were noted on-site. The wider area remained largely unchanged apart from the emergence of *Tower Royal Works (Engineering)* approximately 65m north-northwest, a *ruin* approximately 70m north, *exhibition & display works* approximately 100m northeast and a *Cadbury-Fry Depot* approximately 200m northeast. *Garages* were also present approximately 180m north and 70m south of the Site. By 1960 (as show in the right image of Figure 3.3), the railway track located on-site had been removed and a new structure built along the southern-south-central portion of the Site. The wider area remained relatively unchanged in the 1960's other than the notable development of a new garage, named *GPO Garage* (15m north), and a *works* (17m east). It is noted that the *GPO Garage* is later associated with a Mercedes Benz garage and car dealership.

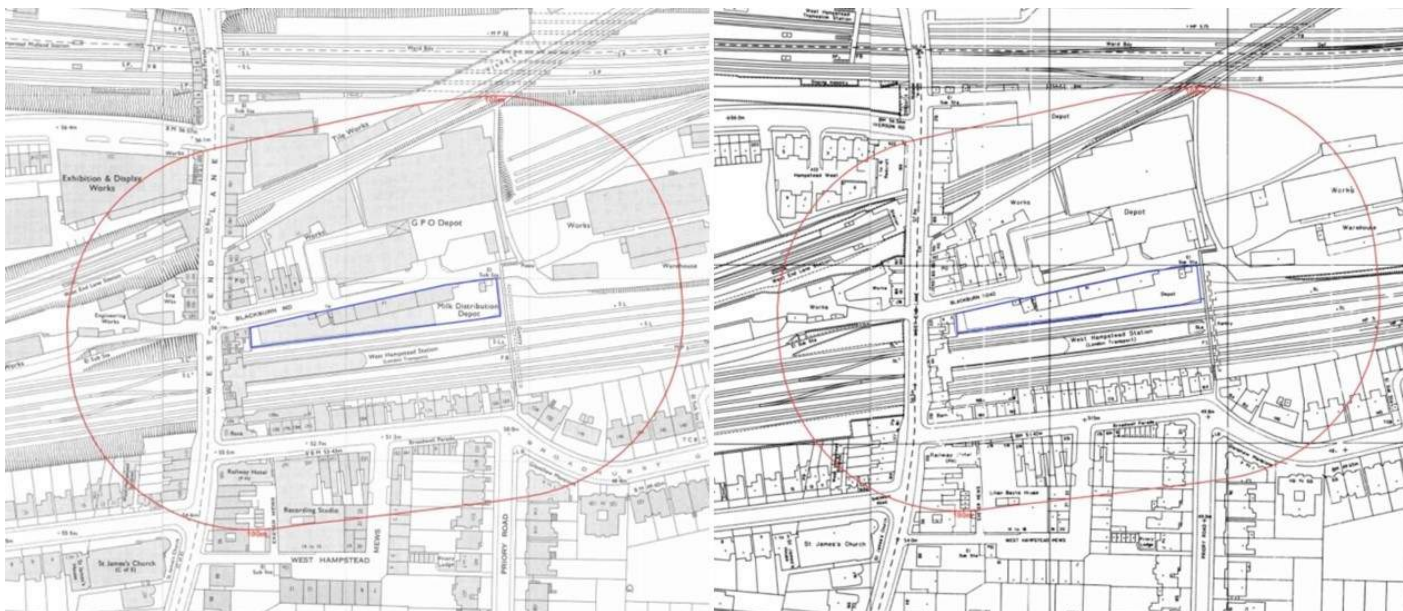
Figure 3.4 Historical maps dated to 1974 (left) and 1992 (right) © Ordnance Survey (1:2,500 scale)

By 1974 (left image of Figure 3.4), the Site had been developed into a *Milk Distribution Depot* with the western expansion of the structures already present. An electrical substation is noted to have been constructed in the northeastern portion of the of the Site, which currently stands to the present day. In the surrounding area by 1974, the former *Canadian Building* and *cocoa factory* had been converted into *depots*, *works*, and *warehouses*. Between 1974 and 1992 (as shown in Figure 3.4), very little change had occurred on-site with notable changes in the surrounding area including the demolition of the *exhibition & display works* followed by subsequent redevelopment into a residential estate and the change in name of new *engineering works* to *works*.

No discernible changes were observed in the vicinity of the Site. Small changes were observed on-site between 1992 and 2010, notably the change in name of the *milk depot* to *depot*.

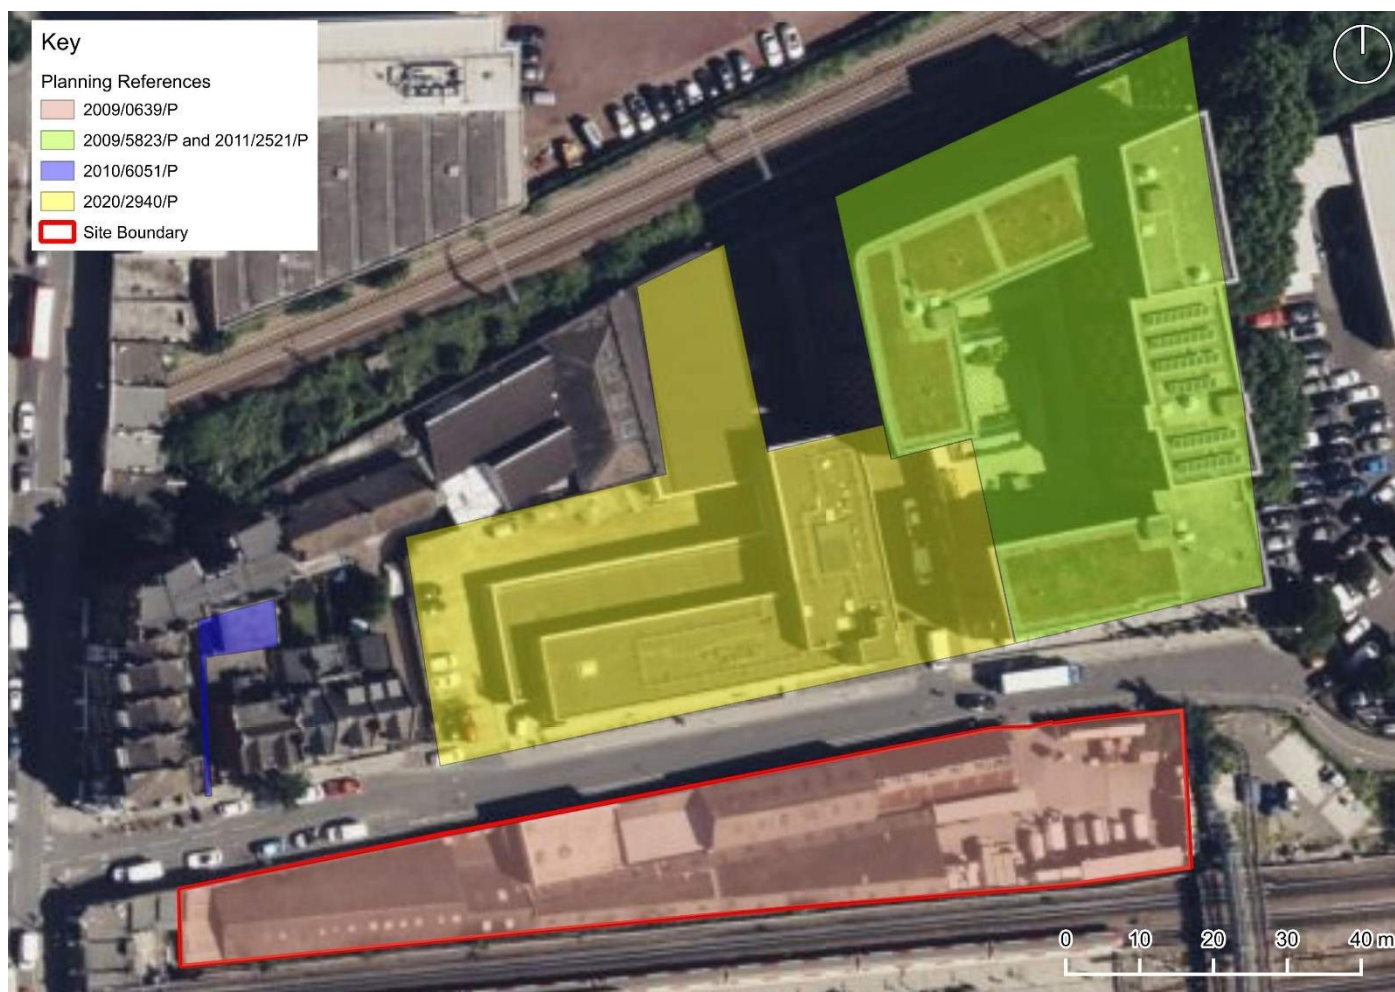
Figure 4.1 Planning References with relevant geo-environmental documentation

The identified planning references are spatially illustrated in relation to the Site in Figure 4.1.
