**12 Pilgrims Lane
London
NW3 1SN**

Site Investigation &
Basement Impact Assessment
Report

J21282
Rev 4

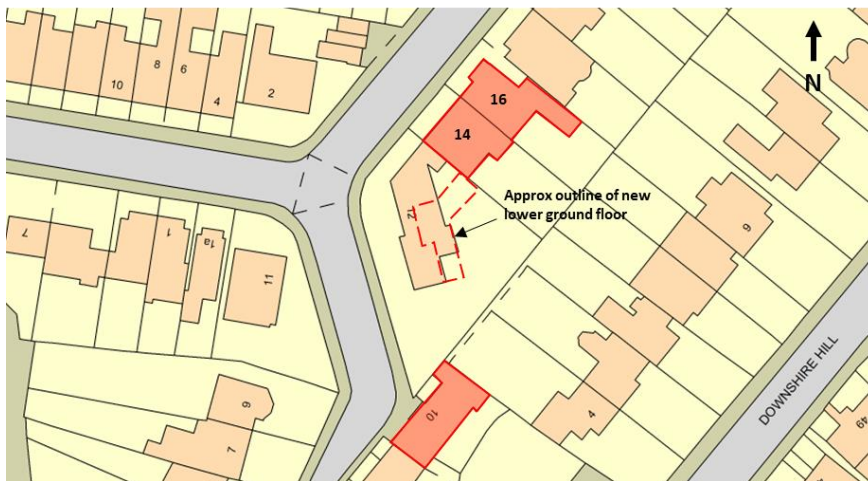
Nearby sensitive structures comprise the adjoining 14 and 16 Pilgrims Lane to the northeast and 10 Pilgrims Lane to the south, as shown on the plan below.

The heights of the buildings have been estimated from observation, and from drawings provided by the consulting engineers. The underside of the foundations of 14 Pilgrims Lane have been determined based on the trial pitting described in the previous section, and the foundations of 16 Pilgrims Lane, which adjoins 14, have been assumed to be the same. The foundations of 10 Pilgrims Lane have been assumed. The heights and underside of foundations are summarised on the table below.

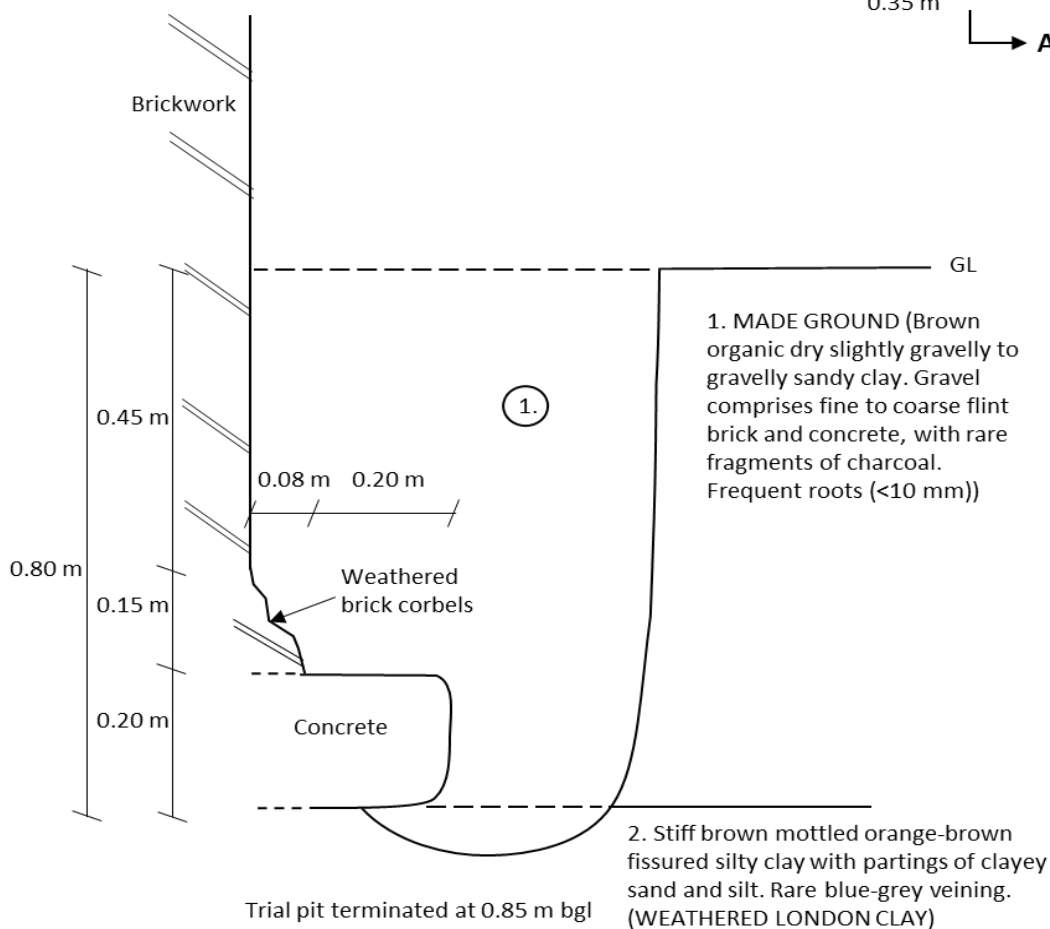
TP3: Section A-A

Front wall

| Trial Pit No | Structure | Foundation detail | Bearing Stratum |
|---|---|---|---|
| 3 | Front Wall | Brickwork over concrete strip / trench fill foundation Top: 0.55 m Base: 0.75 m Lateral projection: 280 mm | Stiff brown mottled orange-brown fissured silty clay with partings of clayey sand and silt. Rare blue-grey veining. |
