Sample Panel Record for glazed brickwork repairs

**Grand Connaught Rooms Lightwell, Freemasons Hall,
60 Great Queen Street, London, WC2B 5AZ**

Sample Panel Glazed Brickwork repairs

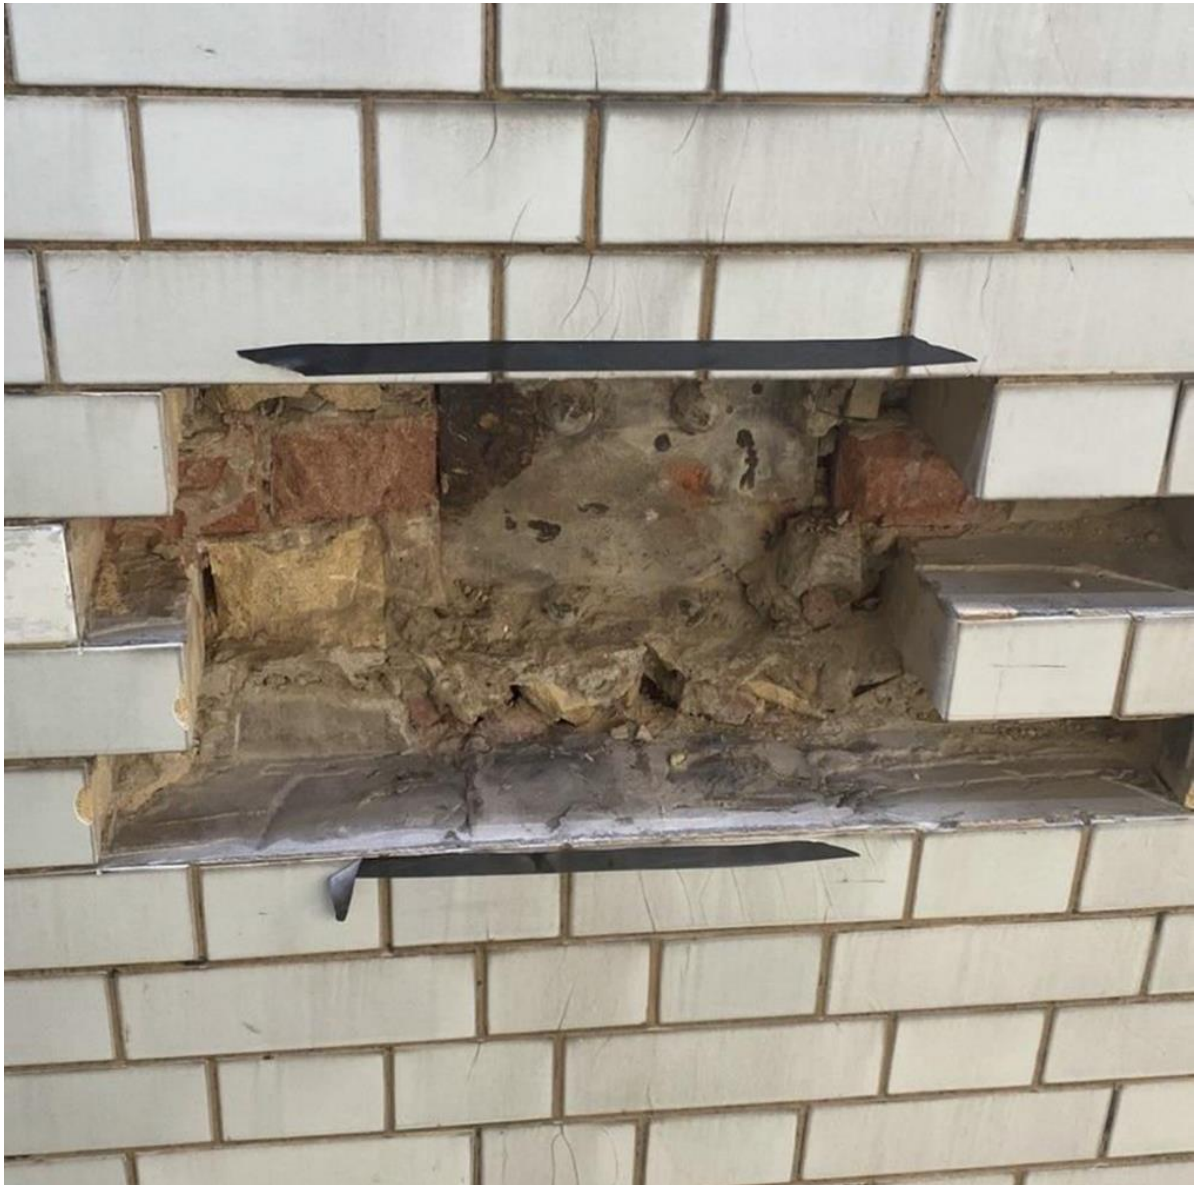
Photo 1. Existing brickwork opened up to investigate corroded steelwork.

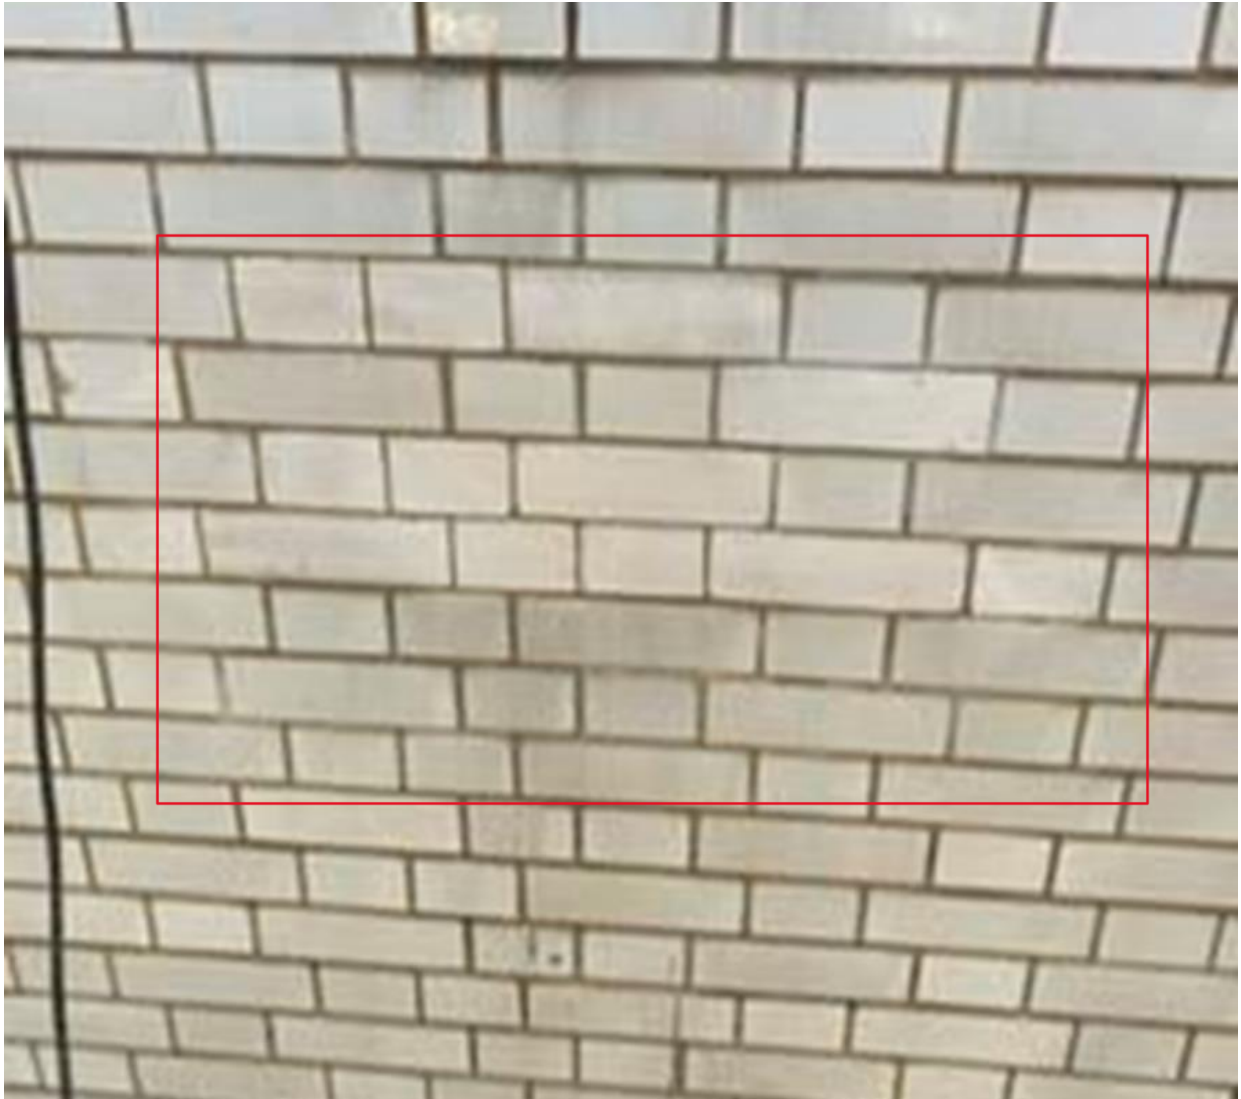
Photo 2. Reinstated brickwork repair.

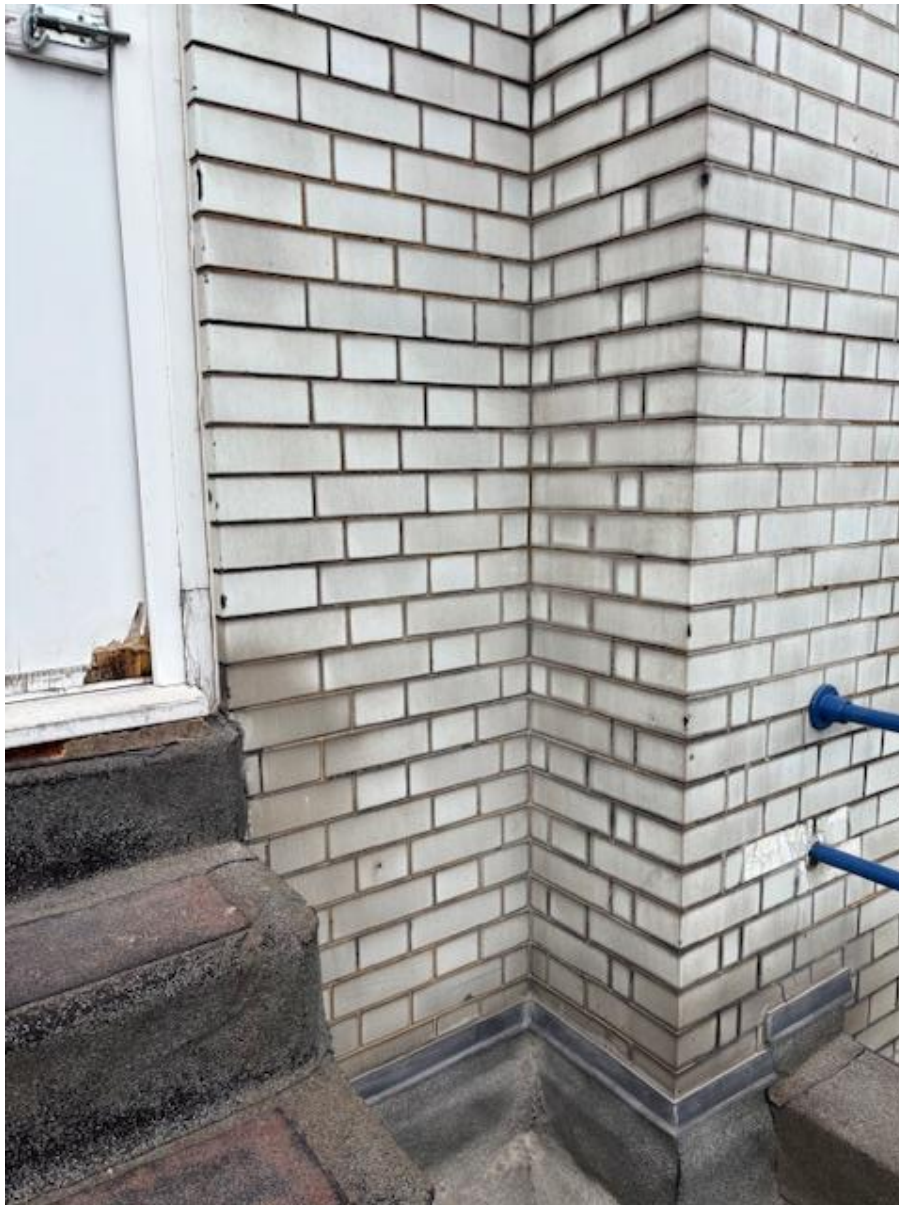
Photo 3. Existing glazed brickwork.

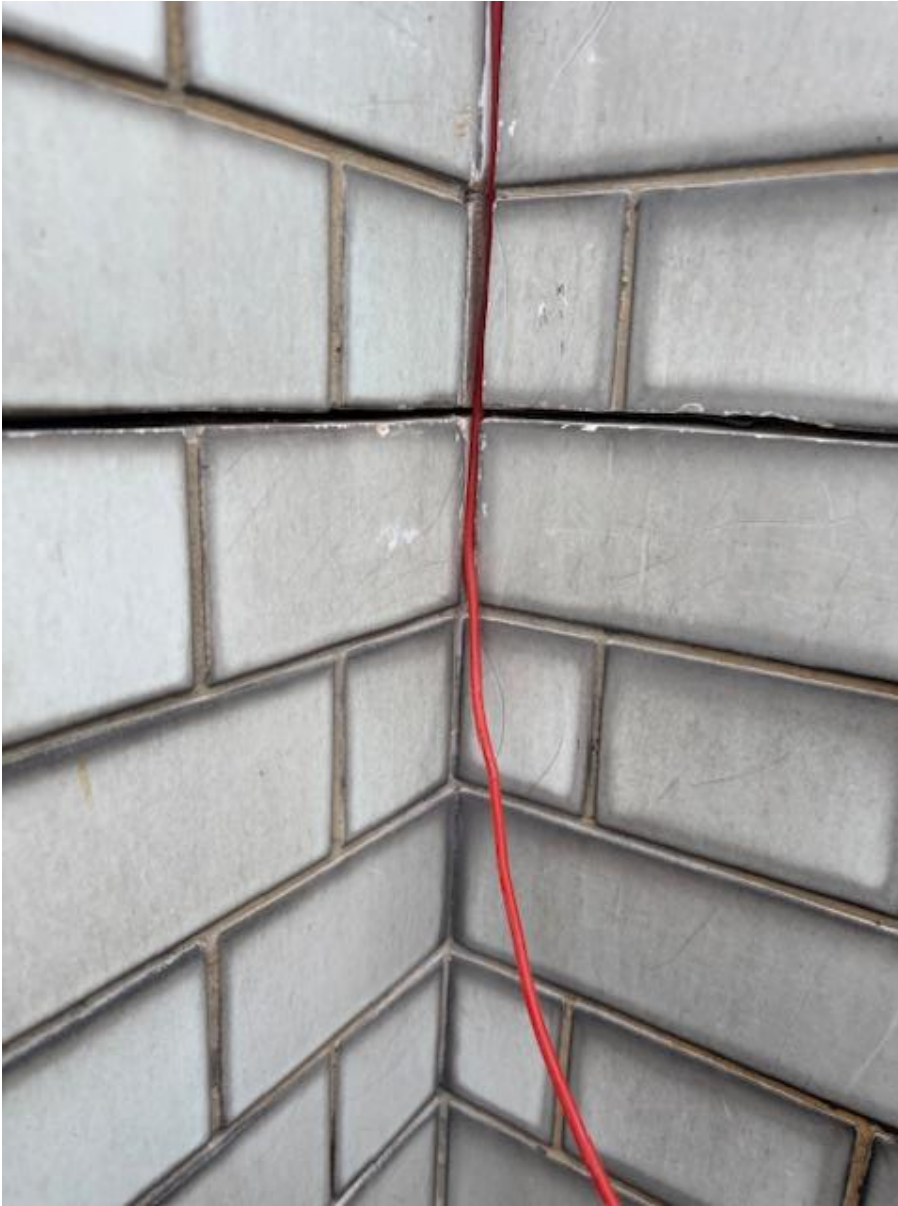
Photo 4. CP ribbon being installed to corner vertical joint.

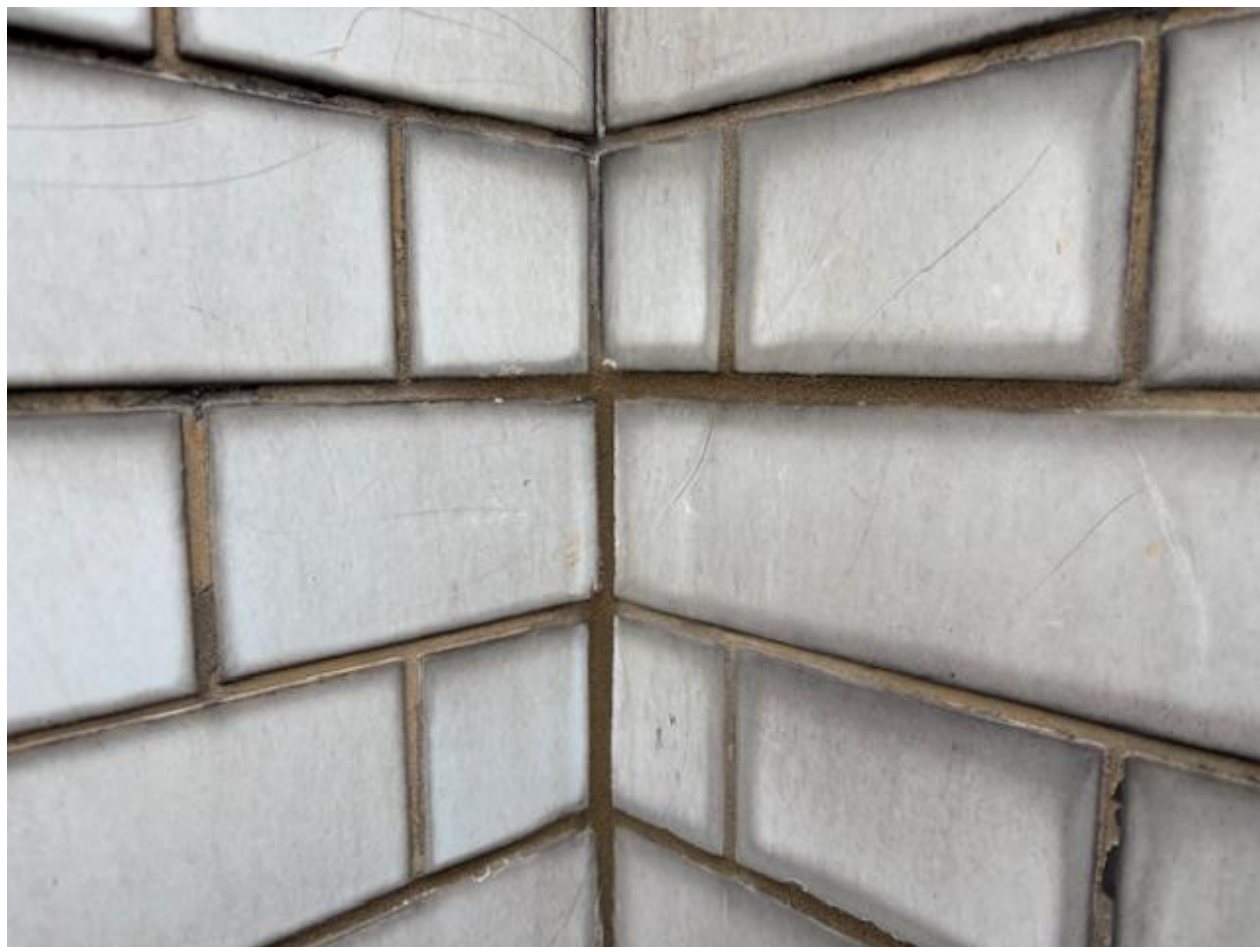
Photo 5. CP ribbon installed and repointed.
