Root Investigation by TreeRadar

15 Chalcot Square,
London,
NW1 8YA

OUR REF: TRA 0479

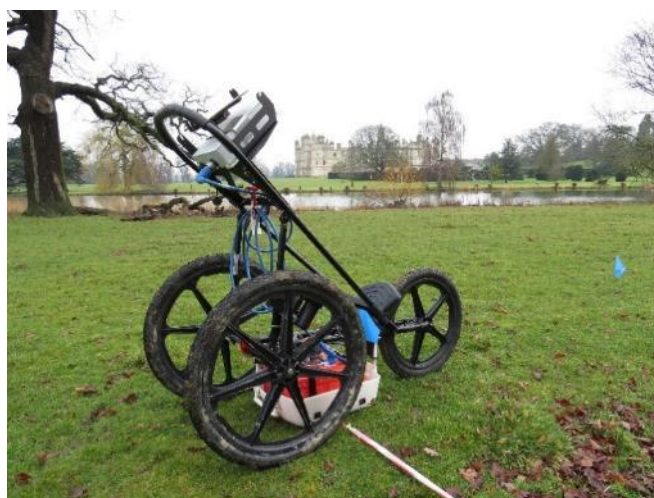
Photo 1. Photo of the TreeRadar cart (in a different setting)

- 3.1 This report identifies locations of roots with a diameter greater than 20mm along scan lines. The TreeRadar unit is a scanning cart with a 400MHz antenna which sends a beam every 1cm down to a depth prescribed by the operator (usually between 2 - 3m, which is the maximum depth). The reflection is recorded in a field computer and then analysed by the latest software, TBA. Water and metal reflect, therefore the machine records live roots which contain moisture, and cannot detect dead dried out roots. For each scan line a 'virtual trench' is produced which shows all roots with a diameter greater than 20mm. The machine cannot determine root diameter, other than it being greater than 20mm, due to the lack of correlation between the amounts of live root tissue in a root compared to the thickness of a root. For example, a large root may have a partially desiccated or dysfunctional central core with low moisture content and so give a relatively weak radar return, while a smaller root may be filled with water molecules and give a much stronger return. An anticipated update of the software is expected to begin to address this issue.

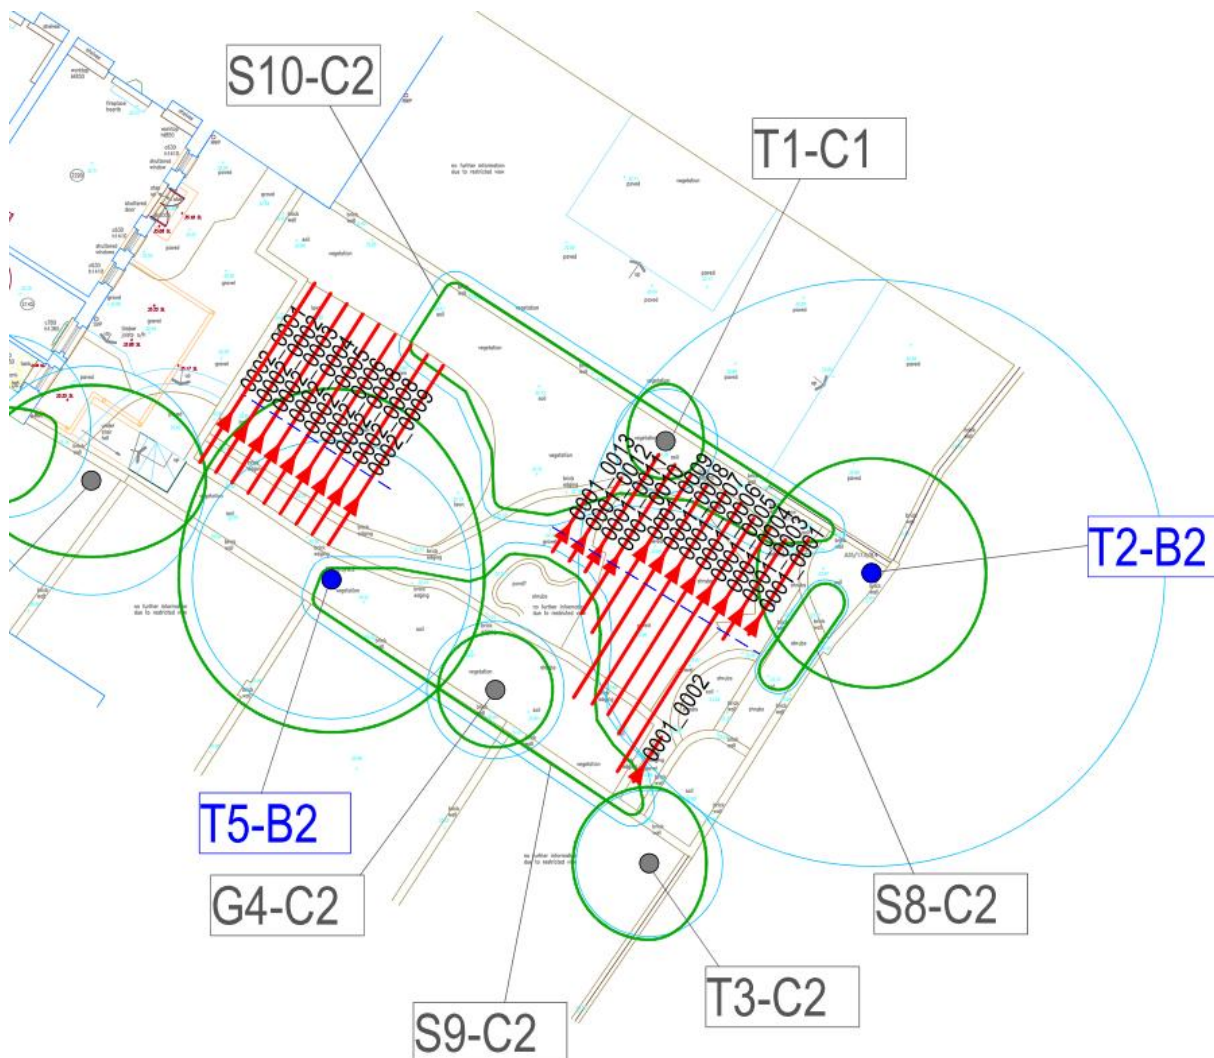
Plan 1 – Extract from TRA 0479TR showing the survey area. Do not scale.

Red lines are the scan lines. Blue lines are survey markers. North is vertical.

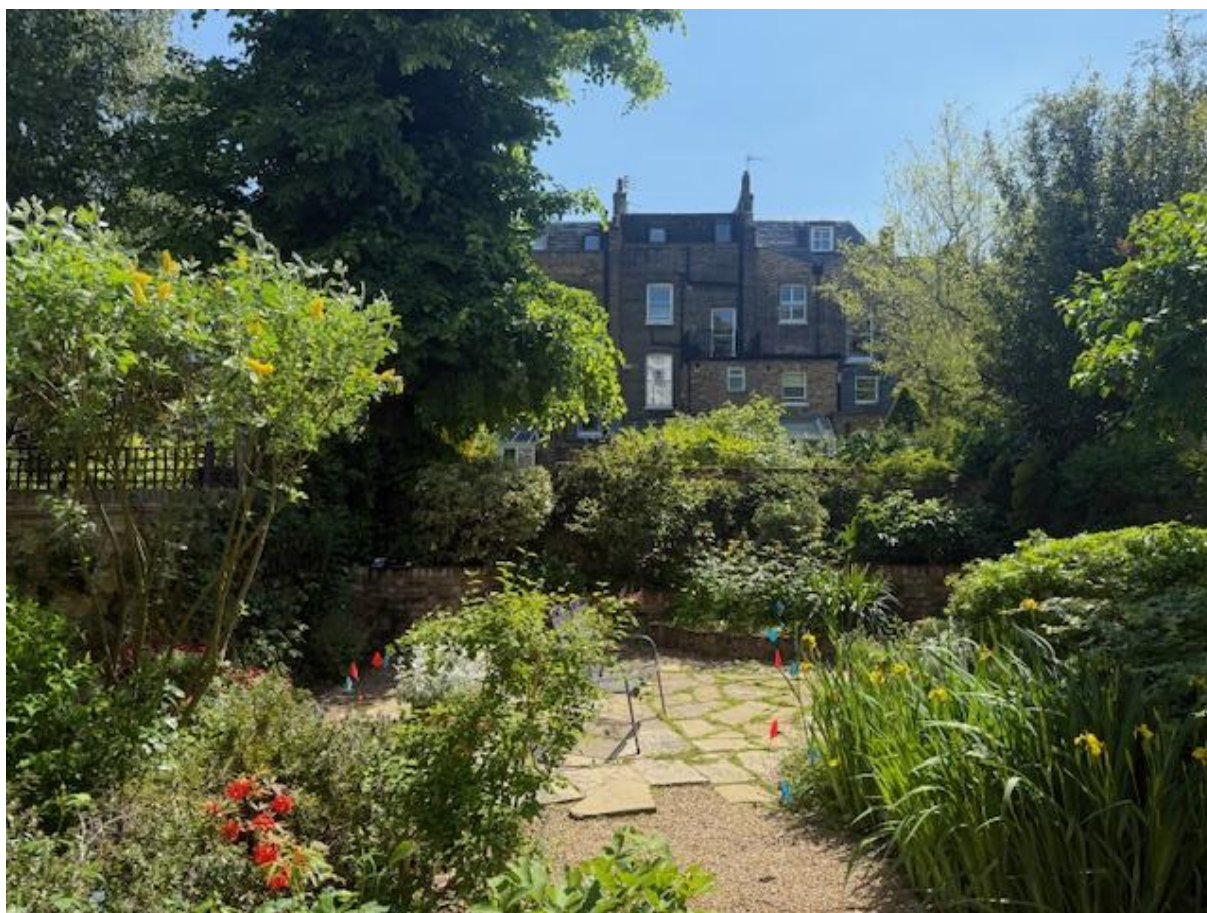
Photo 2. Survey area for the 0001 series.

4.1.1. Results: Roots in this area are initially found in high densities, with the density slowly falling with increased distance from tree T2, reaching moderate density along 0001_0005 and low along 0001_0010 and beyond. Slightly raised densities are found at either end of the scan lines where the lines are close to the shrub beds containing woody shrubs and small trees. This distribution is best shown visually on the tree root density plan in section 8 of this report, with areas of high density shown in warm colours and lower density in cooler colours. The distribution shows that the tree is rooting beneath the shrub bed walls and extending into the garden area. The density on the outer RPAs is slightly higher than typically expected for an open grown tree, likely as a result of restricted rooting to the north and east from the boundary walls.

4.1.2. The majority of the roots are found in an unevenly distributed band between 10-90cm deep, with the soils appearing highly disturbed and containing a number of metals and non-root reflectors. This is typical of urban environments which may have been dug up and redeveloped over an extended period.

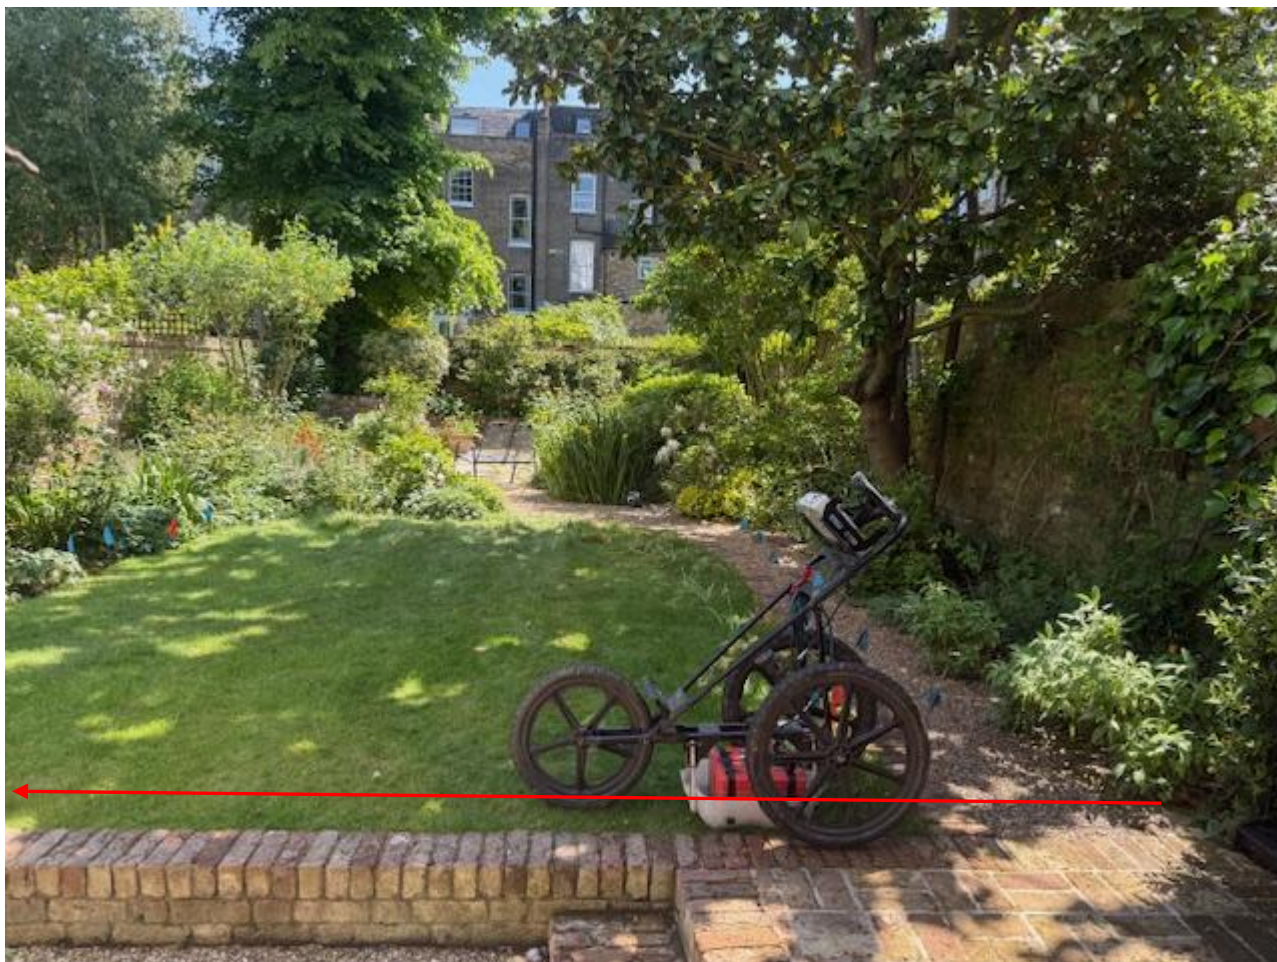
Photo 3. View of the survey area for the 0002 series.

Arrow shows the located of scan line 0002_0001.

4.2.1. **Results:** Roots are initially found in extremely low density along lines 0002_0001-0003, rising to low along 0002_0004 and then moderate along lines 0002_0007-0009. However, the measure of density along the length of the scan lines does not give the full picture of rooting, with areas of higher density seen closer to the tree and shrub beds at either end of the lines and much lower density in the middle of the lawn. This distribution is best shown visually on the tree root density plan in section 8 of this report, with areas of high density shown in warm colours and lower density in cooler colours.

4.2.2. Rooting density remains significant beyond the theoretical RPA, likely due to the partially restricted rooting resulting from the boundary wall, although cracking to the wall shows that the footings do not form a complete barrier to tree roots.

4.2.3. The majority of the roots are found in an unevenly distributed band between 10-80cm deep, with the soils again appearing highly disturbed and containing a number of metals and non-root reflectors. This is typical of urban environments which may have been dug up and redeveloped over an extended period.

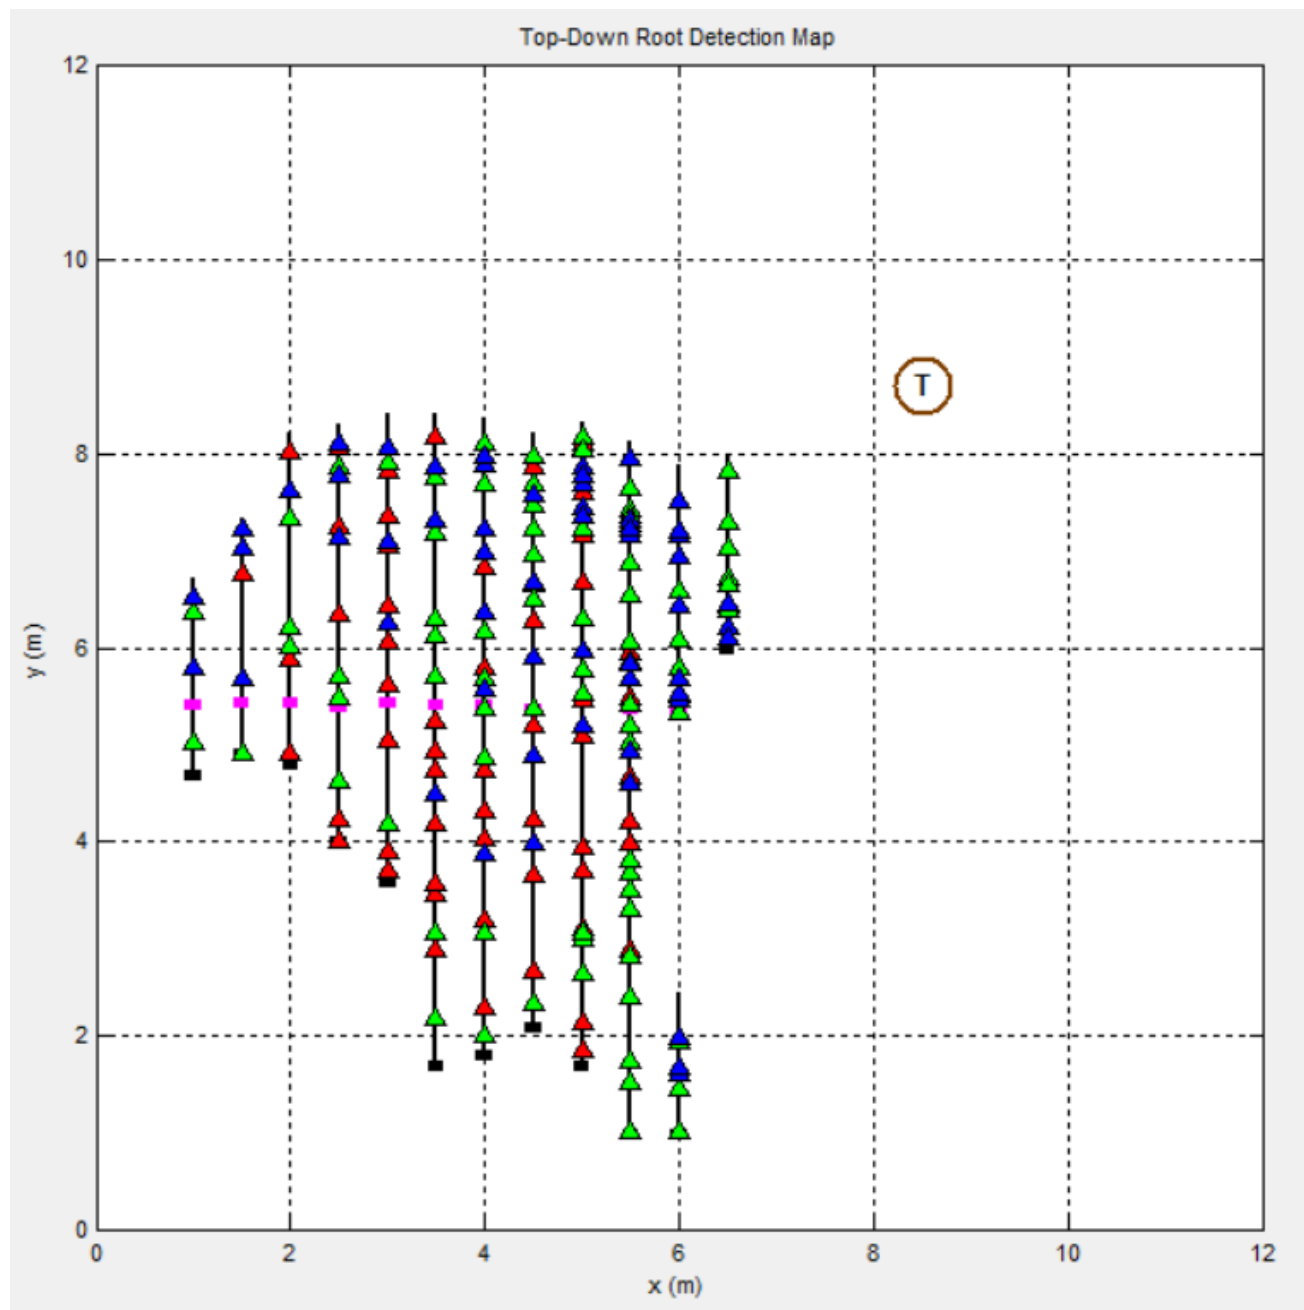
SCAN LINES 0001_0001-0013 – ROOTS (WITH A DIAMETER GREATER THAN 20MM) AT ALL

RED = 0-20cm GREEN = 20-40cm BLUE = 40-250cm
