Design and Access Statement

St Pancras Hospital Boundary Wall, Granary Street,
London NW1 0NF

March 2014

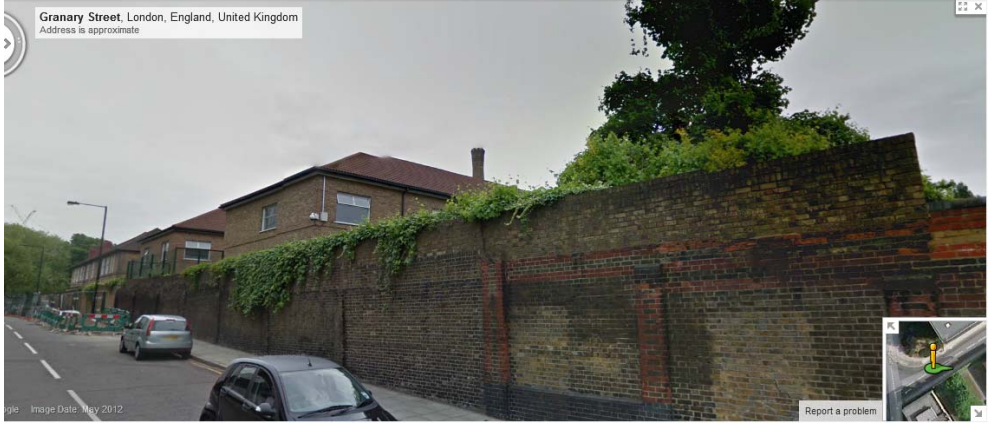
Photograph Number	Photograph Description	Photograph
1.	<p>Original Boundary Wall</p> <p>General view of the original boundary wall.</p>

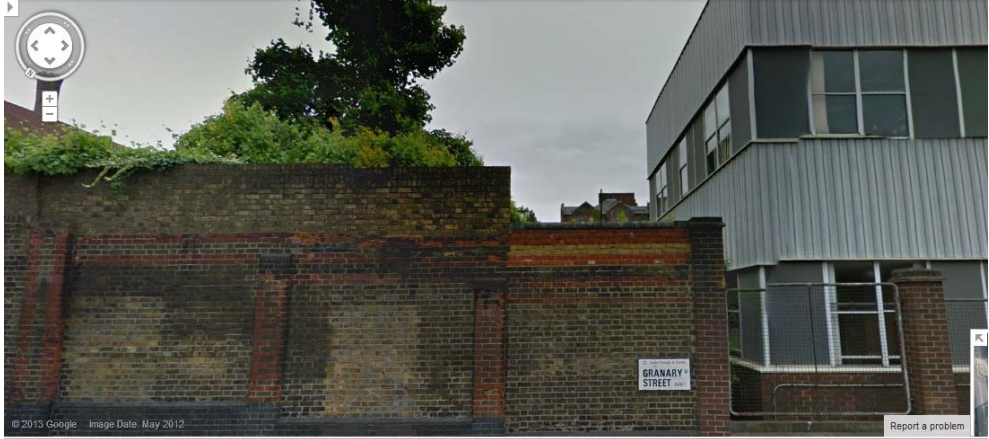
<p>Granary Street, London, England, United Kingdom Address is approximate</p> <p>Image Date: May 2012</p> <p>Report a problem</p> <p>©Google 2014</p>
2.	<p>Original Boundary Wall</p> <p>General view of the original boundary wall.</p> <p>Note: additional courses of brickwork visible.</p>

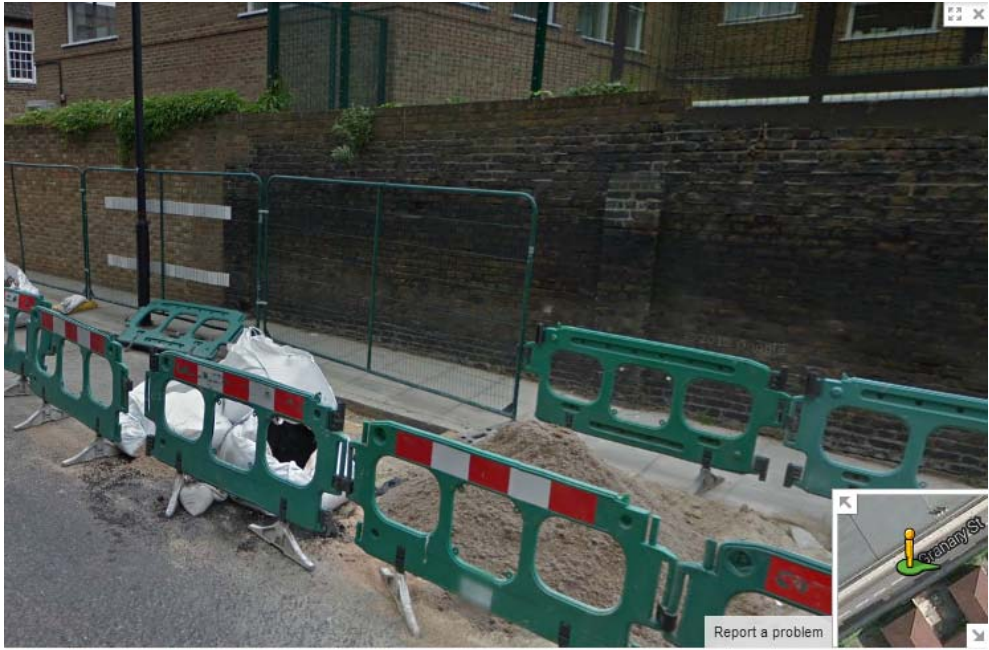
Photograph Number	Photograph Description	Photograph
3.	<p>Original Boundary Wall</p> <p>General view of the original boundary wall.</p>

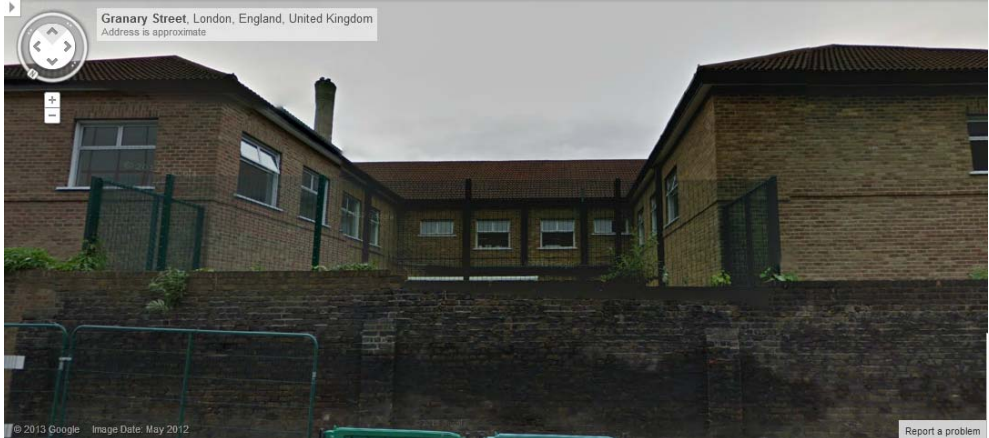
<p>Report a problem</p> <p>©Google 2014</p>
4.	<p>Original Boundary Wall</p> <p>General view of the boundary wall.</p> <p>Note: steel security fencing visible to the rear of the wall.</p>

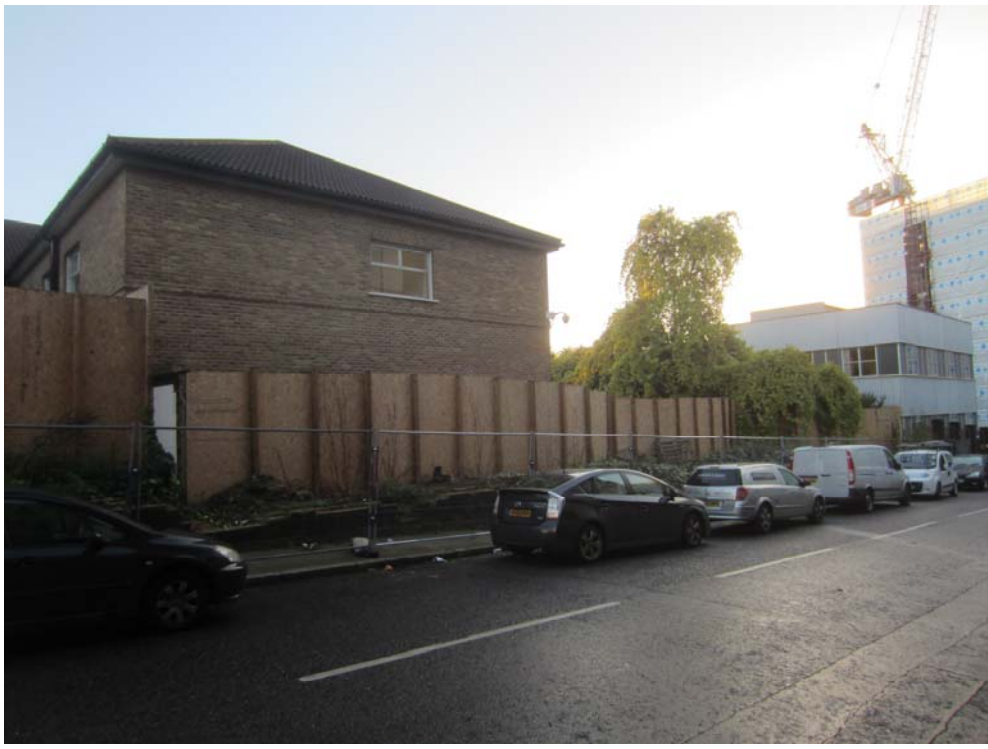
Photograph Number	Photograph Description	Photograph
5.	<p>Existing Wall</p> <p>General view of the collapsed wall.</p>

- The failure was the result of rotation of the wall, roughly from ground level.
- It would be reasonable to build a new wall off the existing wall (making small corrections to the residual wall where it is out of plumb by more than say 25mm).

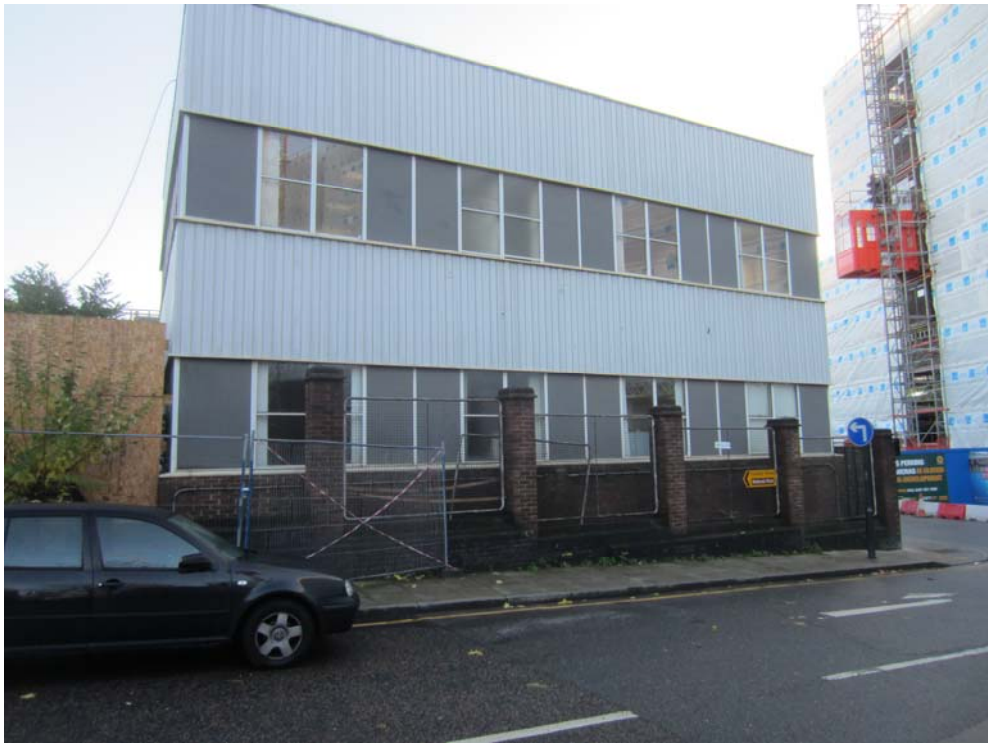
6.	<p>Existing Wall</p> <p>Missing steel grille to the west end of the wall.</p>
