Planning Proposed Minor Amendments 62-63 Tottenham Court Road, 1-3 Goodge Street Revision B

Reference 5315

January 2014

1-3 Goodge Street Façade Report

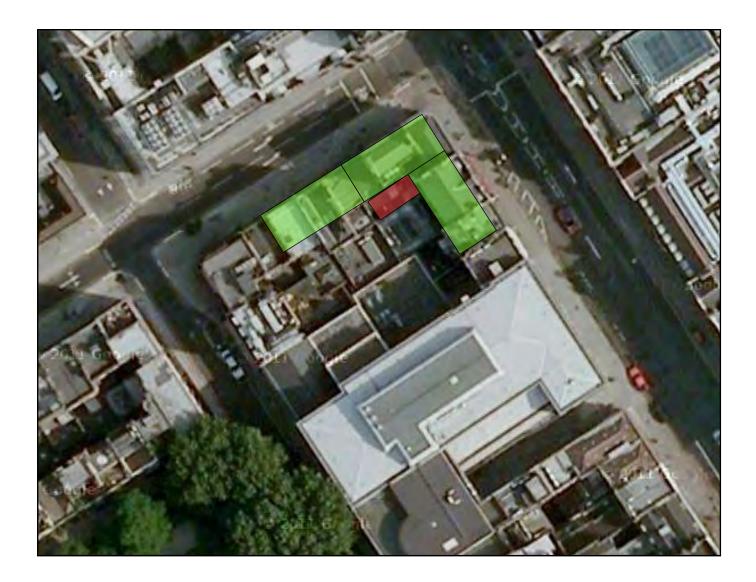
exstg basements

new basement

The proposed development requires a small extension to the existing basement this can be seen on the attached plans, and to deepen slightly the existing areas to match the levels in No 62 Tottenham Court Road.

For that reason we believe that the impact on groundwater flow and local hydrology to be insignificant in this instance. (See the attached plan). We looked at this against the Subterranean (groundwater) flow screening flowchart in Appendix E of the Arup document and conclude that the development will not affect flows in the surrounding local area due its small size and location and therefore no basement impact assessment will be required.

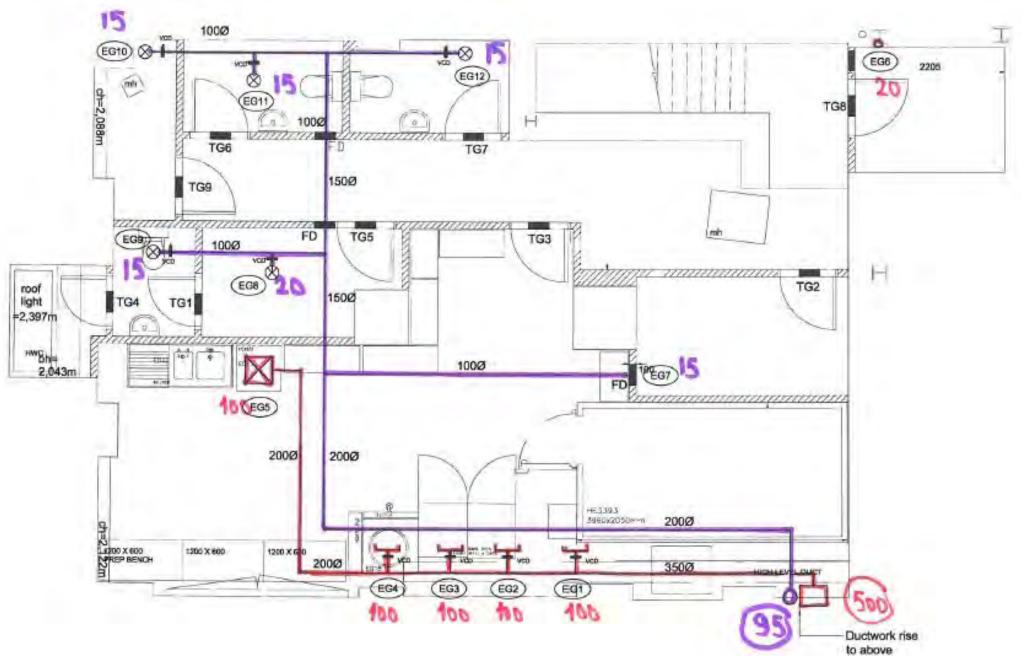
'As Installed' Basement Ductwork Layout

There are currently three ducts serving the EAT demise terminating at first floor roof:

- 1 No. Ø450mm display area extract
- 1 No. Ø200mm toilet extract
- 1 No. Ø350mm kitchen preparation extract

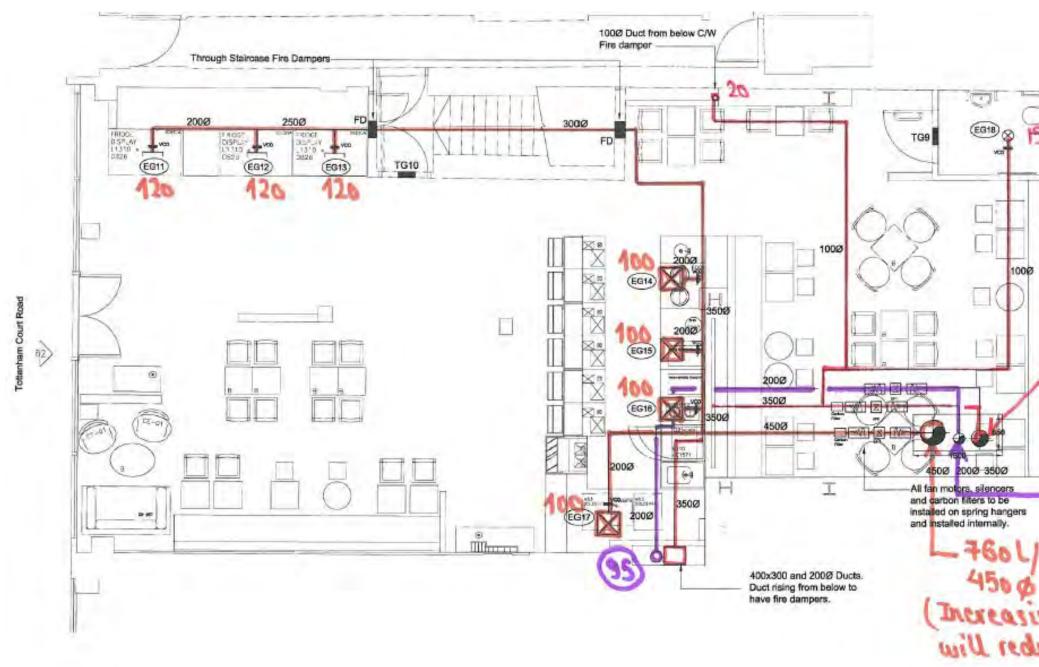
'As Installed' Ground Floor Ductwork Layout

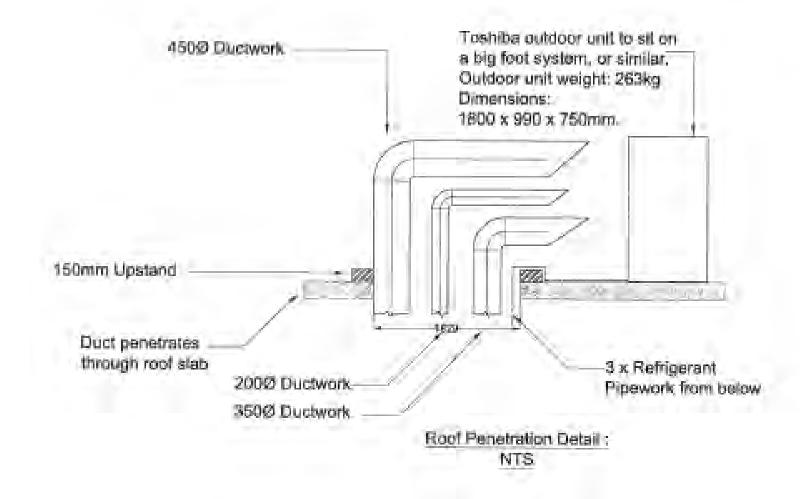
'As Installed' Section (Indicating ducts terminating at first floor)

The existing retail unit to the ground floor of No. 62 Tottenham Court Road has extract ducts that terminate approximately 1m above the existing roof to the first floor. There is a large condenser unit. This area will form a private roof terrace in the approved scheme (refer to drawing T(20)P01 Rev.G

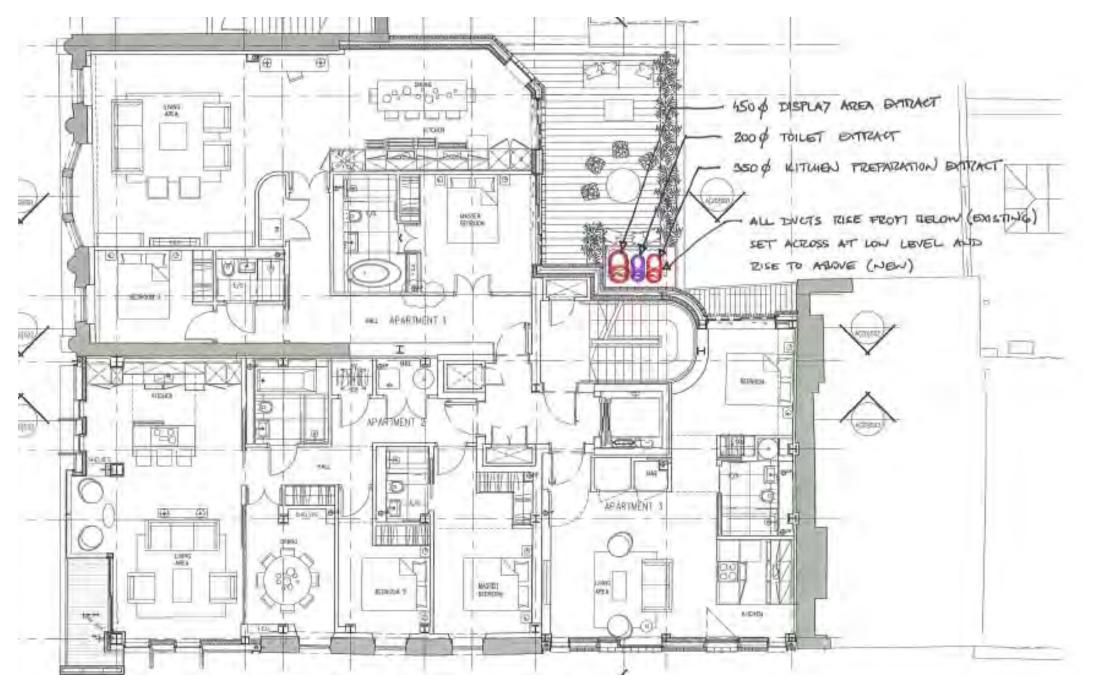
<u>'Proposed' First Floor Layout</u>

The new residential proposal incorporates a large residential terrace at first floor level where the ducts currently terminate. As all ducts carry foul air from kitchen preparation and toilet areas, the intention is to discharge all three ducts above the new roof level to eliminate the negative impact on the residential development as well as the retailer's need for extensive air treatment of the existing ventilation system.

It is proposed to cut the existing ductwork at first floor level and install new ductwork extending to the new roof level and running externally within an architectural enclosure/cladding. Appropriate access in line with relevant standards will be incorporated into the design of both, the ductwork and its enclosure.

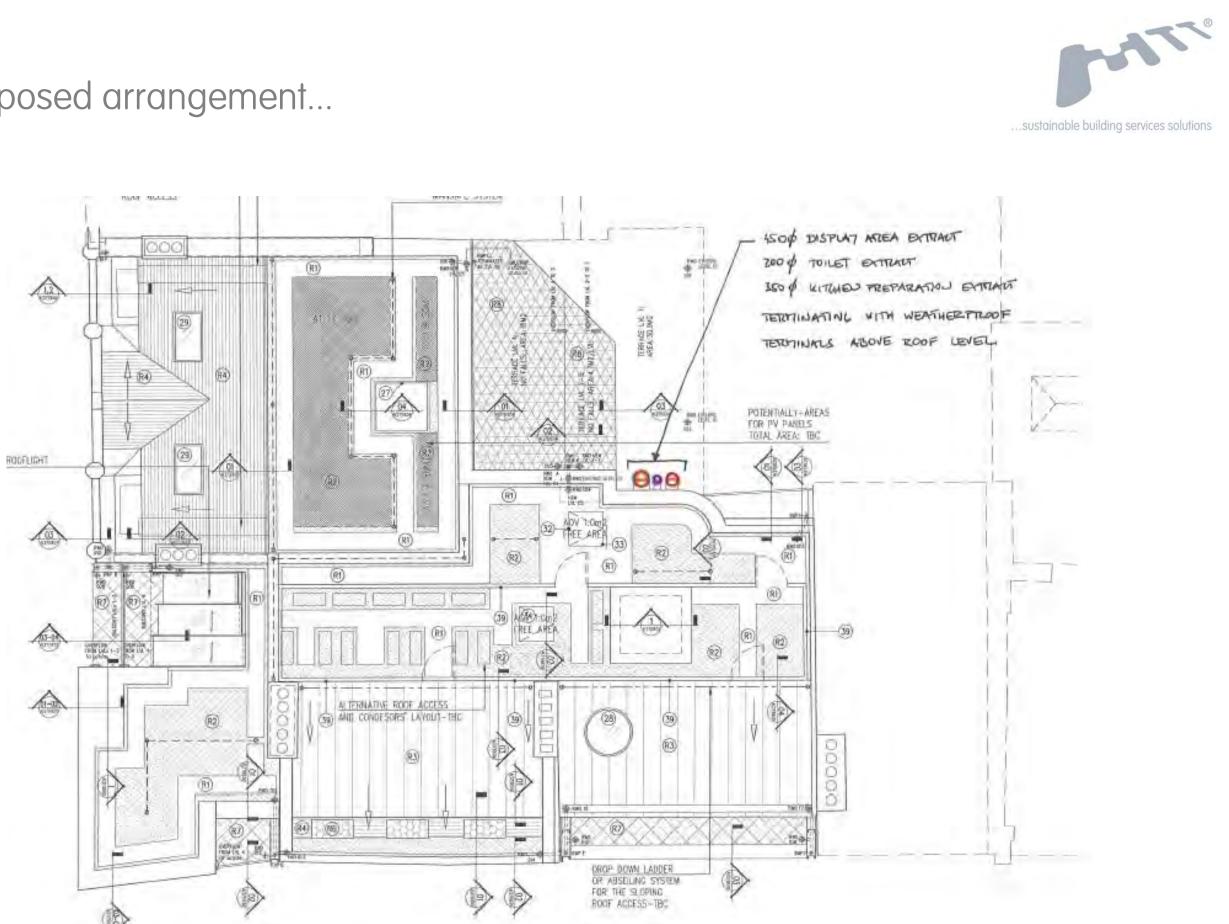
'Proposed' Roof Layout

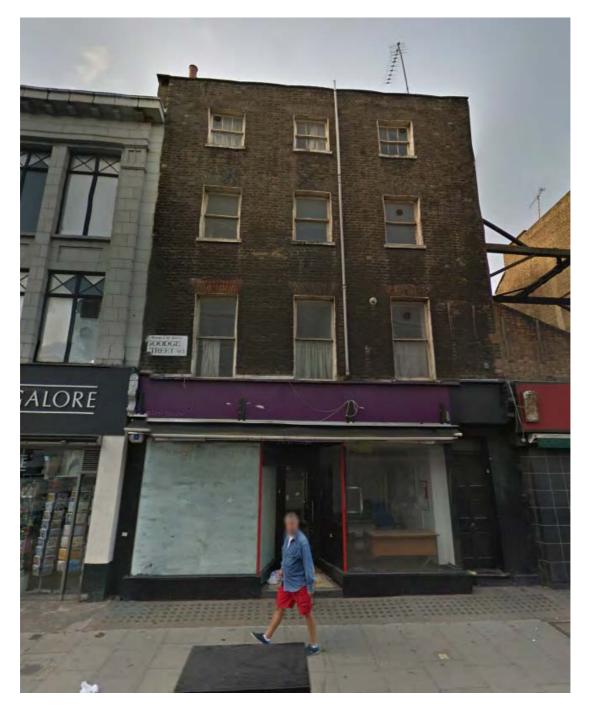
PHOTO 1 - Front view of brick facade of 1-3 Goodge Street with surrounding buildings:

1-3 Goodge Street was built in circa 1763. The building was four storeys in height and three bays in width (see photos: 1, 2 and survey elevation on page 3).

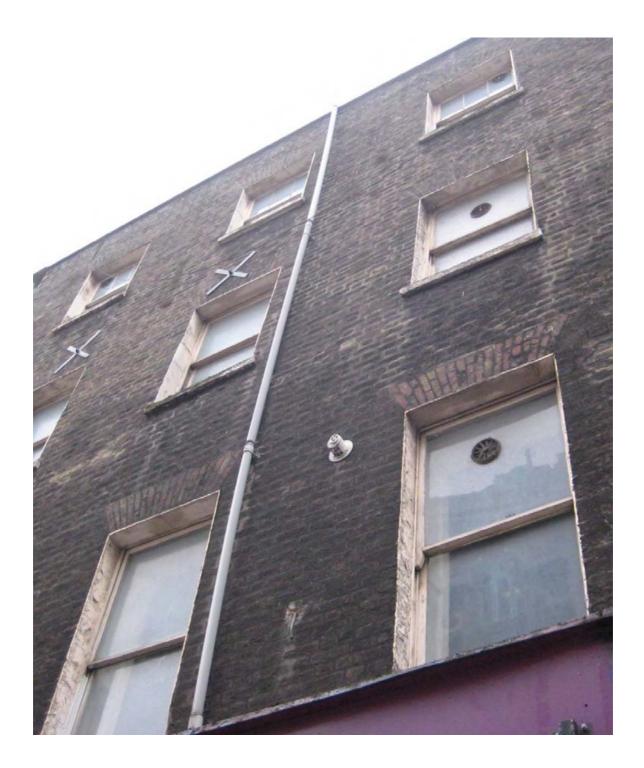
PHOTO 2 - Close up of brick facade of 1-3 Goodge Street:

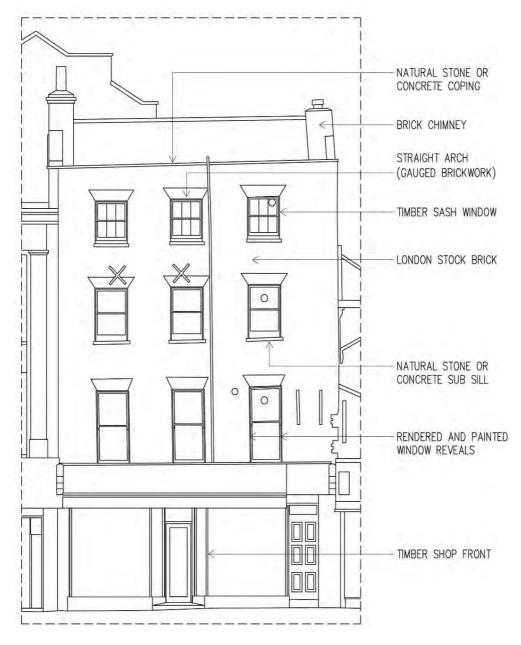
MEASURED SURVEY ELEVATION - 1-3 Goodge Street Facade:

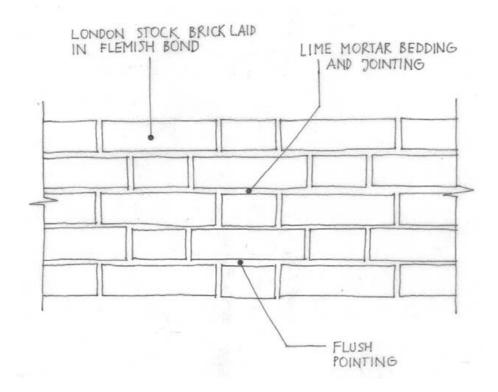
EXISTING DETAIL 1 - Detailed elevation of facade illustrating brick bonding and pointing:

The facade was constructed using London stock bricks with lime mortar bedding and jointing. The façade was sooted giving an uneven blackened appearance. The salvaged bricks reveal the original brownish / pinkish grey colouration and confirm imperial brick dimensions. Bricks were laid in Flemish bond with flush pointing.

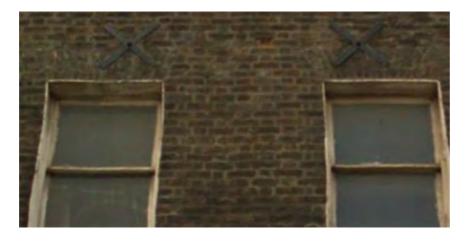
PHOTO 3 - Close up of facade illustrating bricks laid in Flemish bond with flush pointing. Structural ties evident above.

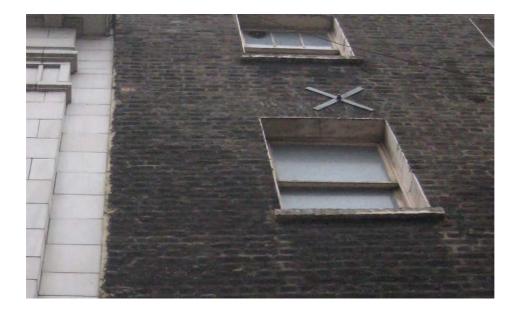
PHOTO 4 - Close up of facade illustrating brick bonding and pointing. Blackening is evident

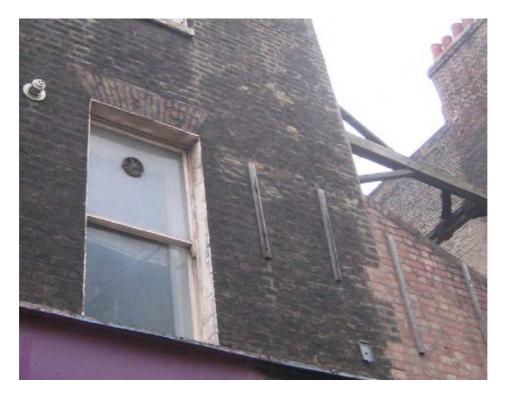
PHOTO 5 - Close up of facade illustrating brick bonding and pointing:

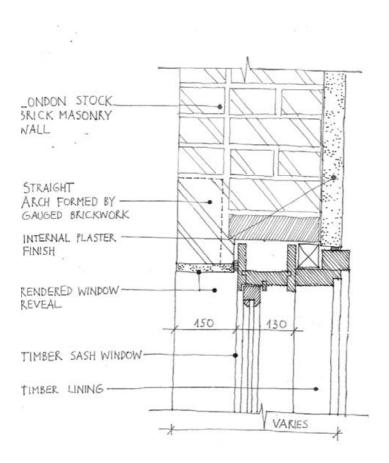
EXISTING DETAIL 2 - Detailed section cutting through the window head:

The heads to the nine windows were straight arches formed using gauged brickwork (see photos: 1, 6 and existing details: 2, 3) One head had been repaired, probably with render / concrete, which had been false jointed and painted in an attempt to match the original brick heads. However the false joints did not follow the jointing pattern of the original brick gauged arches (see photo 7).

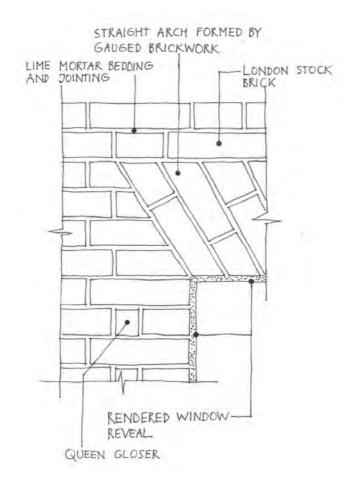
EXISTING DETAIL 3 - Detailed elevation of straight brick arch and bonding to window reveal – original jointing:

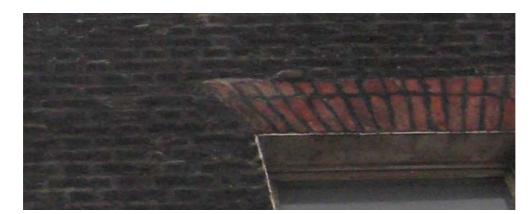
PHOTO 7 - Close up of repaired straight brick arc, jointing does not match original:

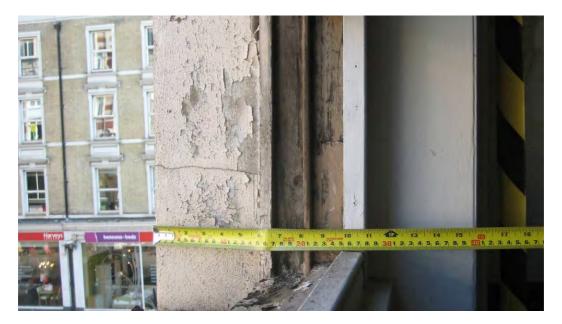
PHOTO 8 - Close up of window reveal and sub sill. Wall thickness varied but window reveal's depth remained constant at approximately150mm. Paint cracking and peeling.

The reveals to the windows were rendered and painted, which was cracking and peeling (see photos: 8, 9, and existing detail 4).

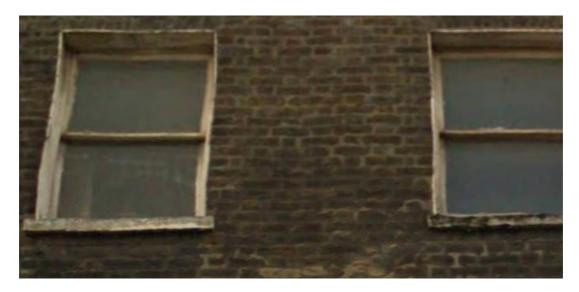
PHOTO 9 - Front view of windows and sub sills in brick wall:

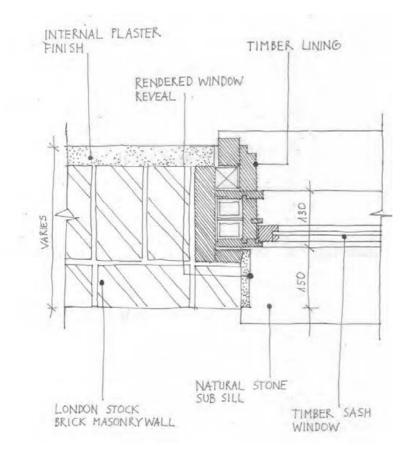
EXISTING DETAIL 4 - Detailed horizontal section cutting through window jamb.

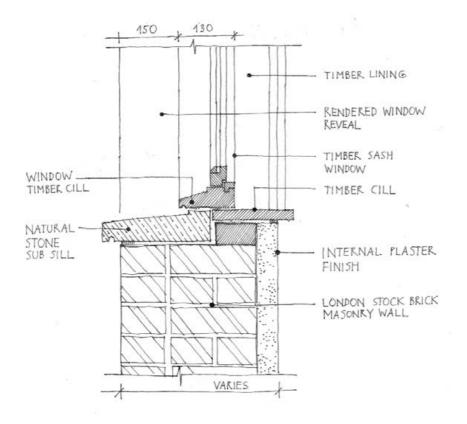
EXISTING DETAIL 5 - Detailed vertical section cutting through the window sill:

The window sub sills are understood to be natural stone or reconstituted concrete (see photos: 10, 11 and existing details 5).

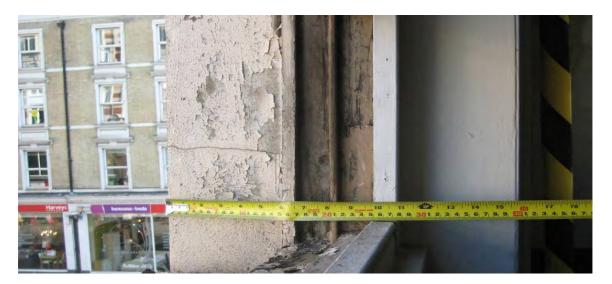
PHOTO 11 - Close up of a typical window sub sill and timber sill. Both sub sill and sill were in poor condition and in need of replacement.

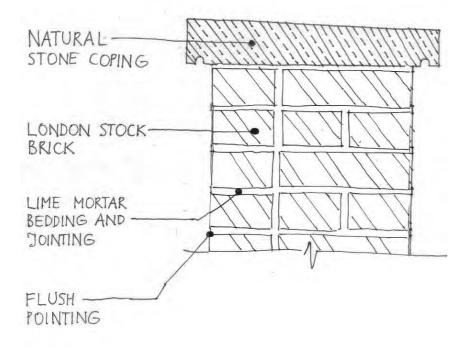
EXISTING DETAIL 6 - Detailed vertical section cutting through brick wall coping:

Coping to the brick wall is understood to be made of natural stone or reconstituted concrete.

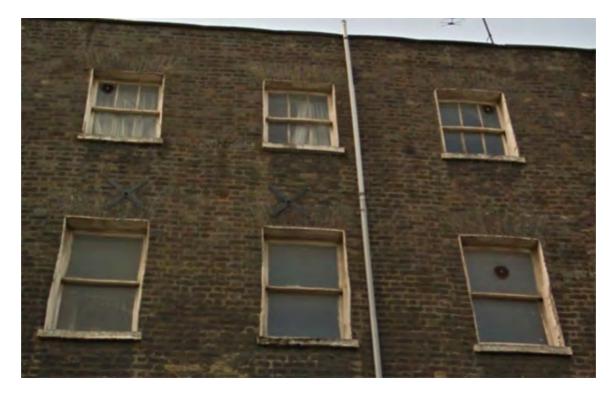
PHOTO 12 - Timber sash windows

Six of the nine timber sash windows are not panelised. It is believed that these windows were not original as panelled windows are more typical of the period. The top floor windows were panelled and as such, are more likely to have been to the original design. Various extract fans had been installed within the glazing to the windows. A down pipe had been unsympathetically installed, exposed on the front elevation.

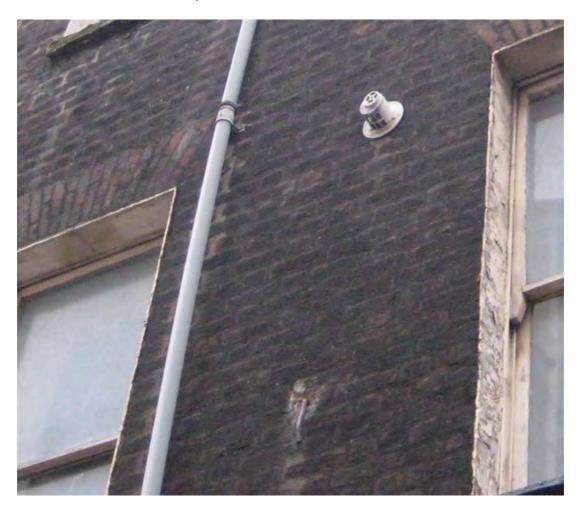
PHOTO 13 - View of brick wall penetrations on the 1st floor:

There were a number of cracks running through the heads and into the spandrel brickwork above, which would indicate movement of the brick facade. The brickwork above the shop front had bowed outwards. There was a balance flue vent and heating overflow pipe in the brickwork at the 1st floor level between the 2nd and 3rd window.

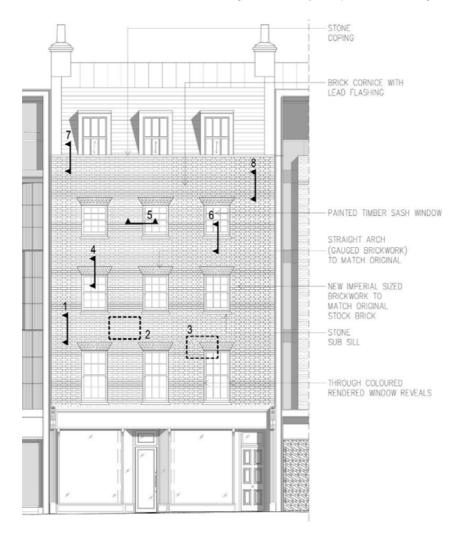
PROPOSED ELEVATION - 1-3 Goodge Street Façade (refer to drawing T20DE01):

The proposed facade will be constructed using modern methods of construction for the internal walls with the external facade and detailing replicating the original appearance. New or reclaimed imperial sized stock bricks will be laid in Flemish bond with lime mortar, jointing and flush pointing (see proposed elevation and details: 1 & 2). Brick to be agreed with Camden.

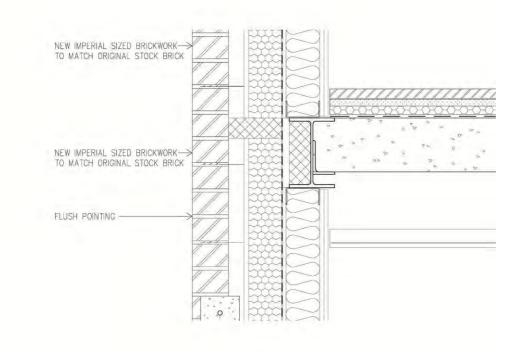
DETAIL 1 - Typical wall to floor detail:

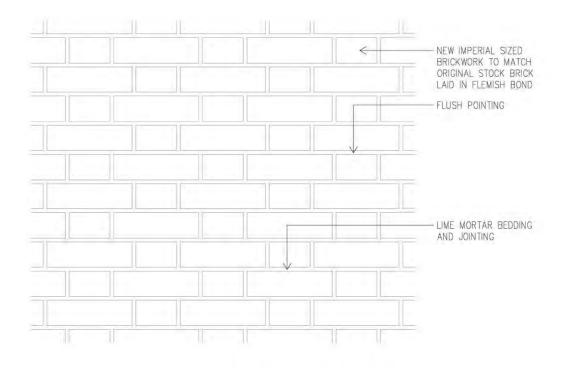
DETAIL 2 - Detailed elevation illustrating brick bonding and pointing:

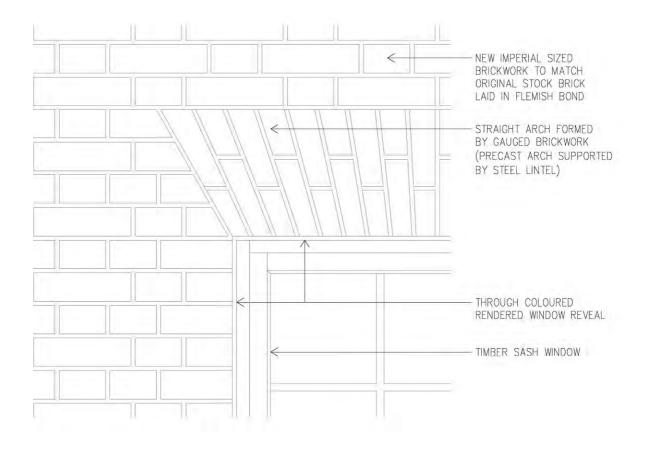
DETAIL 3 - Detailed elevation illustrating brick arch and window reveal:

The heads to the nine windows will be straight precast arches formed using gauged brickwork (to match original red brick in contrast to the rest of the façade). They will be supported by steel lintels or brick support angles (see proposed details: 3 & 4).

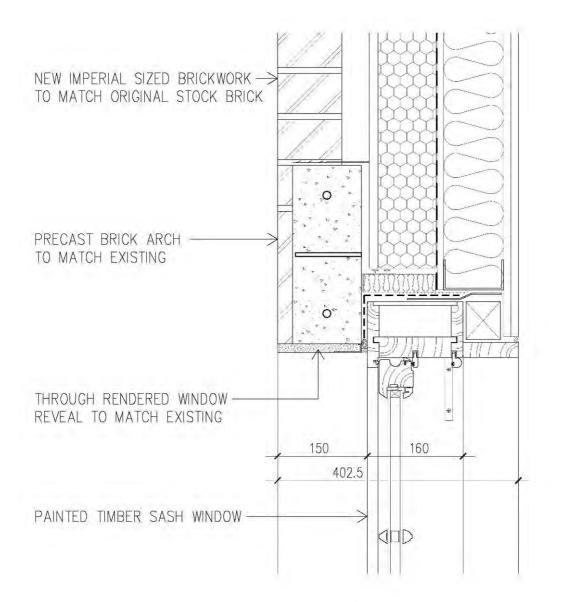
DETAIL 4 - Typical window head detail:

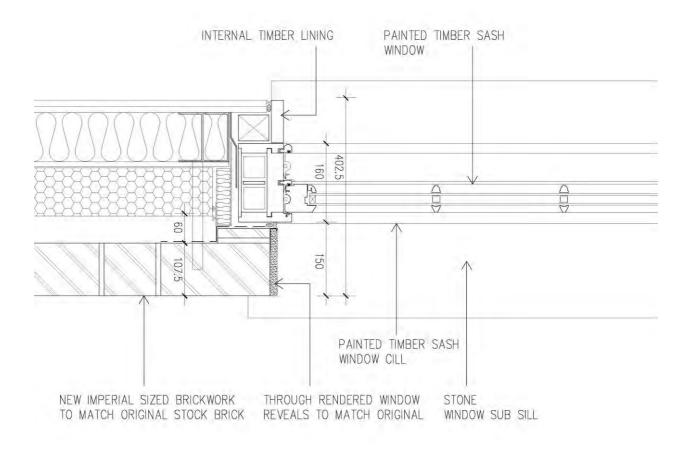
DETAIL 5 - Typical window jamb detail:

The reveals to the windows will be through coloured render (see proposed detail 5).

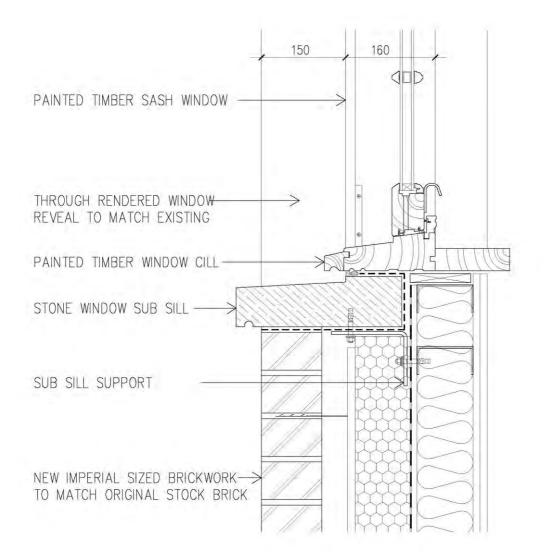
DETAIL 6 - Typical window jamb detail:

The sub sills to the nine windows will be made of natural stone or reconstituted concrete (see proposed detail 6).

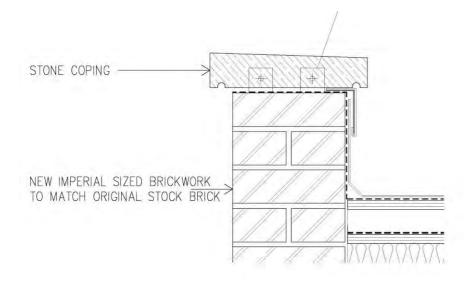
DETAIL 7 - Typical wall coping detail:

Coping to the brick wall will be made of natural stone or reconstituted stone

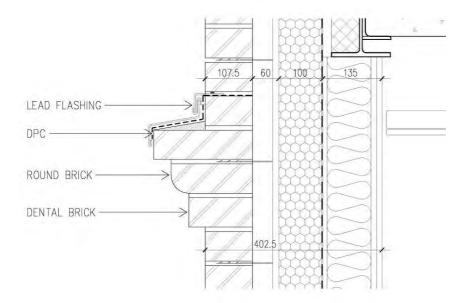
DETAIL 8 - Cornice detail:

Cornice between 3rd and 4th floor will be made of three courses of brick (size and colour same as facade - see proposed detail 8).

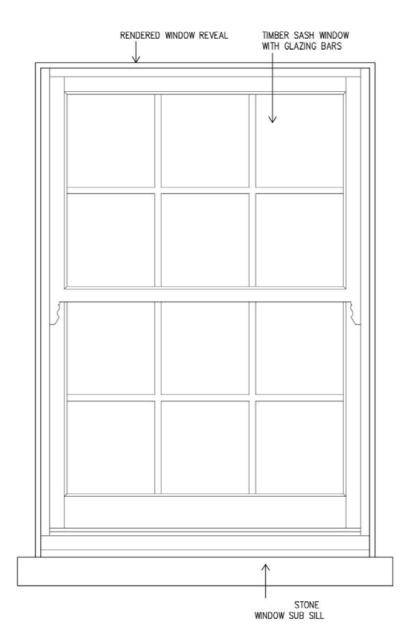
DETAIL 9 - Detailed elevation of timber sash window:

All nine windows will be timber box sash windows with glazing bar division (see: proposed detail 9)

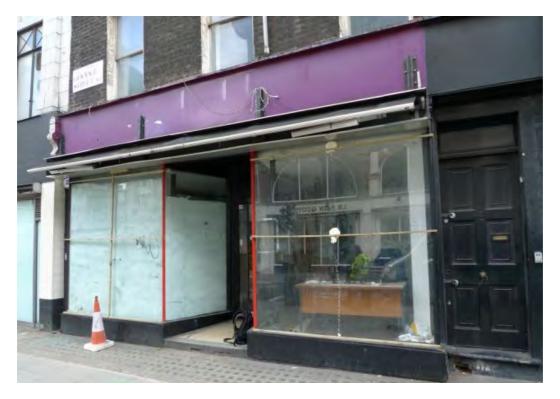
SHOP FRONT - VIEW FROM GOODGE STREET

The frontage has large plate glass windows with a deep inset entrance to the centre. The main entrance door is timber with glazed central panel, the fan light above is timber rather than glass. To the right side is a solid timber panelled entry door which has been adapted with letterbox inserts, there is a glass fanlight above. The slender timber mullions have a decorative capping that was concealed behind a modern canopy

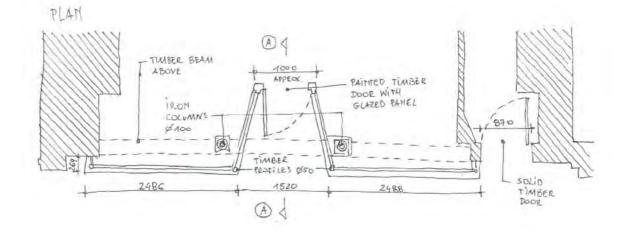
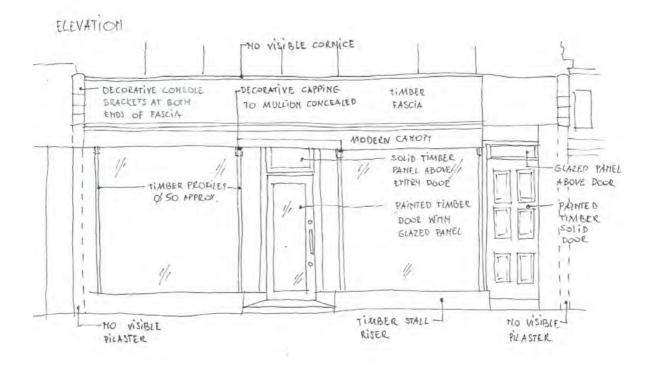
EXISTING SHOP FRONT ANALYSIS – PLAN AND ELEVATION

Whilst there are decorative console brackets to either side, there are no pilasters decorative or otherwise. The stall risers are plain timber without extended sill to the base of the windows. Internally cast iron columns formed support to the Bessemer beam.

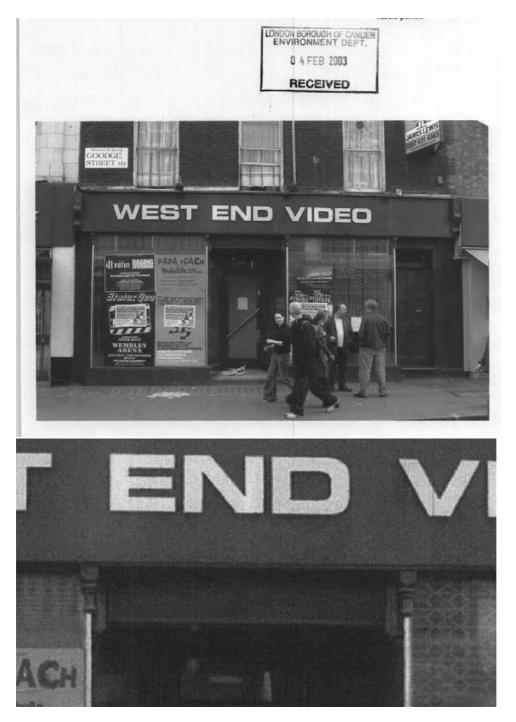
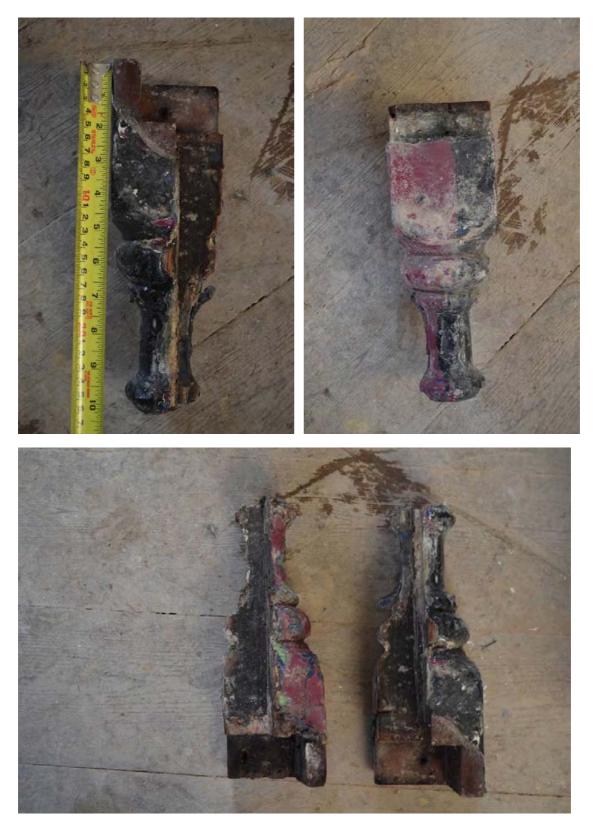
PHOTOS TIMBER DECORATIVE CAPPINGS

The slender timber mullions have a decorative capping that was concealed behind a modern canopy. The capping can be seen below in this image from Camden Online Planning records application No.ASX0304037. These were subsequently covered up.

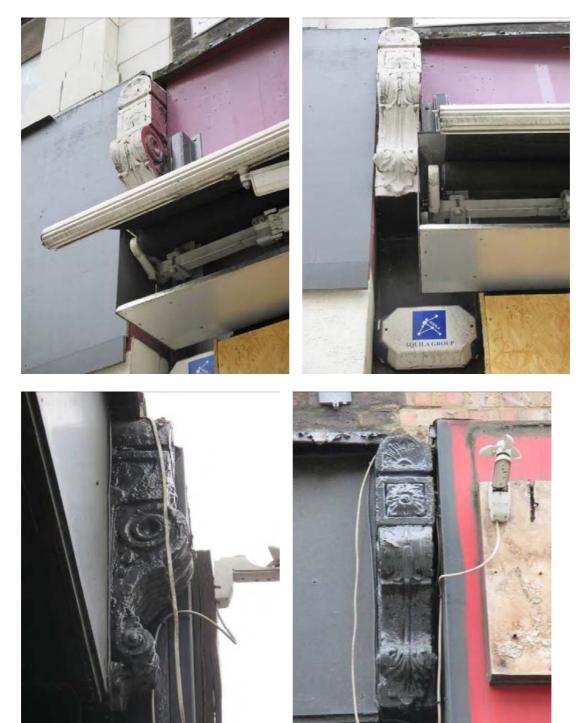
EXISTING CONSOLE BRACKETS

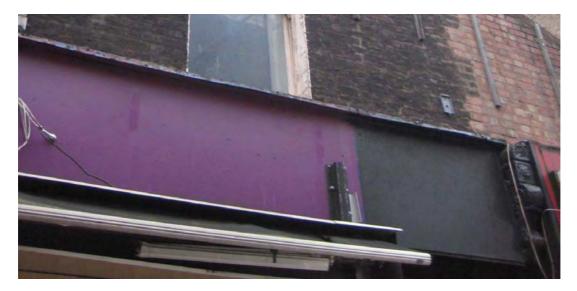
TIMBER FASCIA WITH MODERN CANOPY

The entablature would appear to have been removed or extensively altered as there is no visible cornice and a number of layers of fascia both glass and timber. A modern canopy has been unsympathetically installed. It is unknown when this occurred.

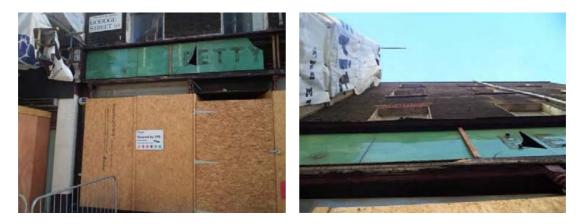
GLAZED FASCIA EXPOSED

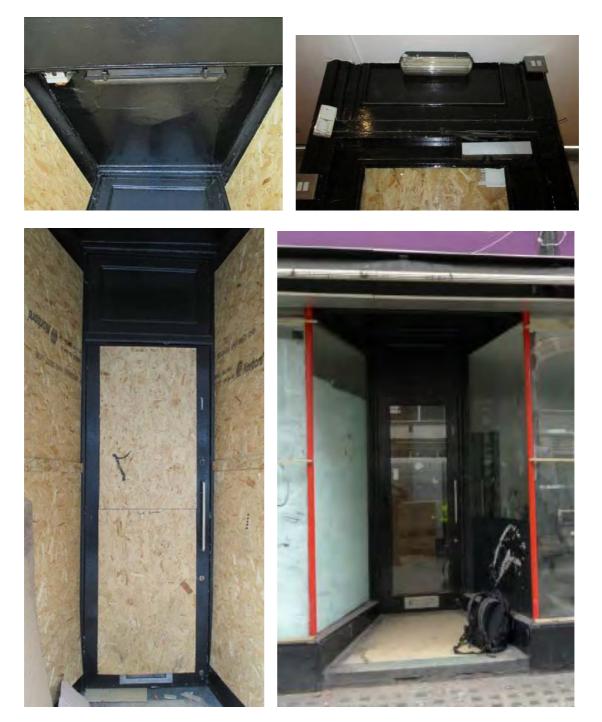
EXISTING TIMBER DOOR - TIMBER FANLIGHT AND SOFFIT PANEL

The existing entrance door has had adaptations over the years with ironmongery being adapted and replaced. It is unknown if the door is from the original Victorian shop front. The fanlight above has a timber infill.

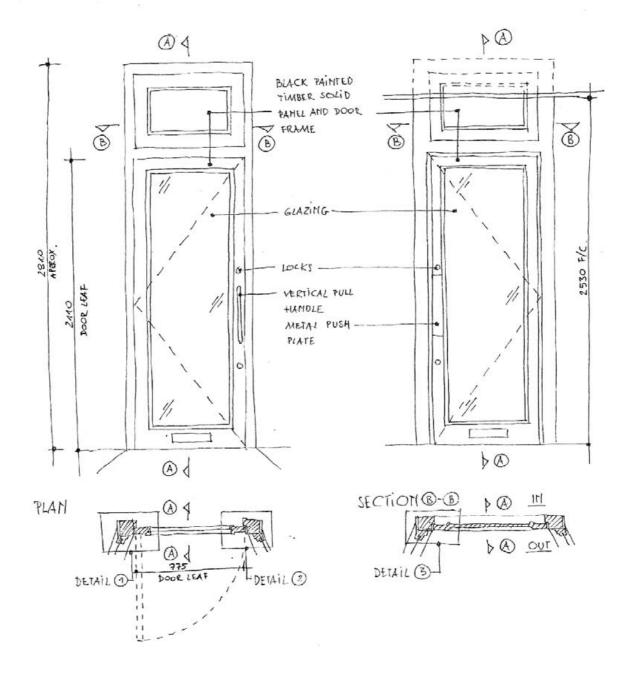
GLAZED DOOR PLAN, ELEVATIONS

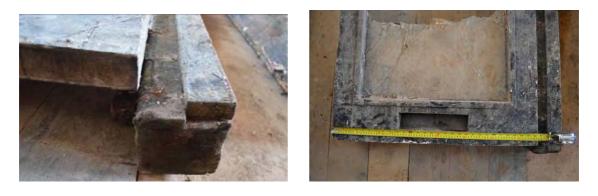
GLAZED DOOR DETAILS 1,2&3

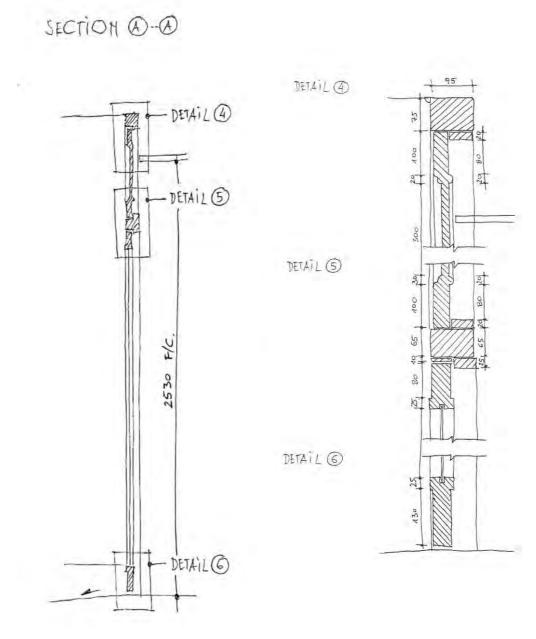
GLAZED DOOR SECTIONS / DETAILS

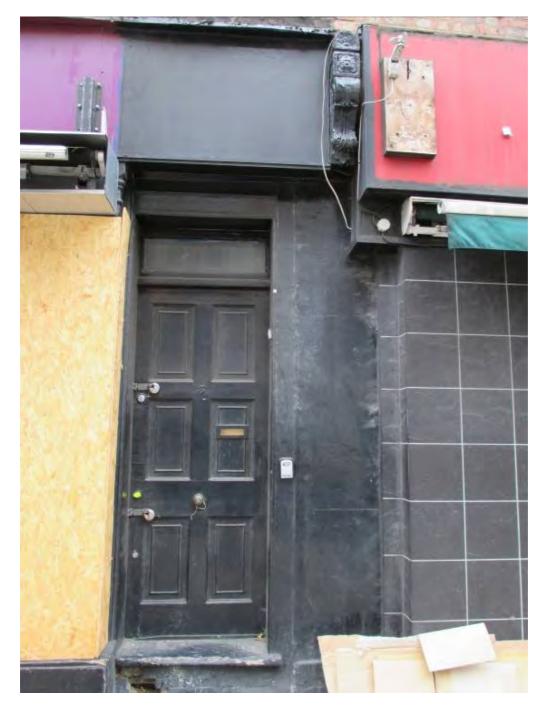
EXTERNAL DOOR

The external side entrance door is a six panelled 44mm solid door with glazed fanlight above. Ironmongery additions have detracted from the quality of the door

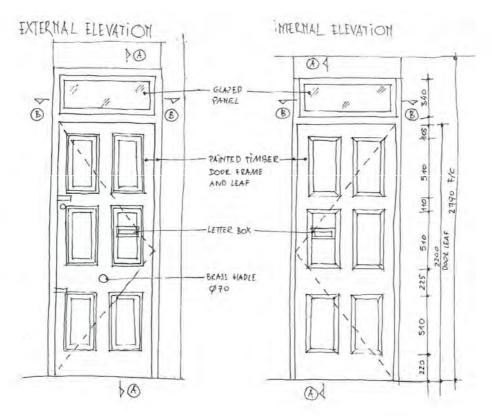
SOLID DOOR PLAN, ELEVATIONS

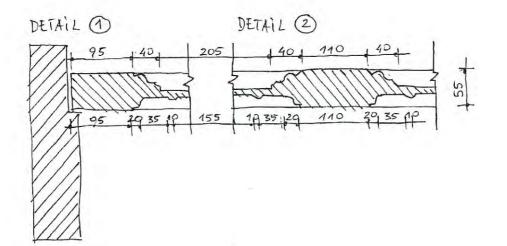
SOLID DOOR DETAILS 1,2&3

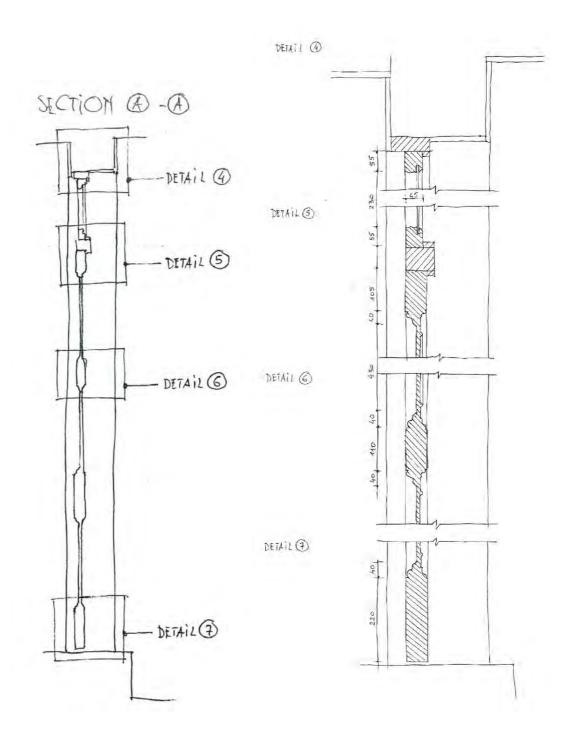
SOLID DOOR DETAILS 4,5&6

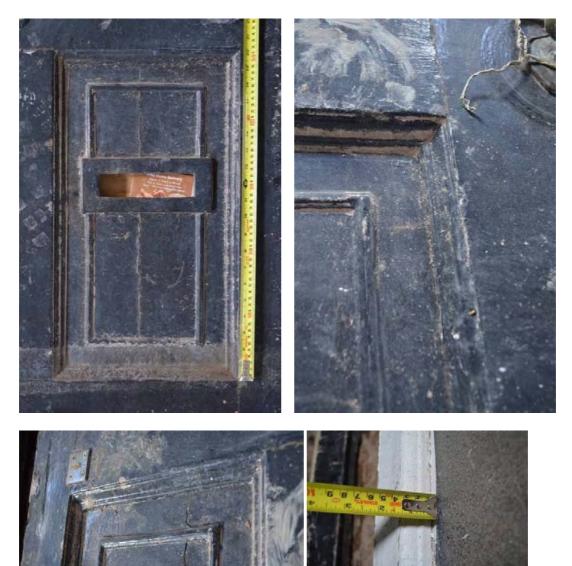
PANELLED DOOR DETAIL

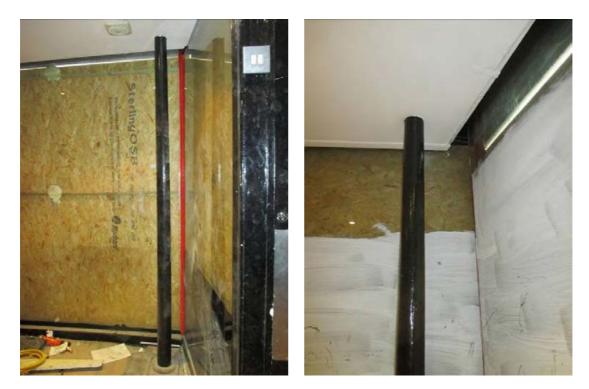
INTERNAL CAST IRON COLUMN - PENETRATION THROUGH GROUND FLOOR CEILING

Internally cast iron columns support the Bessemer beam above. There is a simple yet decorative plinth to the base of the column.

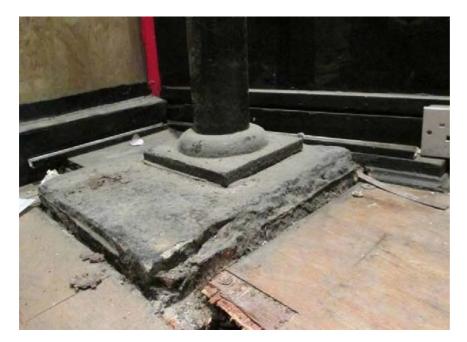
BASE DETAILS

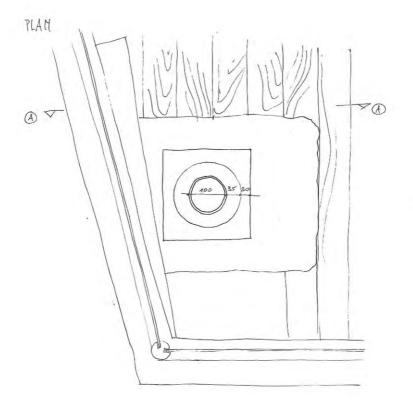
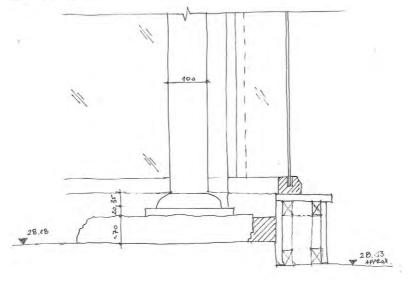
EXISTING CAST IRON COLUMN AND WINDOW BASE DETAIL

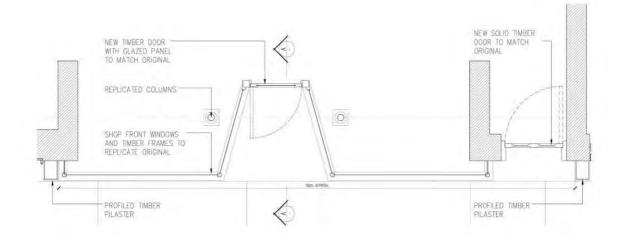
PROPOSED SHOP FRONT PLAN:

A new timber shopfront will be installed. Decorative console brackets to match the original will form the top of new pilasters to either side of the frontage. The entablature will be recreated with a defined cornice, correctly proportioned sloped timber fascia.

Timber window mullions together with decorative capping to match the original will be installed above a simple panelled stall riser. The recessed entrance and timber glazed door with glazed panel above will be installed with sloped glazed panels either side. (It should be noted that whilst this matched the original, Camden Council have previously asked for the recess to be boarded up due to problems with rough sleepers. Our client is happy to consider an in line entrance if deemed appropriate.)

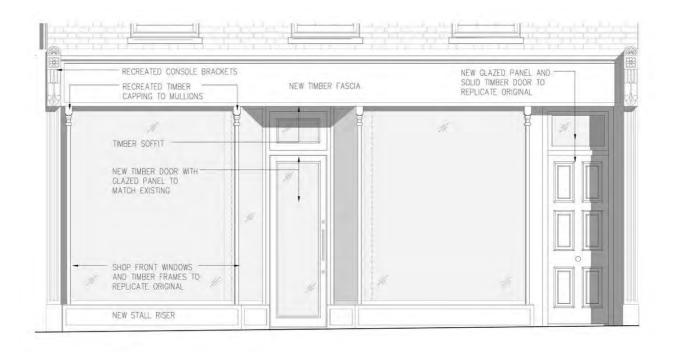
PROPOSED SHOP FRONT ELEVATION:

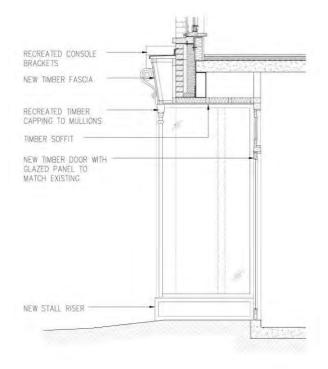
PROPOSED SHOP FRONT SECTION
