49 Doughty St, WC1N 2LX

Proposed New Front Area Stair

Heritage Statement

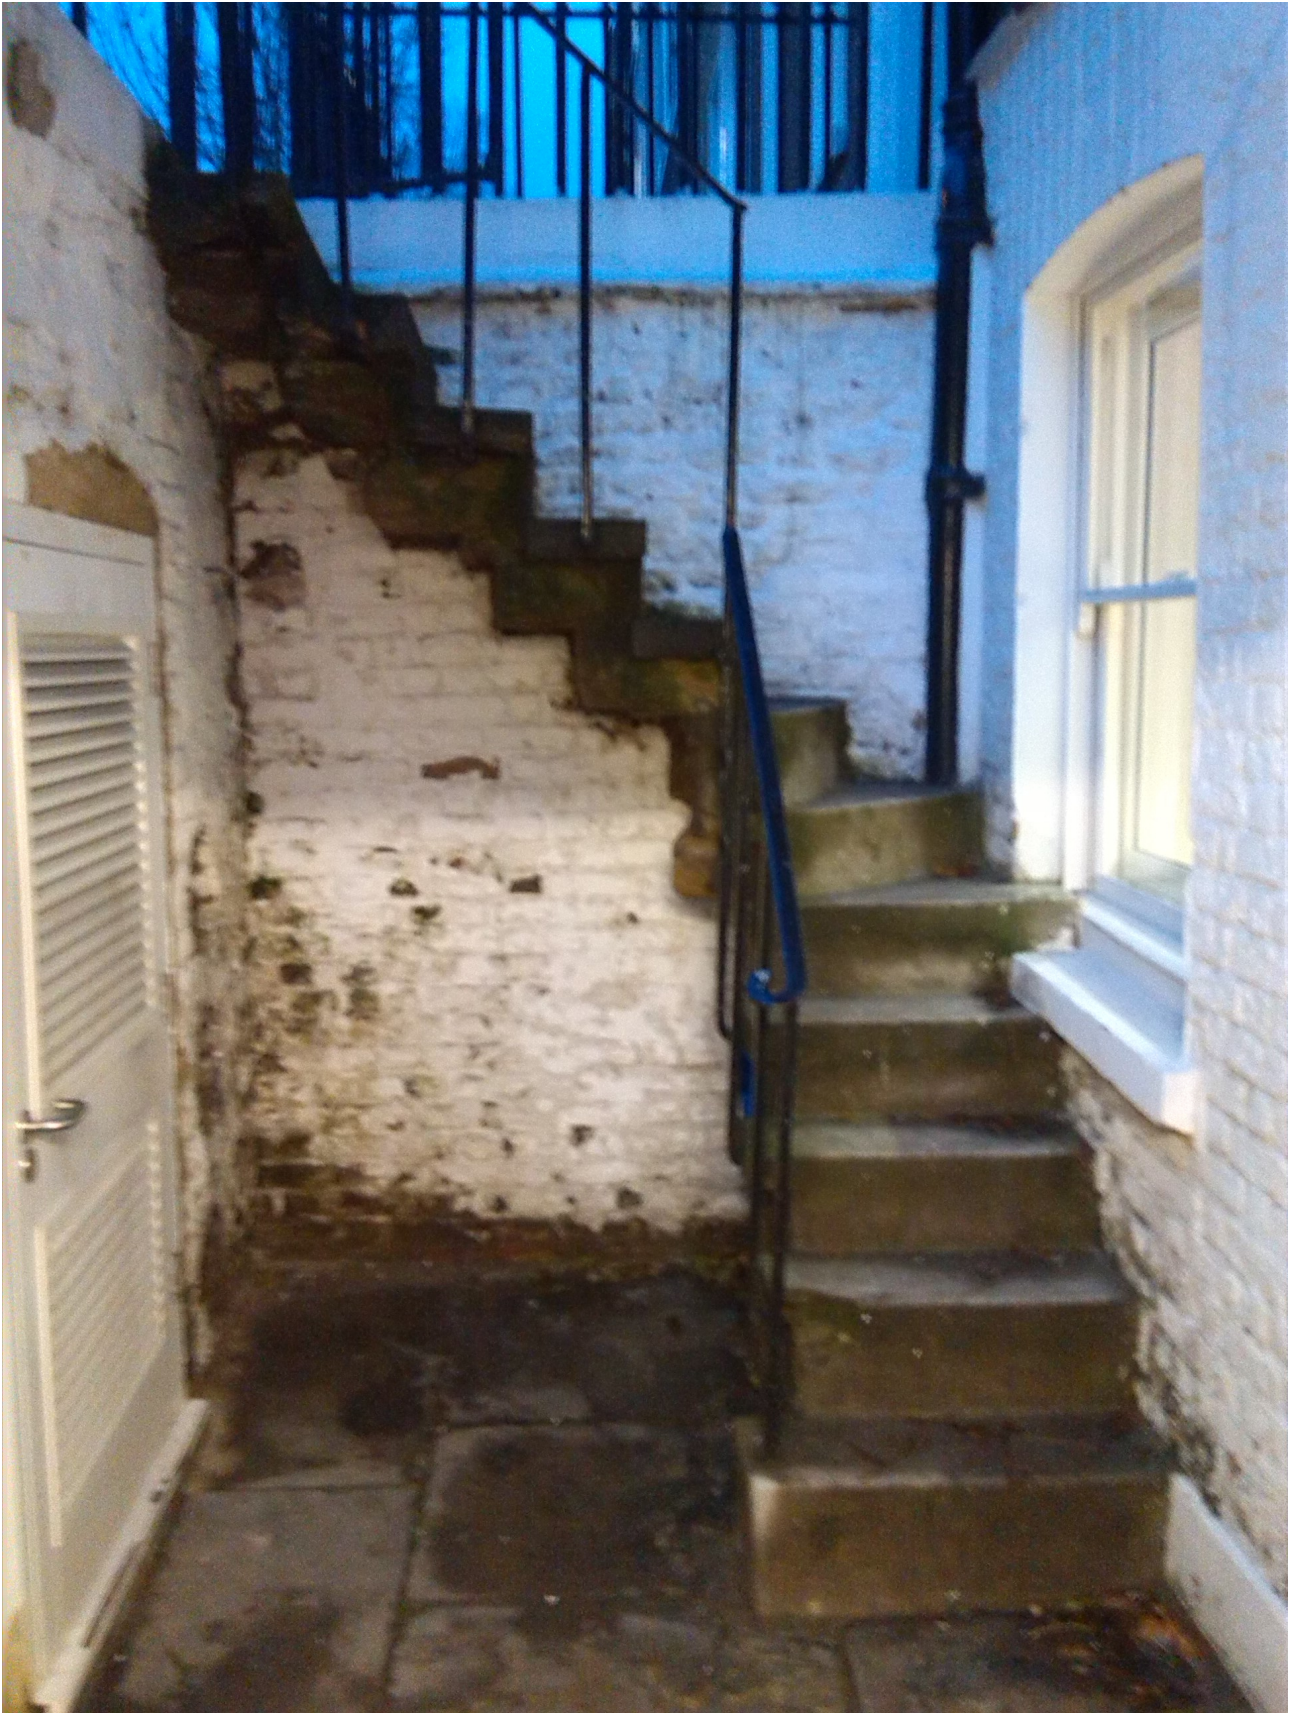
The existing stair consists of a sandstone structure assumed to be the original stair, with mid 20th C concrete treads overlaid, to which are attached a mid 20th C balustrade. See attached photographs.

Existing Stair

- A new steel or aluminium stair and balustrade conforming more closely to current building regulations, but of design which permits retention of the existing railing brace
- Insertion of a new hooped section to the railing in a style similar to the adjacent house and others in the terrace
- Installation of a new gate similar in style and materials to the existing but with a top rail to line through with the rail of the railing and finials to match.

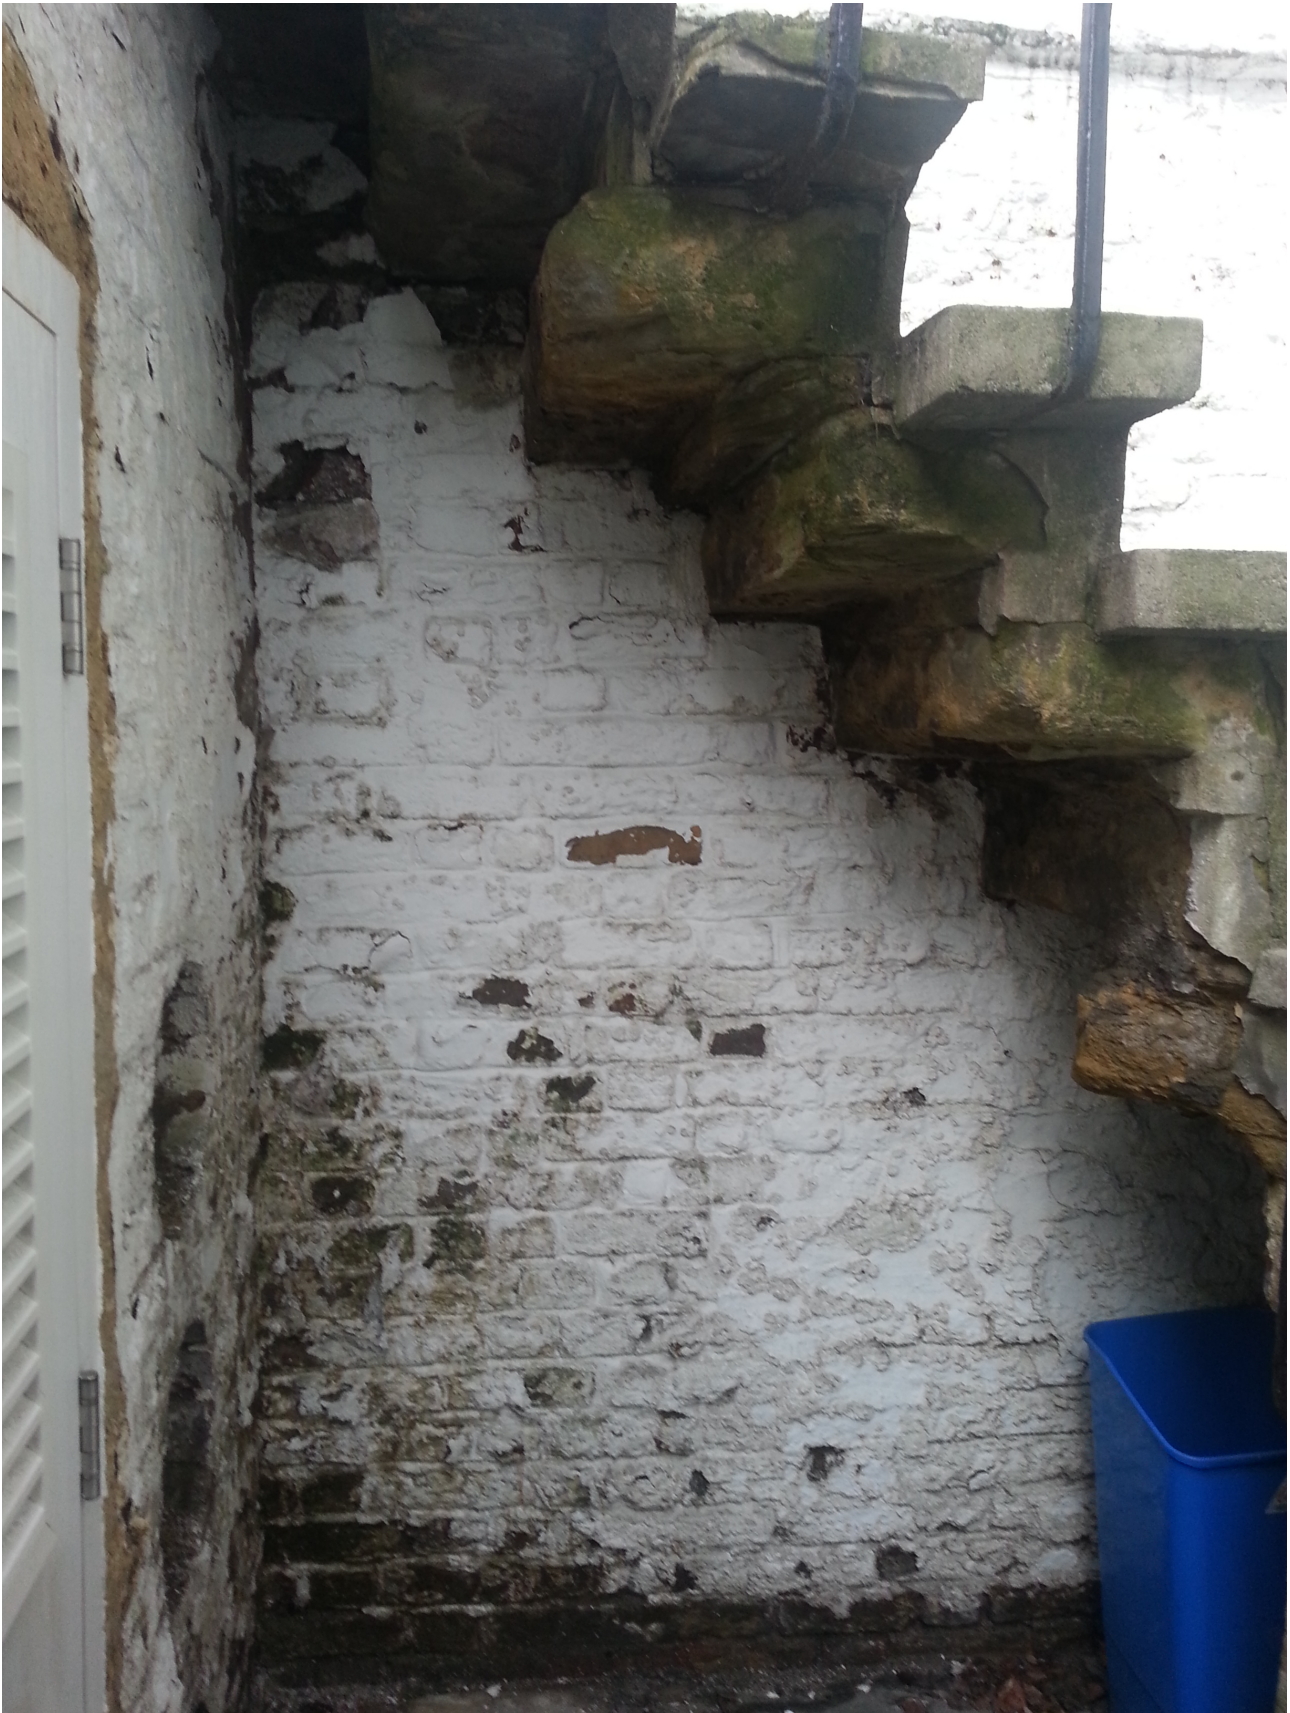
The original stone is badly weathered and delaminating, potentially imperiling the structural integrity of the whole. The concrete treads are spalling, and the fixings of the balustrade have suffered water and frost penetration.

Soffit of showing presumed original stone structure

- The removal carting away of the treads and balustrade of the existing stair
- The dismantling of the sections of the original stone stair and their storage (on site if possible)
- The removal of the section of the upper railing rail directly above the gate

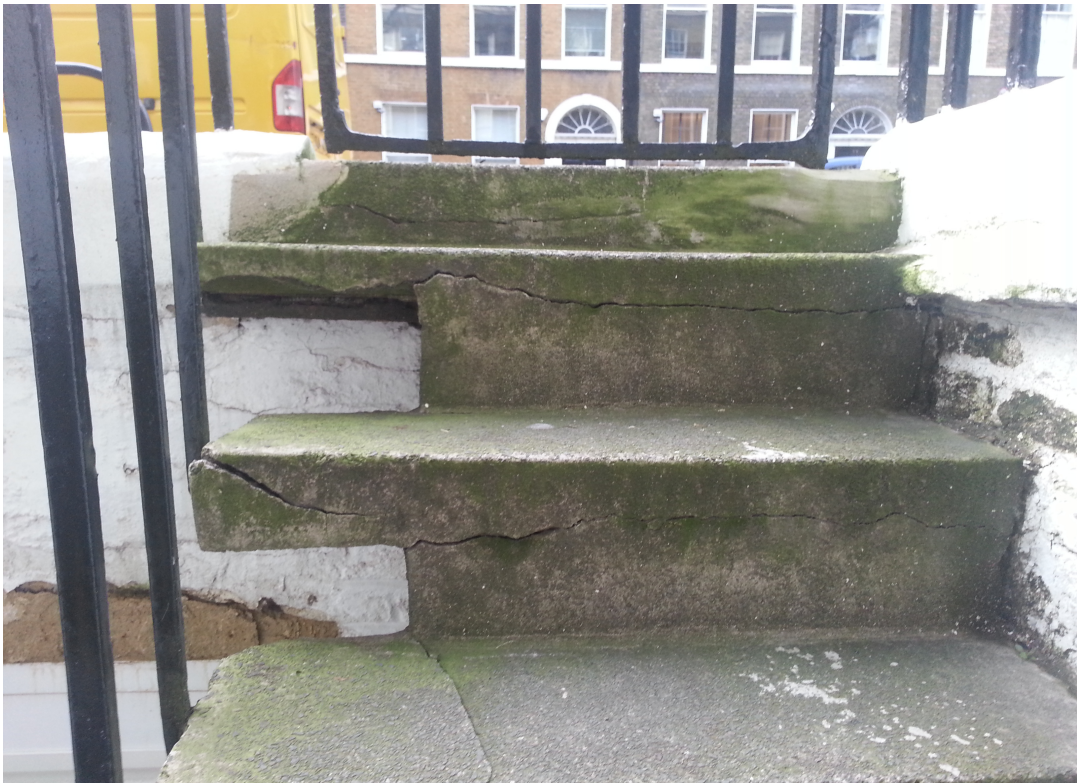
20th C concrete treads showing spalling and handrail fixings

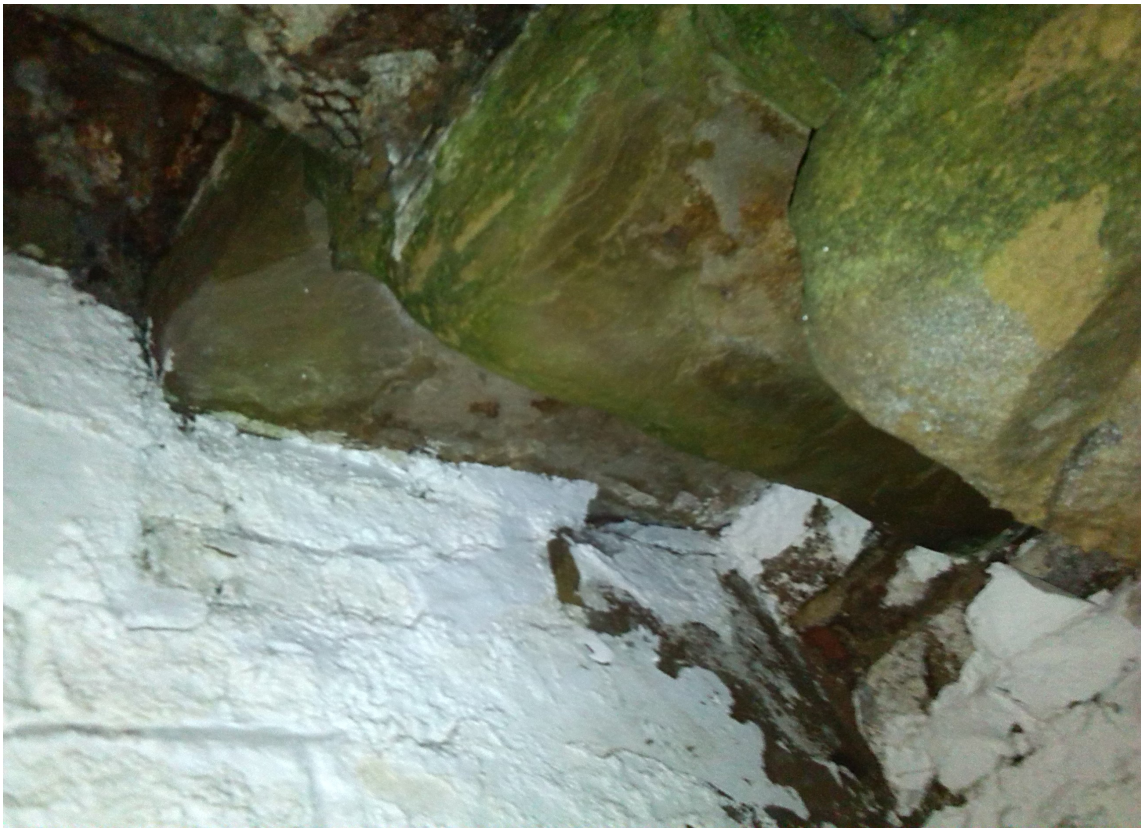
Detail of soffit showing delamination of stone
