**Camden Stables Market
Tack Room**

**Chalk Farm Road
NW1 8AH**

DESIGN AND ACCESS AND HERITAGE STATEMENT

December 2013

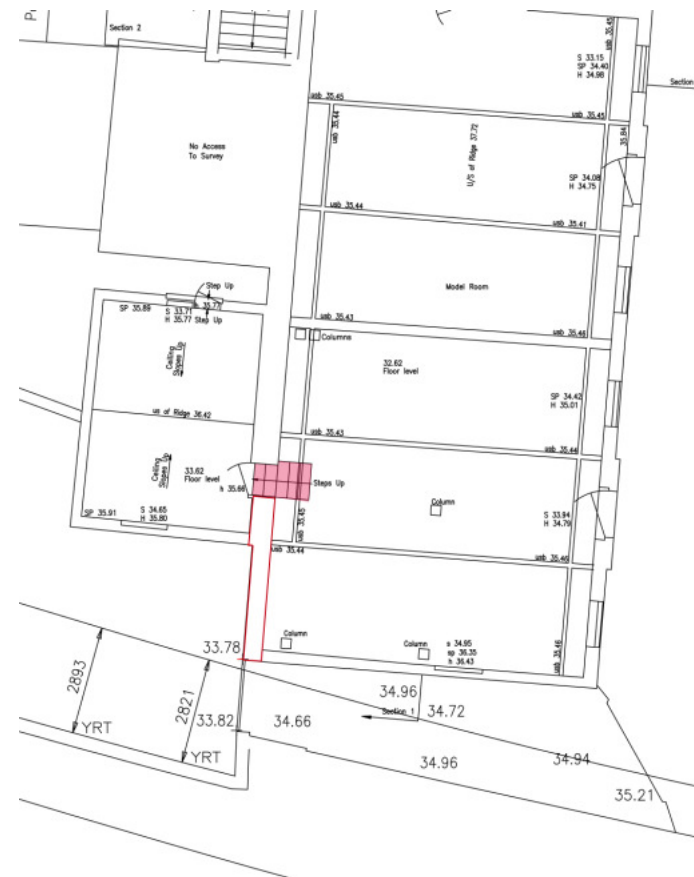
Figure 7: Previous survey of Tack Room upper floor showing west elevation opening in red and wall thickness at the southern end outlined also in red.

The southern sector of the west elevation at upper floor appears reduced in width, as depicted in previous surveys and current photographs.

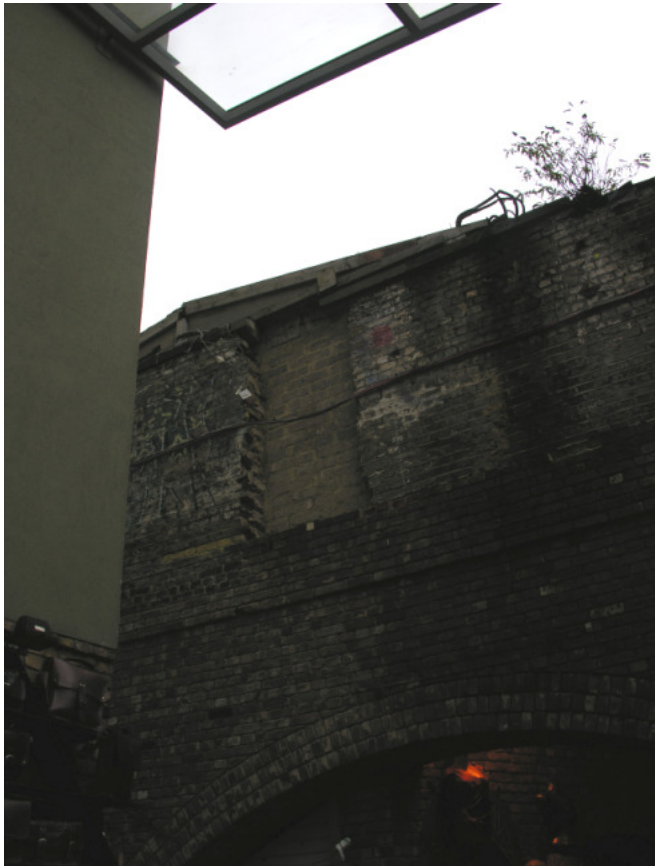
Figure 8: Tack Room west elevation south section upper level.

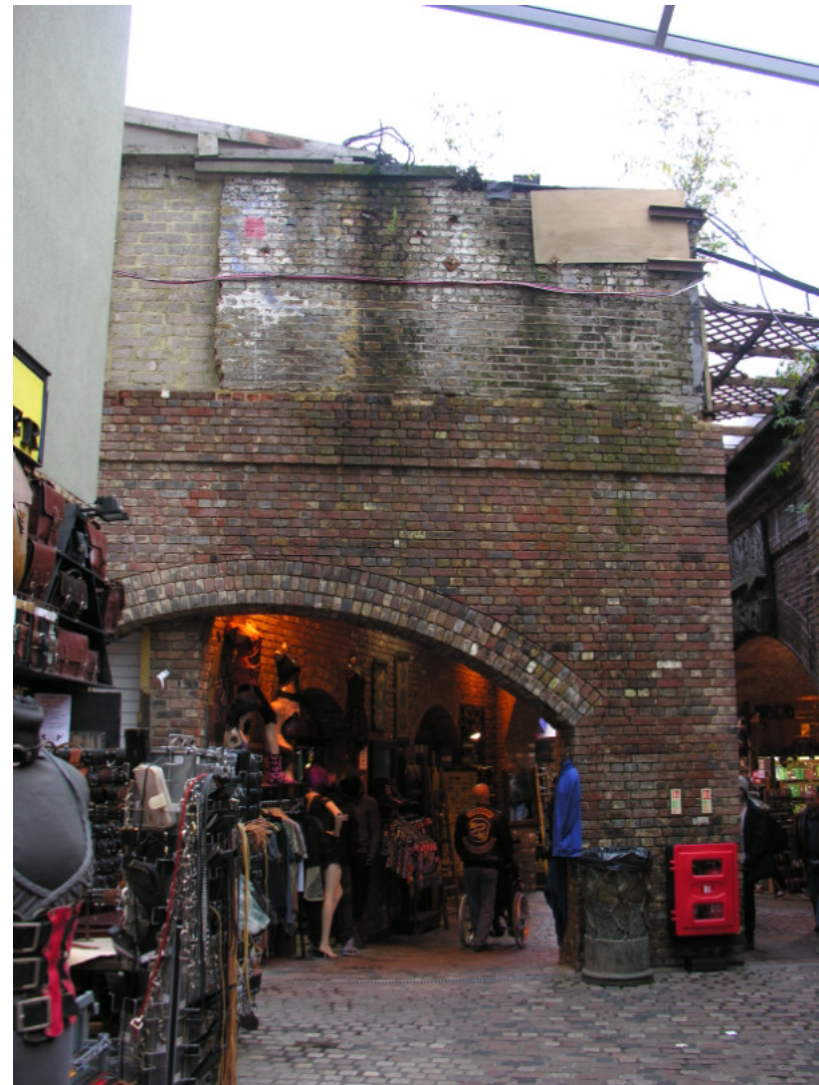
Figure 9: Tack Room west elevation south section.

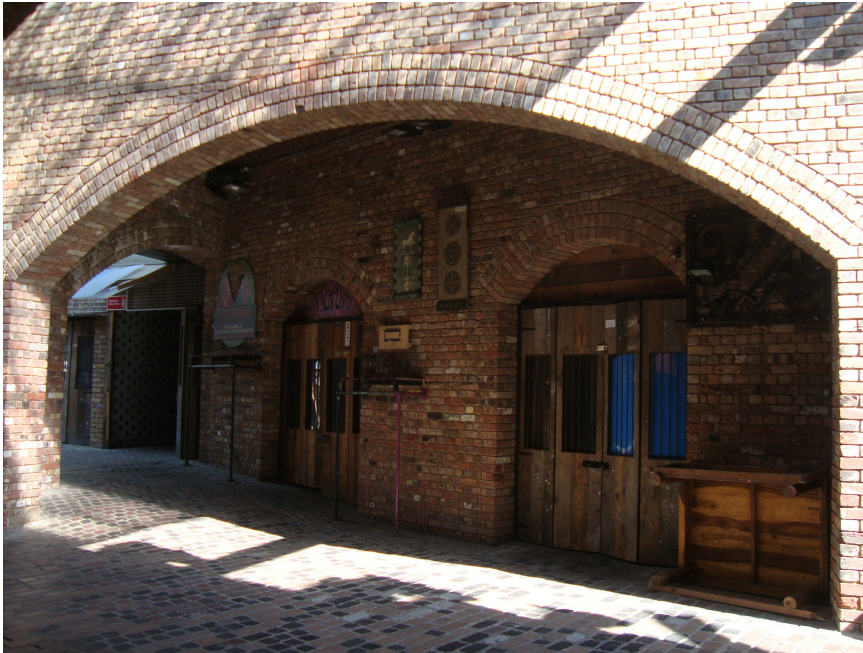
Figure 10: Tack Room south elevation ground floor.

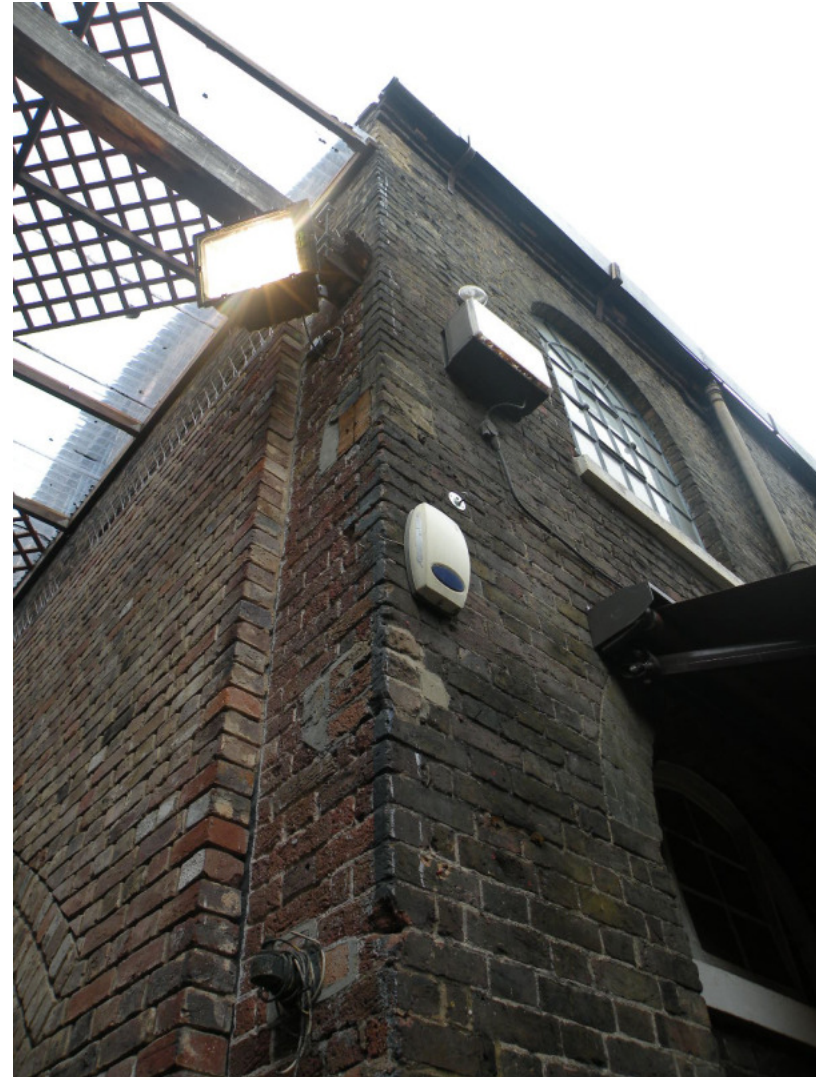
Figure 11: Tack Room south east corner showing overlapping brickwork.

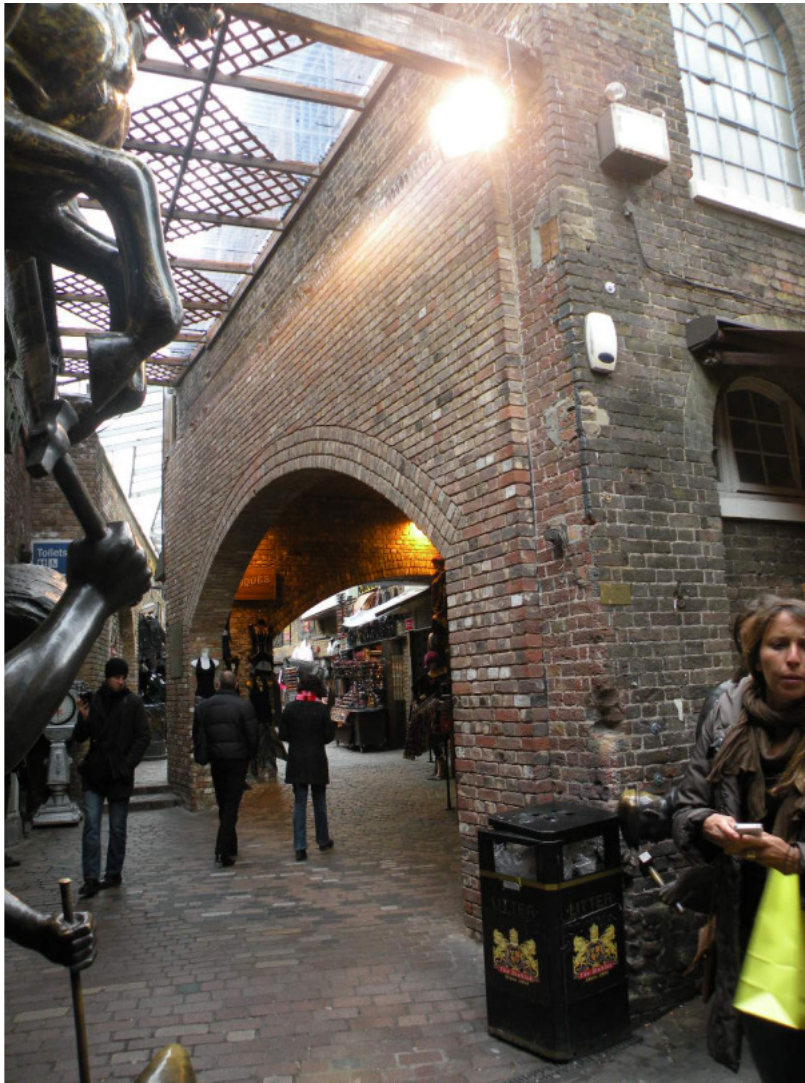
Figure 12: Tack Room south elevation.

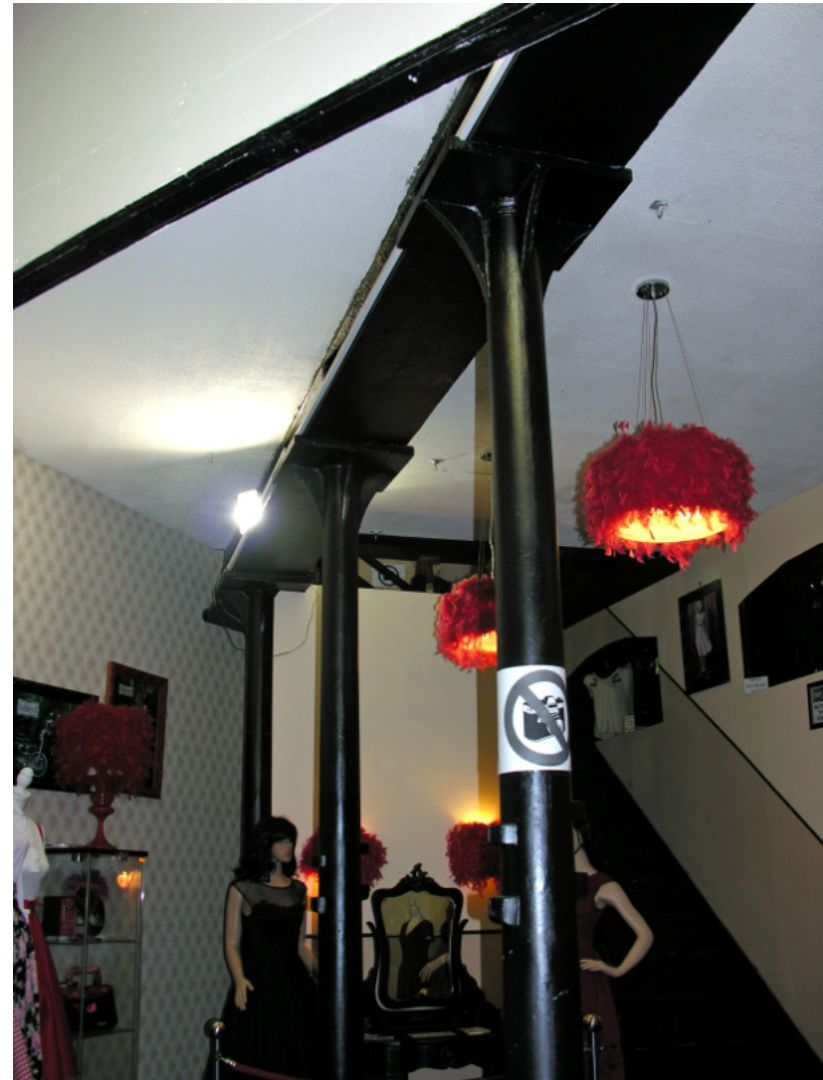
Figure 13: South end interior.

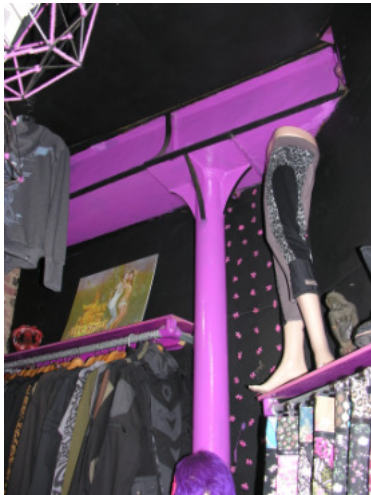
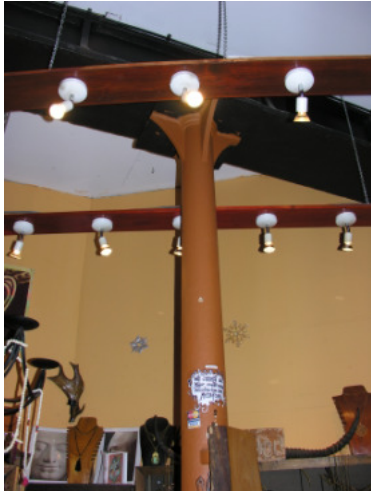
Figure 14: Cast iron column and girder south end interior

Figure 15: Cast iron column and girder south end interior

Internally, the missing cast iron column and girder section in the southwest corner will be reinstated. The proposed works will see the column replaced to look identical to the original. The above beam structure of the portico will also be strengthened and repaired to match the original. All works will be carried using traditional techniques and high quality materials. Please see drawing No 3788-01 by Walsh Associates.

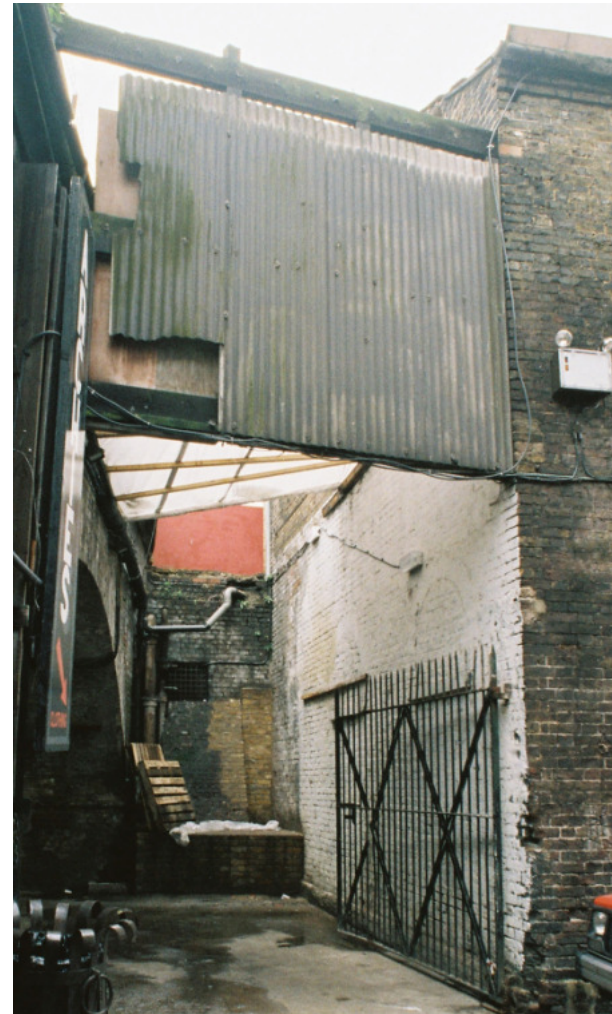
Figure 16: South elevation in 1997 showing at least two arches in the brickwork

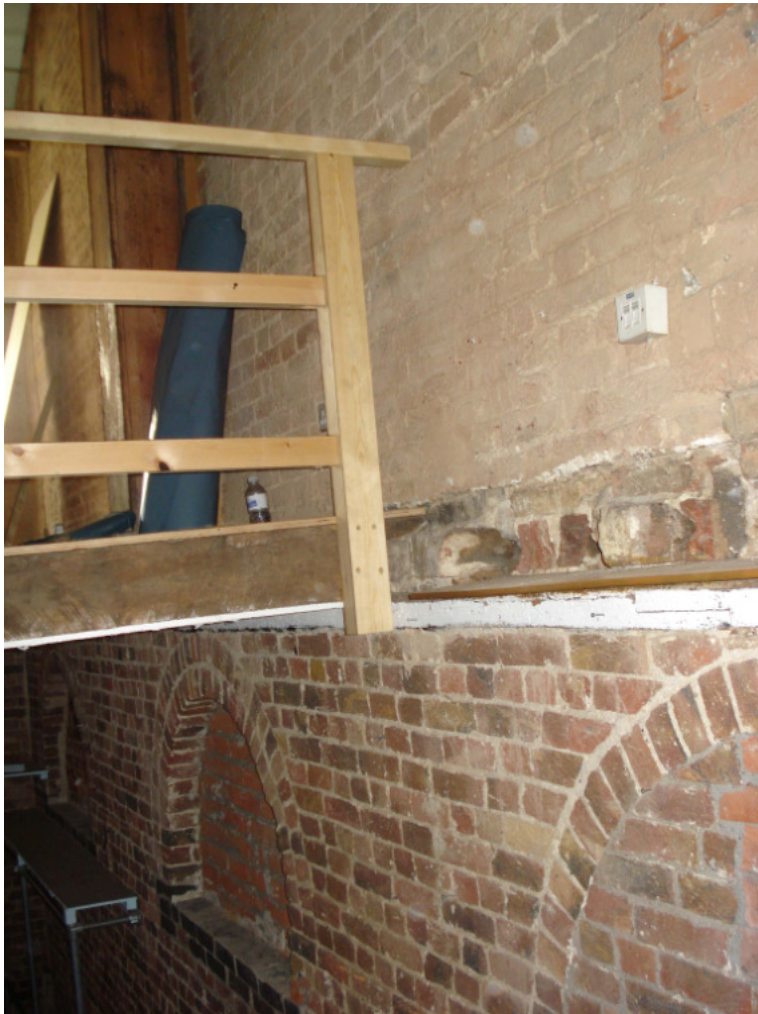
Figure 17: Interior of south elevation pre-demolition showing three infilled arched openings.
