PLANNING &
HERITAGE
STATEMENT
December 2013
(Rev 6 January 2014)

28
MUSEUM
STREET

28 MUSEUM STREET, LONDON WC1A 1LH

ARCHITECT'S PLANNING & HERITAGE STATEMENT

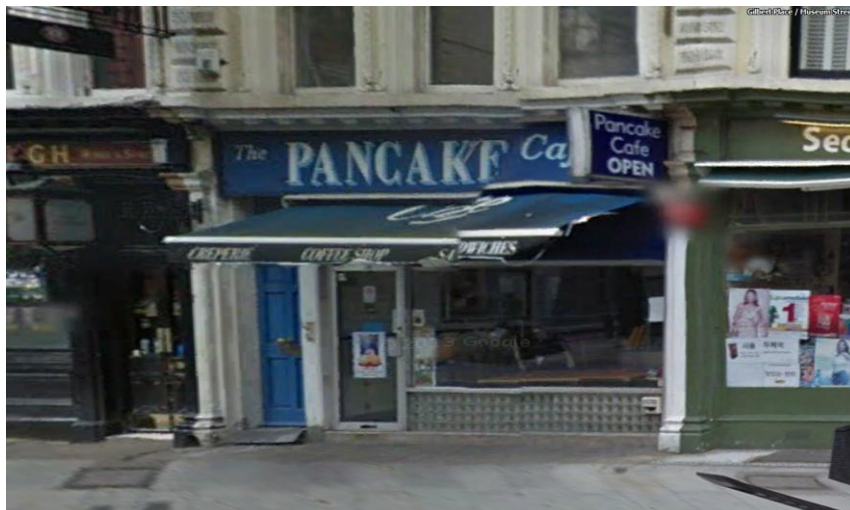
Google Streeview composite of the shop frontage, taken in 2012, showing terrazzo step, aluminium shopfront framing, glass-block stall-riser, awning and fascia.

The existing shop frontage to No.28 however, is not of good quality, and contains no visible material likely to date earlier than mid C20th.

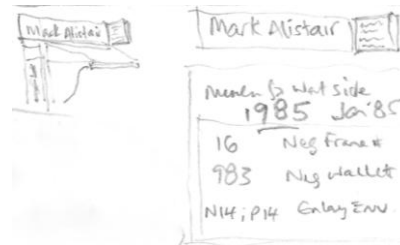
Photographic evidence for the shopfront in January 1985 (Camden Archives (CA) Neg 16/983/N14;P14 - Museum Street West Side - contact only) shows a similar arrangement, including projecting signage (although the lower sections are obscured by the traditional awning opened to the pavement and with shaped side panels), trading as ‘Mark Alistair’.

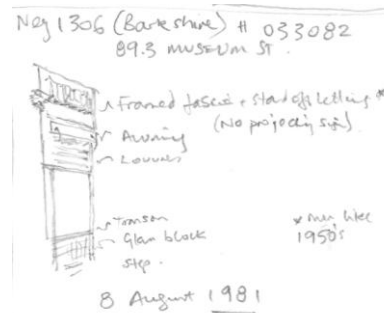
A further print dating to 8 August 1981 (CA - Neg 1306 (Barkshire) H033082-89.3 Museum St) gives a good view of the entire shopfront, in all respects similar to the existing arrangement, with the exception of horizontal glass louvres within the aluminium framed over-panel, and signage to the fascia apparently carried out in 'stand-off' lettering in capitals (stylistically 1950's?).

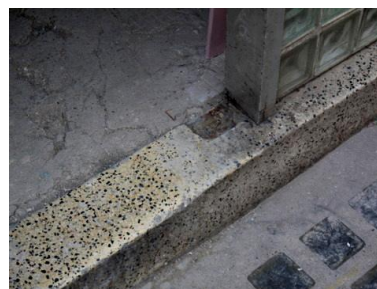
Physical evidence shows the terrazzo step being carried through below the aluminium and glass block infill. Further, the presence of an outline in the terrazzo step, close to the door frame is thought to be a clue to an earlier, narrower timber door frame member, contemporary with, or pre-dating the terrazzo (right).

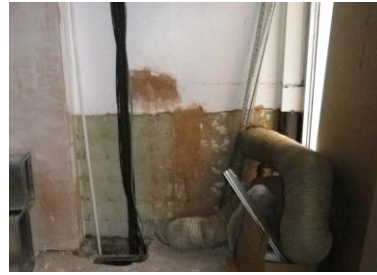
The only internal evidence alluding to the use of the premises as a butcher's or poulterer's shop is in the photograph (right) taken in August 2013, showing a section of wall behind the shopfront, where the outline of characteristic butcher's wall tiling is visible below the white painted plastering. It is likely that this area survived being behind the serving counter.

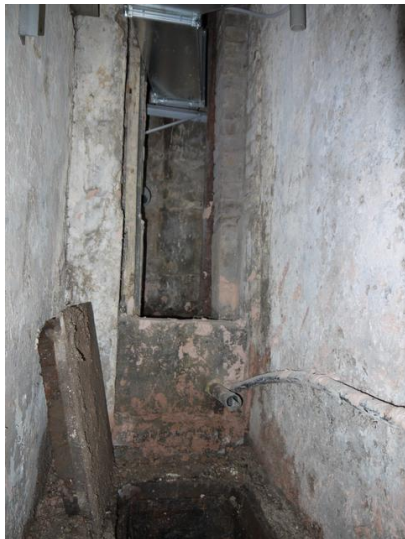
View to window opening at rear of B7

Internally, physical finishes relating to the original build are very limited. At basement level, unimproved wall finishes remain exposed at the rear (B7) used as a ducting route to the rear of the building.

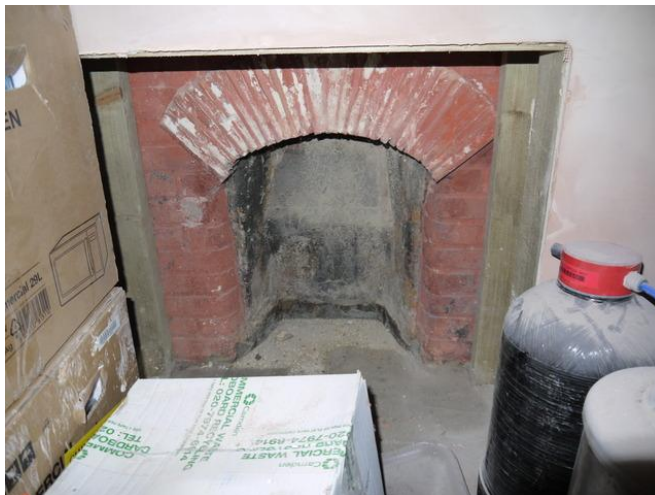
Within the rear basement room (B3) a small fireplace with surround comprising tiled arch and bull-nosed brick jambs, has been retained behind the plaster-boarded dry-lining. Although locating an original flue, the fireplace is a fairly crude, post-war feature.

Fireplace surround with projecting creasing tile arch and bull-nosed brick jambs

- The basement walls to B2 and B3 are to be dry-lined with preservative treated timber studwork and plasterboard, including forming panel access to the retained fireplace in the rear room (B3).

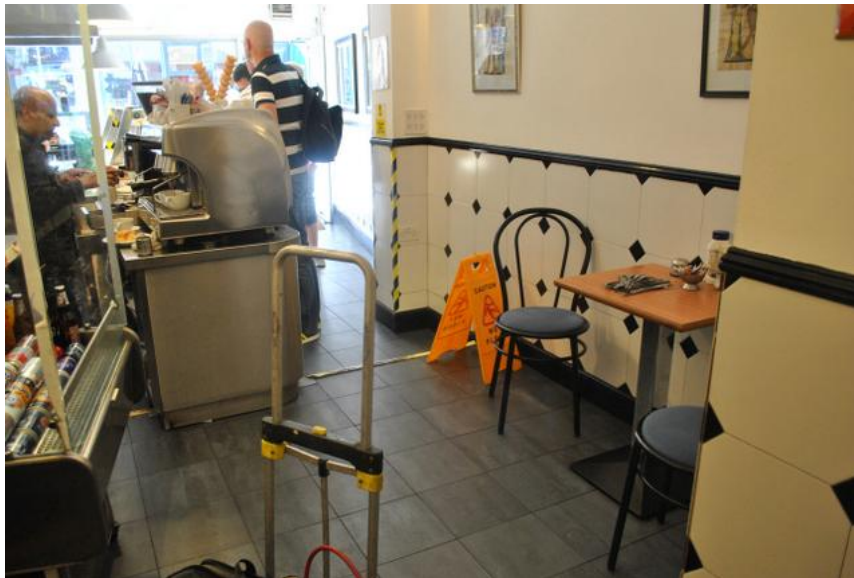
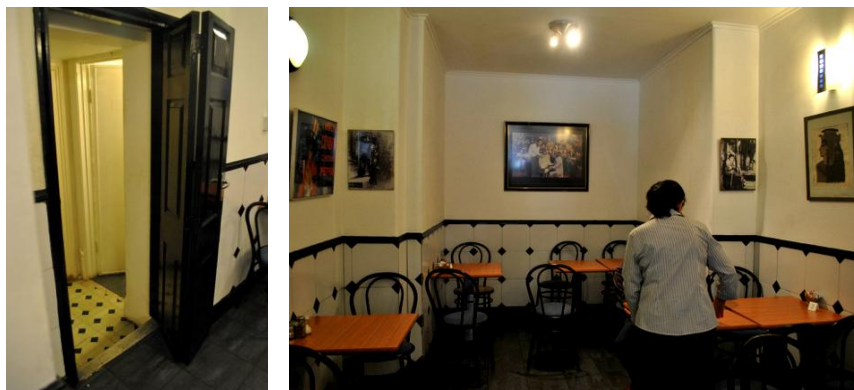
General views of ground floor café arrangement

Throughout the ground floor public level the floor was laid with grey, 300 x 300mm stone-effect ceramic tiles on a concrete screed. The walls were finished with dado tiling comprising 300mm clipped white tiles and black diamond inserts, laid with a plain ex-100mm painted skirting and a 32mm ogee architrave as capping, with painted plaster above. The ceiling was of suspended plaster concealing servicing, and finished with a small planted cove.

The images (previous page) show the ground floor cafe space (G1 - G4), including the retained bi-fold door leading to the staircase lobby. From the stylistic treatment it is probable that the ground floor finishes are likely to date to around 2000 (or between say 1995 and 2005).

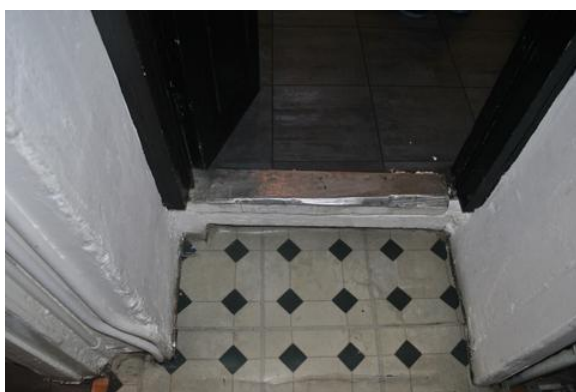
The lobby (G5) was laid with vinyl flooring on part-screed, part-floor boarding (below), with the toilet (G5) tiled as the café. An aluminium nosing protected the step between the café (G3) and the lobby.

Before with vinyl flooring to lobby

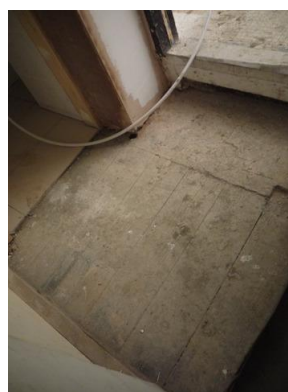
During refurbishment

The plastered (on masonry) wall and jamb finishes to the lobby and toilet areas have been repaired or renewed.

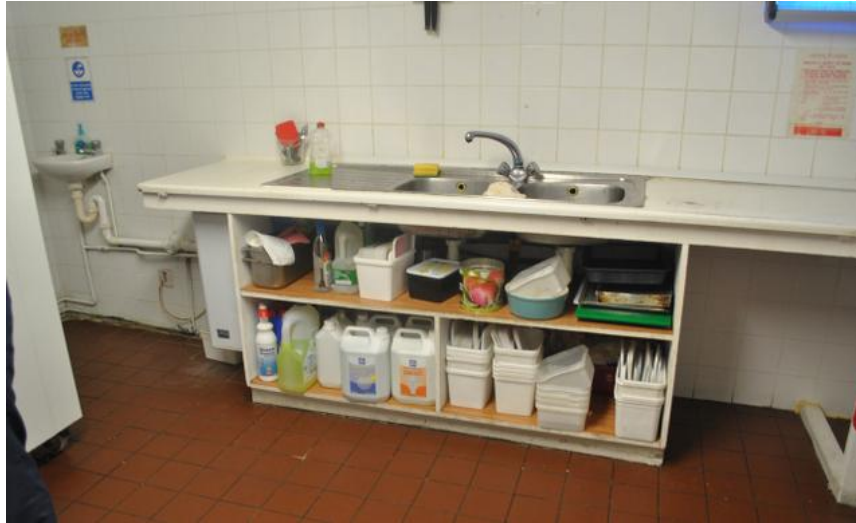
The main rooms within the basement (B1, and B2) were fitted out as a kitchen serving The Pancake Café. Photographs show plain, white, 150mm ceramic-tiled walls with red quarry tiled floors. The ceilings were plastered and painted. There is no evidence for the presence of skirting boards.

Kitchen (B1) looking east, September 2013, prior to refurbishment

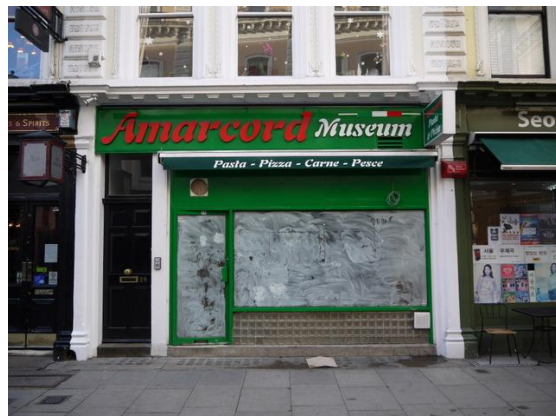
Right: Near-completed shop front, with Amarcord Museum signage on fascia, in unknown font.
