OUR REF: L/2012/27371/S/MLL/kh/nap
REF: TBA
POLICYHOLDER: Mr R B Goldstein
ADDRESS: 261 Goldhurst Terrace, London, NW6 3EP

PHOTOGRAPHS TAKEN DURING MONITORING INSPECTION
ON 04 SEPTEMBER 2013

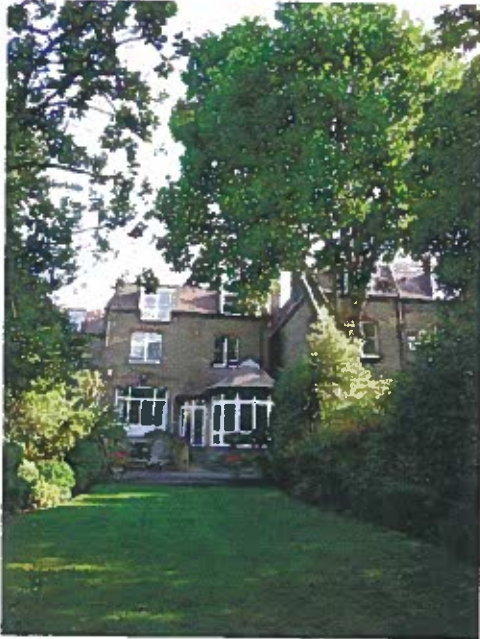
PHOTOGRAPH 01:

This photograph gives a general view of the rear elevation of the insured property showing the single storey extension and the London Plane tree.

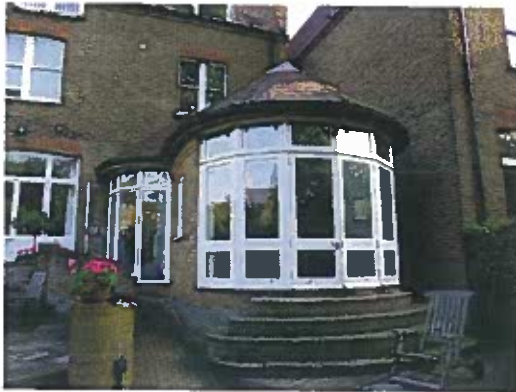
PHOTOGRAPH 02:

This photograph gives a closer view of the extension.

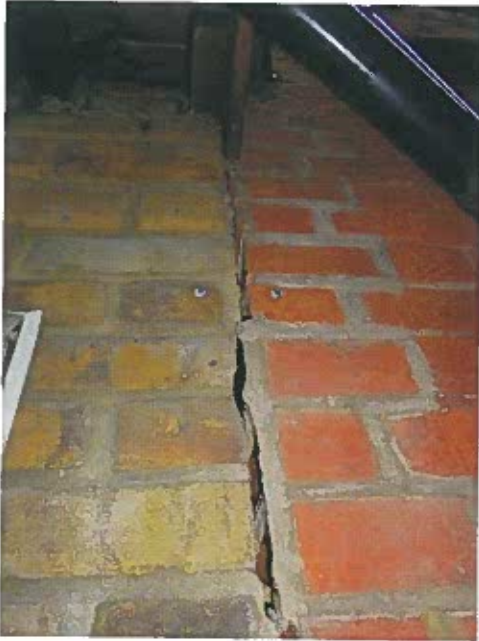
PHOTOGRAPH 03:

This photograph shows the crack to the left side of the extension which has increased in width by 2mm.

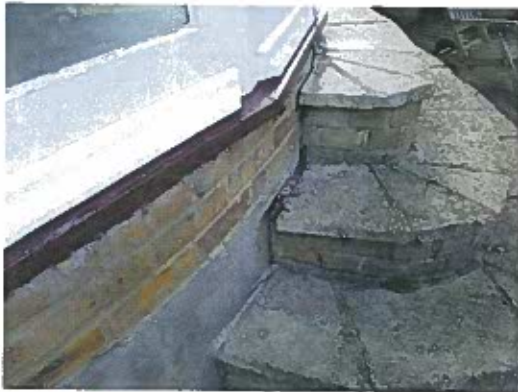
PHOTOGRAPH 04:

This photograph gives a view of movement of the rear steps.

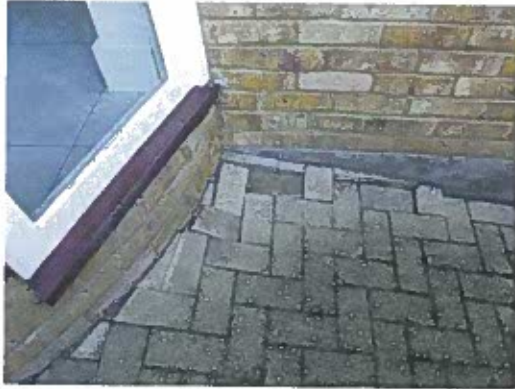
PHOTOGRAPH 05:

This photograph gives a view of movement of the brick paved path to the right side of the extension.

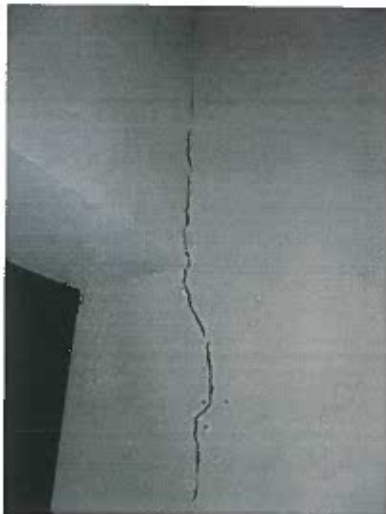
PHOTOGRAPH 06:

This photograph gives a view of the vertical crack internally to the right side of the extension at the junction with the main building.

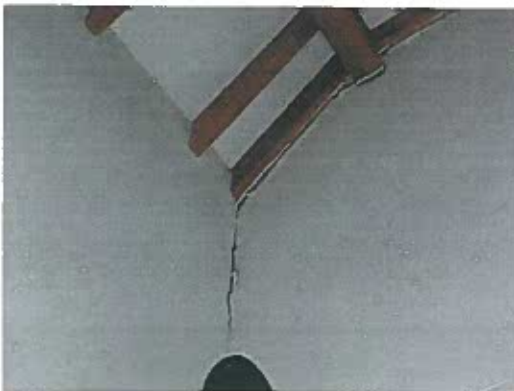
PHOTOGRAPH 07:

This photograph gives a view of the crack towards the centre of the extension at the junction with the main building.

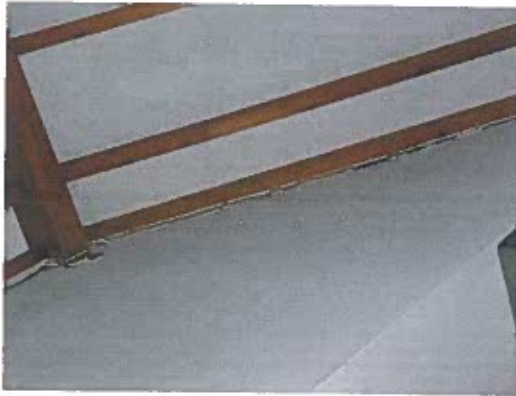
PHOTOGRAPH 08:

This photograph shows the crack along the wall ceiling junction with the extension which has increased in width substantially.

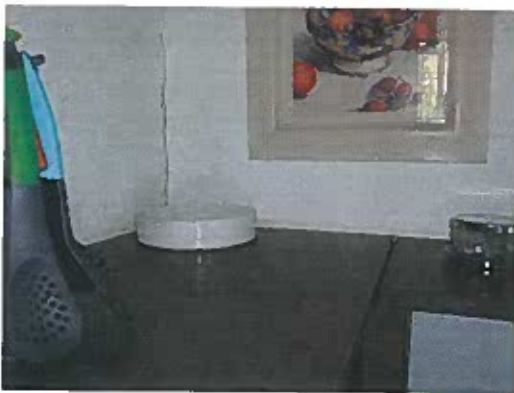
PHOTOGRAPH 09:

This photograph gives a view of the crack to the left side of the extension at the junction with the main building also showing movement of the kitchen base units.

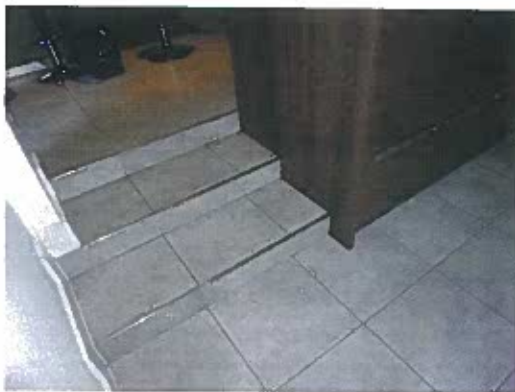
PHOTOGRAPH 10:

This photograph gives a view of the tiled floor which is somewhat uneven at the base of the stairs between the extension and main building.

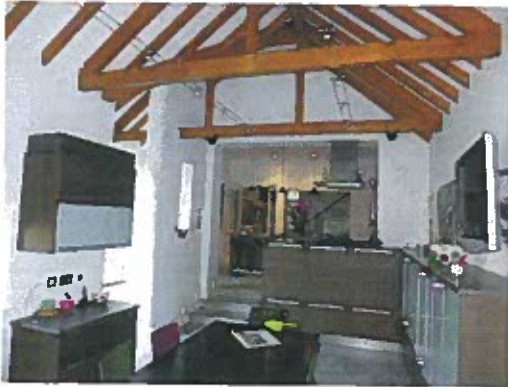
PHOTOGRAPH 11:

This photograph gives a general view of the dining room within the extension extending through to the kitchen which is in the rear left corner of the main house.

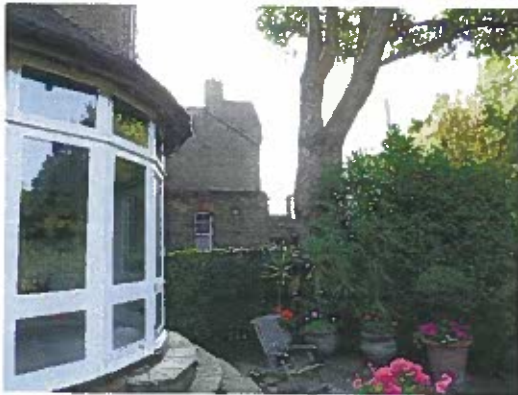
PHOTOGRAPH 12:

This photograph gives a view along the rear of the extension showing the proximity of the large mature London Plane tree which is also very close to a neighbouring property.
