Desk Study Report

9-12 New College Parade
Finchley Road
London
NW3 5EP

J13299

October 2013

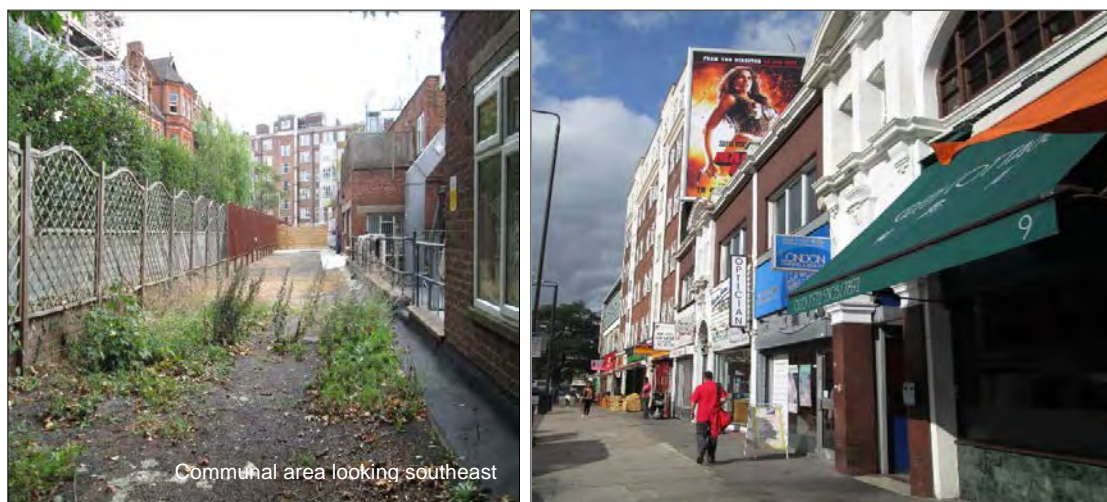
Communal area looking southeast

Finchley Road slopes down towards the east and the site is on a number of different levels. The building is cut into the slope of the ground, such that it comprises two storeys with basement at the front and a single storey with double basement at the rear. At the front of the building is a paved pedestrian walkway and at the rear a communal concreted area approximately which is shared with the building to the southeast.
