Arboricultural Impact Assessment

Tree Protection Plan

187 Kentish Town Road, London NW1.

**Proposals: 5 Storey Redevelopment of 187 Kentish
Town Road**

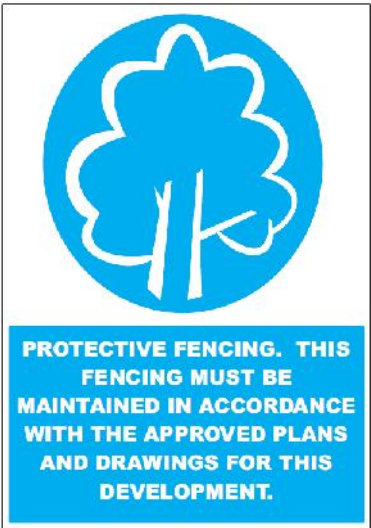
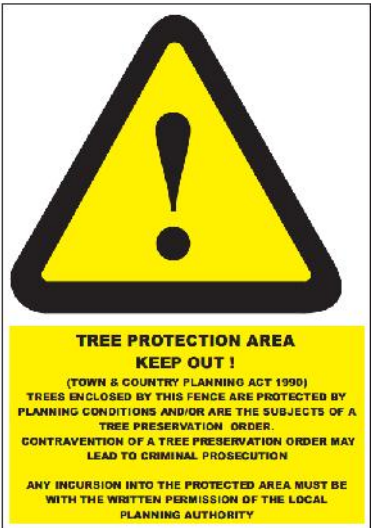
A sign, similar to that shown below will be firmly attached to the outside of the timber box around each tree.

- o The CEZ will be clearly identified (see construction exclusion zone sign example, below)
