Gospel Oak Primary School Camden

Ground Investigation Report

On behalf of NPS Property Consultants

Report 140361/GIR1
November 2013

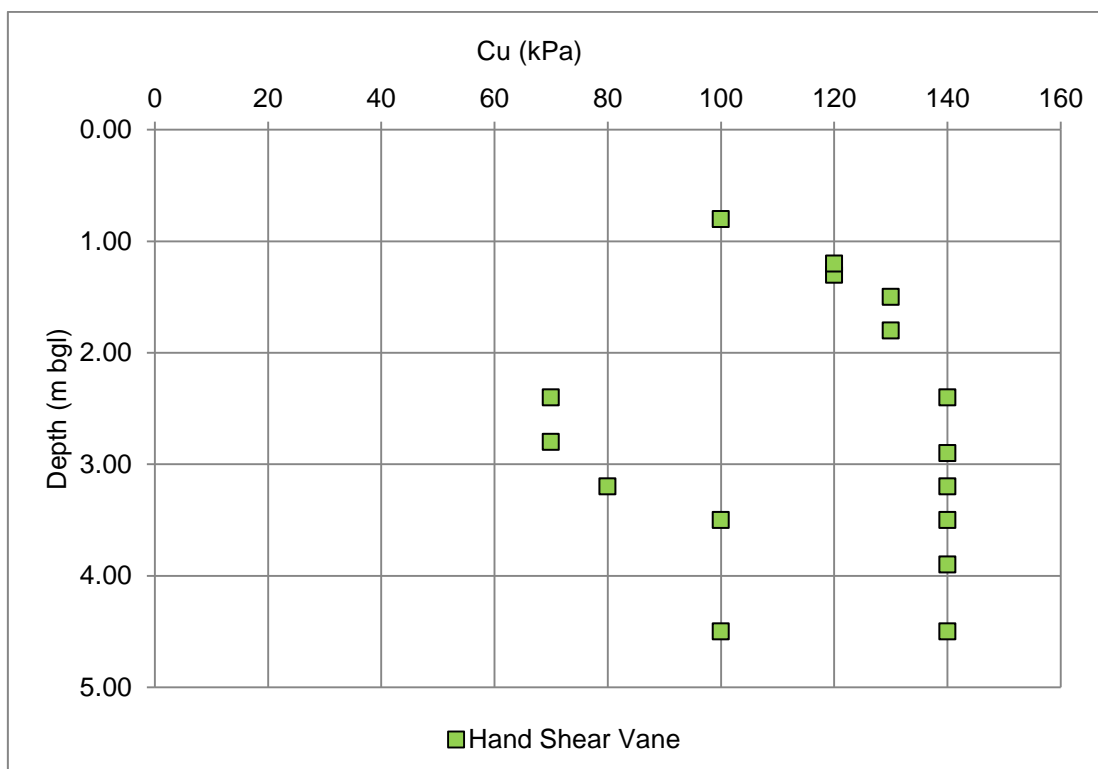
Figure 3 Shear strength

The results of hand shear vane tests ranged from 70kPa to 140kPa (the upper limit of measurement for the apparatus). The shear strength values are shown on Figure 3.
