Ground Investigation and Basement Impact Assessment Report

99A Frognal
Hampstead, London, NW3 6XR

J13053

May 2013

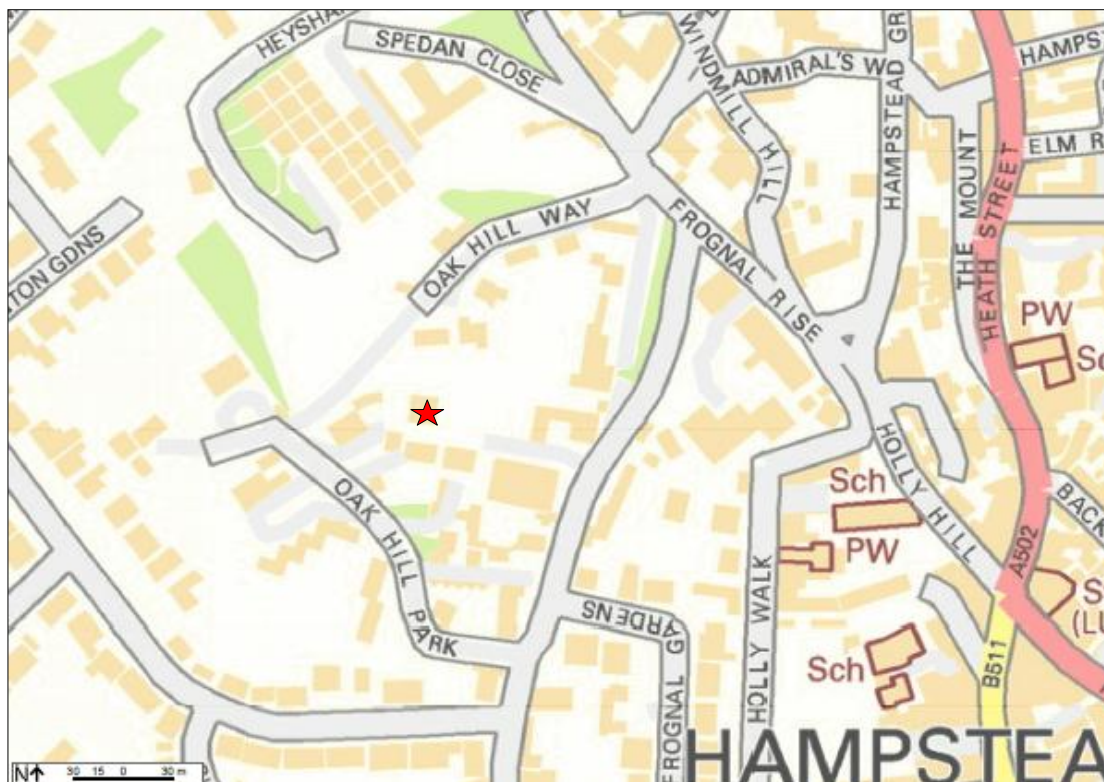
The site is currently occupied by a house with an adjoining garage, located along the southern elevation. The building is cut into the slope of the ground, such that it comprises two storeys along the eastern elevation and a single storey along the western elevation, although there is an enclosed basement lightwell present along the eastern elevation.

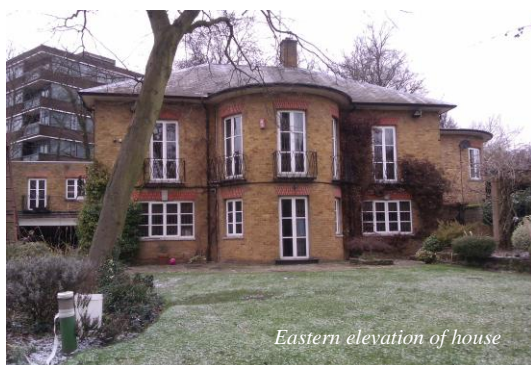
Eastern elevation of house

Along the eastern elevation of the house is an essentially level patio area at approximately 119.29 m OD, leading onto a central lawn, which slopes gently towards the east from 119.29 m OD to 117.26 m OD over a distance of roughly 30 m. In the northern part of the garden is a number of terraces, leading up to an ornate garden at 121.08 m OD. Further steps lead up to a patio area, located along the rear elevation of the house and garage at 122.31 m OD. A lawn is present at this level at the southern end of the patio area. In the southwestern corner of the site a single storey outbuilding is present. Another set of steps are present to the south of the garage building from the driveway at 119.18 m OD leading up to the rear garden at 122.31 m OD.

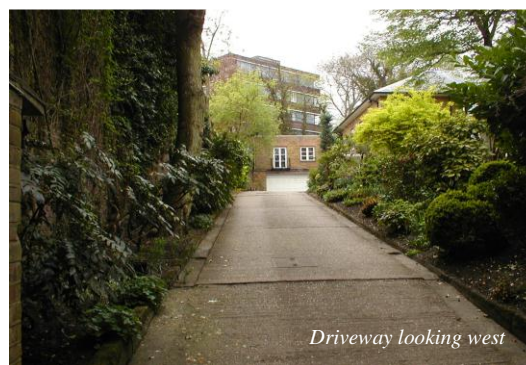
Driveway looking west

At the front of the house a driveway is situated between the existing house and the southern garden boundary wall. The driveway slopes down in an easterly direction from 119.18 m OD to 115.29 m OD over a distance of roughly 40 m, to meet the private access road.

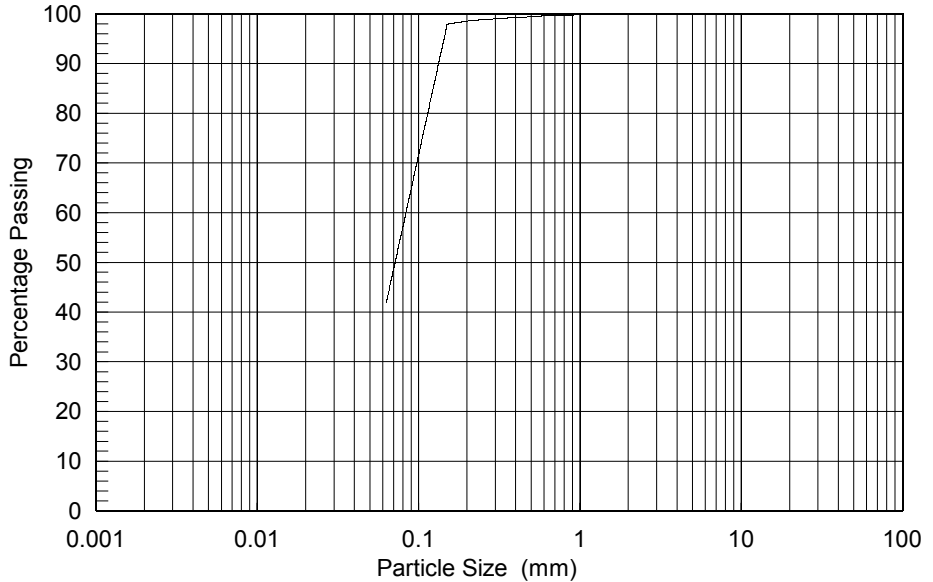
SIEVE	
Sieve	% pass
200 mm	100
125 mm	100
90 mm	100
75 mm	100
63 mm	100
50 mm	100
37.5 mm	100
28 mm	100
20 mm	100
14 mm	100
10 mm	100
6.3 mm	100
5 mm	100
3.35 mm	100
2 mm	100
1.18 mm	100
600 µm	100
425 µm	99
300 µm	99
212 µm	99
150 µm	98
63 µm	42

Particle Proportions		
Cobbles	0.0	%
Gravel	0.0	%
Sand	58.2	%
Silt & Clay	41.8	%
