THE ELMS

Fitzroy Park, Highgate

A selection of the original windows was examined on behalf of Luard Conservation Ltd, to find out how they were painted when the house was first built. The list of windows from which samples were taken, and the examination procedure that was carried out, are given at the end of this report.

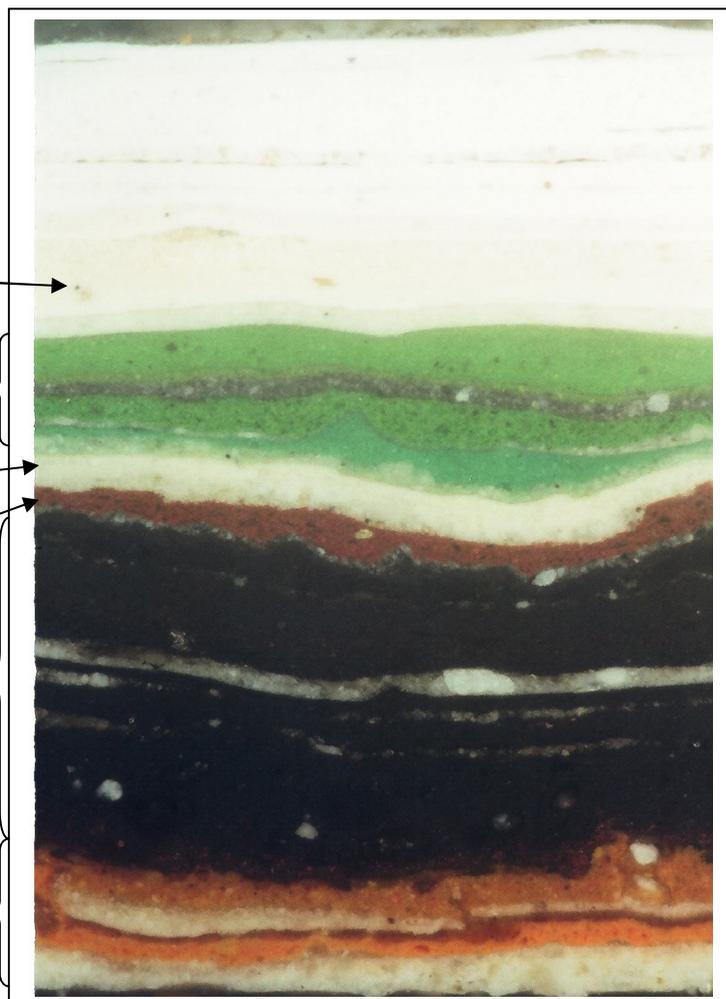
SAMPLE 8

Narrow, rectangular sash [0601]
[x200]

A good example of the layers
found on all the sashes.

1930s? zinc oxide white →

early C20th greens }
}

white →

end of C19th dark brown →

later C19th blacks }
}

mid C19th grainings }
}

The method used on this house was not the standard technique for nineteenth-century oak graining: the layers involved an orange/brown ground [see Sample 8, p.4] rather than the usual ochre ground, and it may have been a mahogany graining. Alternatively the effect may have simply been a glossy, glazed brown, giving the general impression of varnished hardwood. The only way to find out for certain would be to reveal a small area on site.

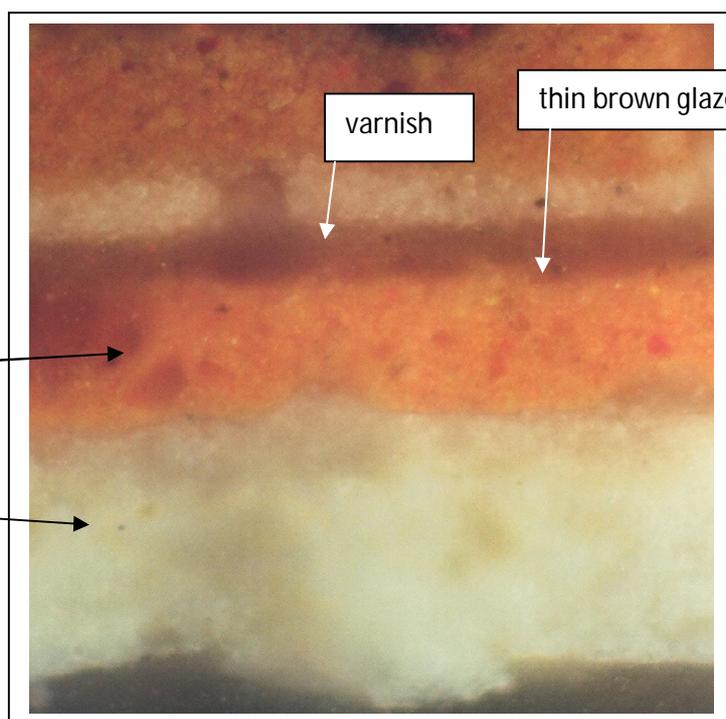
**Detail of the first scheme**

[x500]

varnish

thin brown glaze

orange/brown undercoat →

lead white primer →

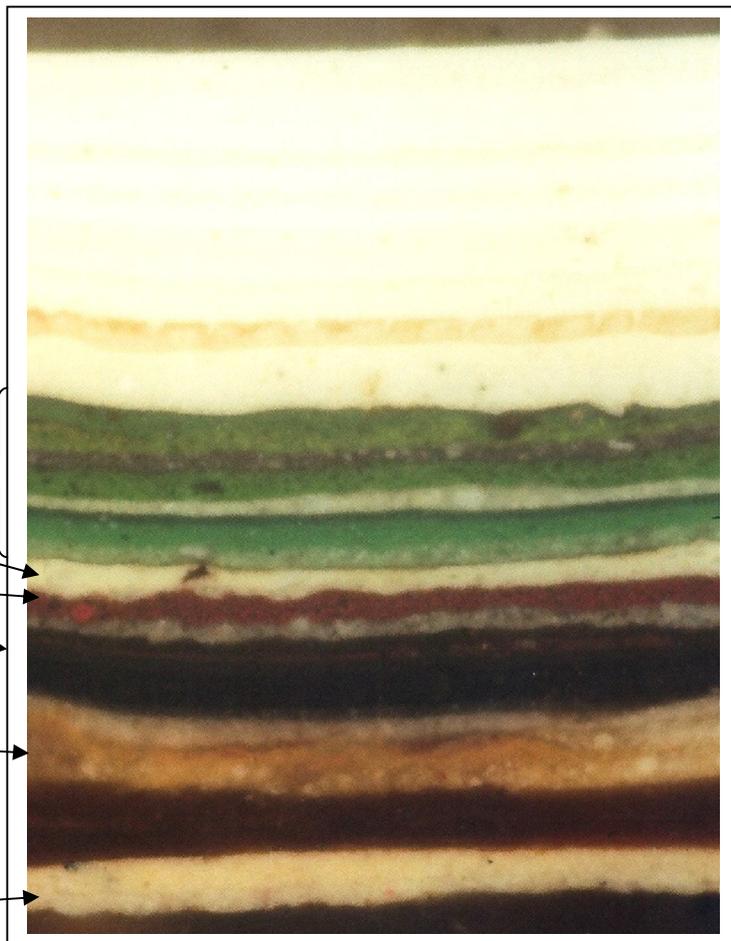
SAMPLE 13

Glazed door with iron frame

early C20th greens

white

dark brown

blacks

2nd graining

1846 graining

The glazed doors with metal edges [0305] were oak grained in the traditional manner. The layers involved an ochre-coloured ground, a thin brown glaze and clear varnish [see Sample 13, p.5]. The technique was typical of nineteenth-century graining, imitating oak.

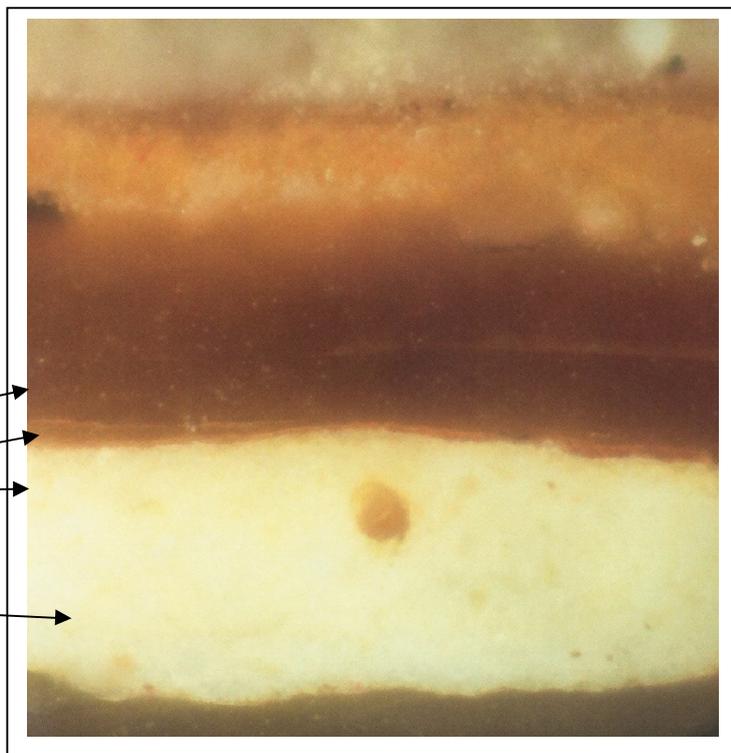
**Detail of the earliest layers**

These layers are typical of C19th oak
graining

varnish

thin brown glaze

ochre undercoat

lead white primer

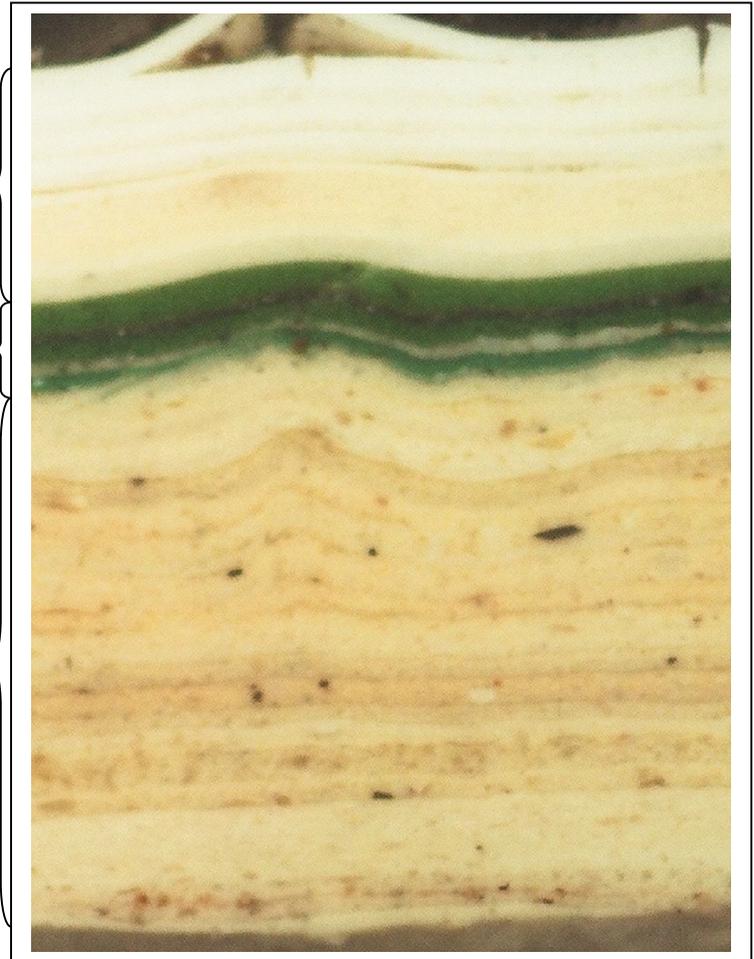
SAMPLE 16

Sash frame for window
with arched top
[x200]

late C20th whites

early C20th greens

from 1846 until the last years
of the C19th, the frames
were painted a stone colour

The window frames were painted a stone colour [see Sample 16, p.6]. The same stone colour was also used for the wooden sun blinds. One can speculate that the same paint was also used for the render on the walls

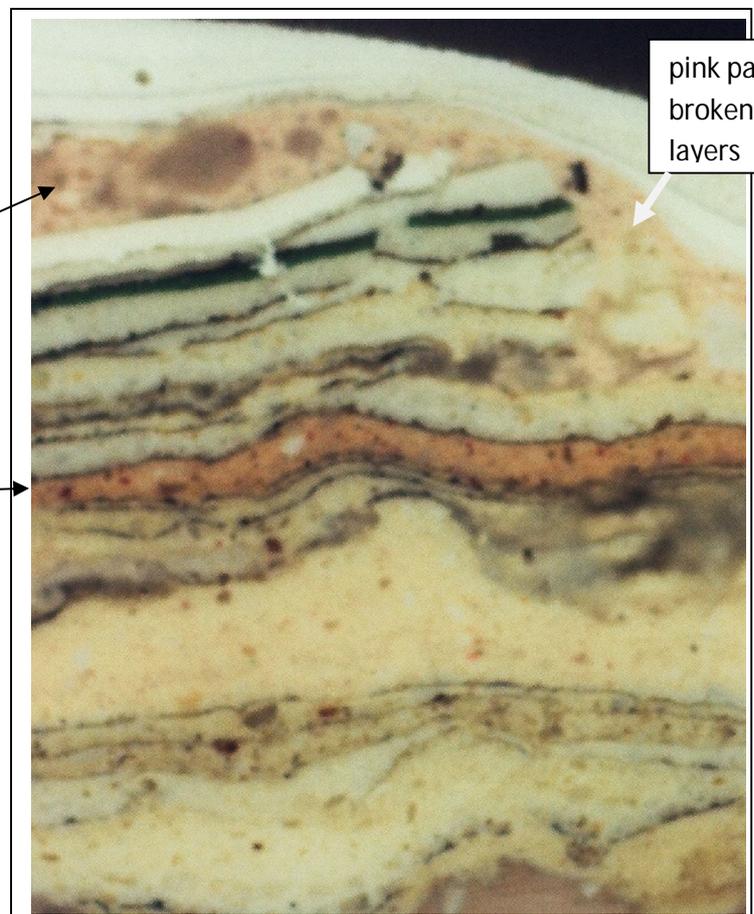
SAMPLE 17

Sun blind with pink paint showing
[0397]

The pink seen today is
this late C20th scheme

circa 1870s pink

pink paint over
broken earlier
layers

This cross-section shows how the layers
were mostly stripped off in the later
C20th and the blind painted pink.
Old paint only survives at the edges
where this fragment was taken

The frames and the window blinds continued to be painted a stone-colour or off-white. There was just one exception to this formula. Half way through the black period, perhaps in the 1870s, the window blinds were painted a dull pink, or putty colour [see Sample 17, p.6].

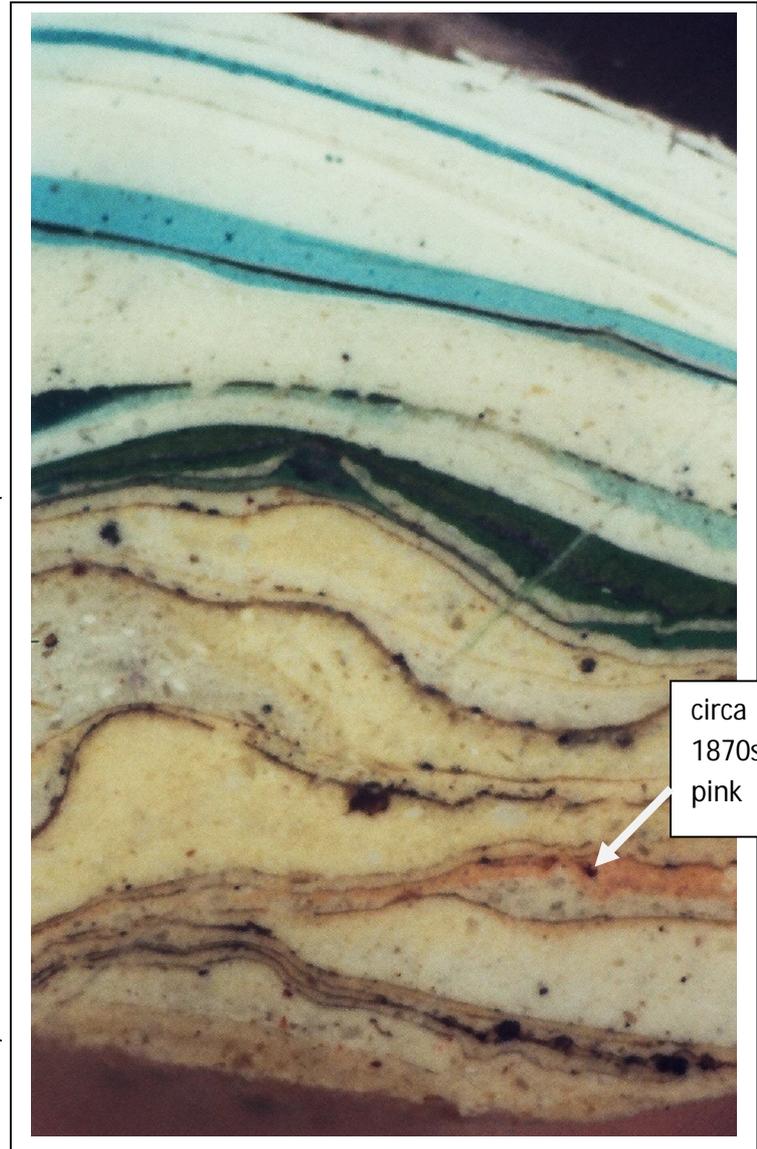
SAMPLE 18

Sun blind, with blue paint showing
[0400] for window 11

This was painted blue four times
over the second half of the C20th

end of C19th/early
C20th greens

stone colours, with
just one pink
scheme

circa
1870s[?]
pink

At some point during the second half of the twentieth century, the sun blinds were partly stripped. Some of them were painted pink just once [e.g. the blinds for windows 4 and 11]. Others were painted pale blue on four occasions [see Sample 18, p.7]. Presumably these blinds came from different sides of the house. In recent years the blinds were returned to white

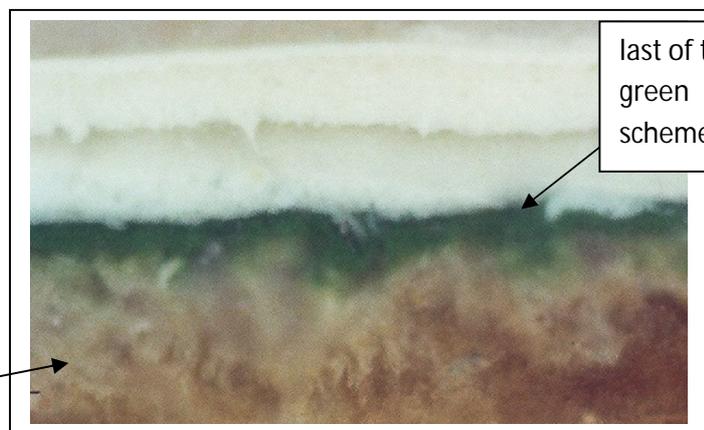
SAMPLE 14

Sash with different profile
[0573]

The glazing bars of this sash have a
square shape, instead of pointed.
It is clearly later, as all the pre-green
layers are missing

wood

last of the
green
schemes

Towards the end of the green phase some work must have been carried out on the house, because at least one sash window [no.0573] was replaced. The new sash has glazing bars with a square profile, unlike the pointed shape of the original sashes.

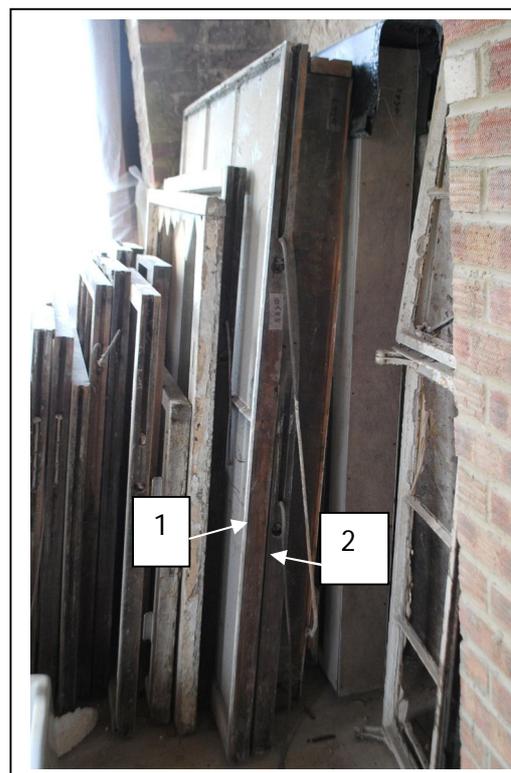
Window with arched top

- 1 lower sash [0588]
- 2 upper sash [0588]

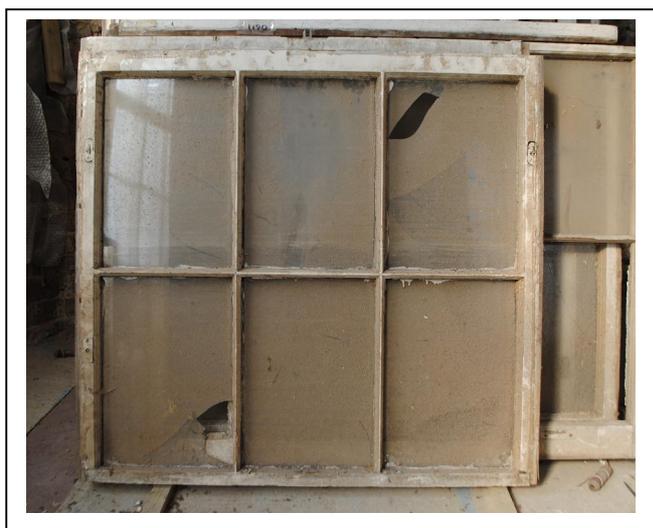
**Four examples of large square sashes -**

All with narrow profile to glazing bars

- 3 square sash [0577]
- 4 square sash [0576]
- 5 square sash [0578]
- 6 square sash [0575]

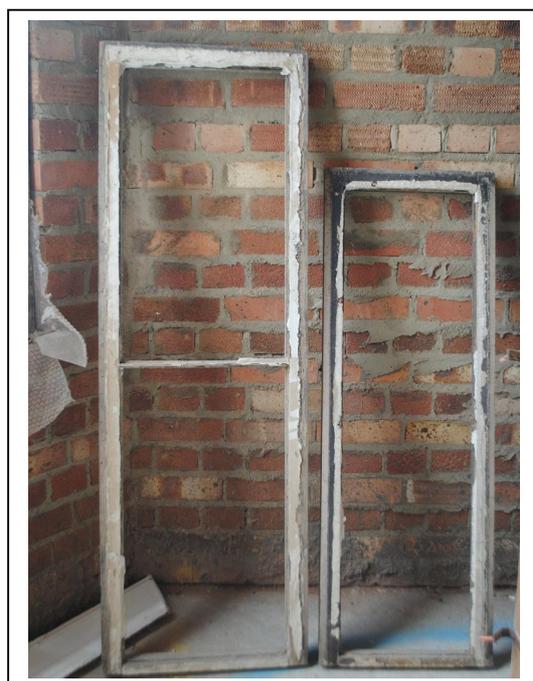
**Two examples of narrow rectangular sashes**

- 8 rectangular sash [0601]
- 9 rectangular sash [0565]

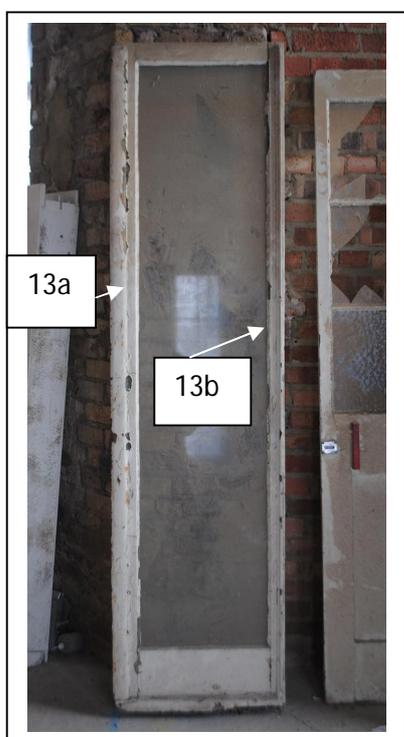
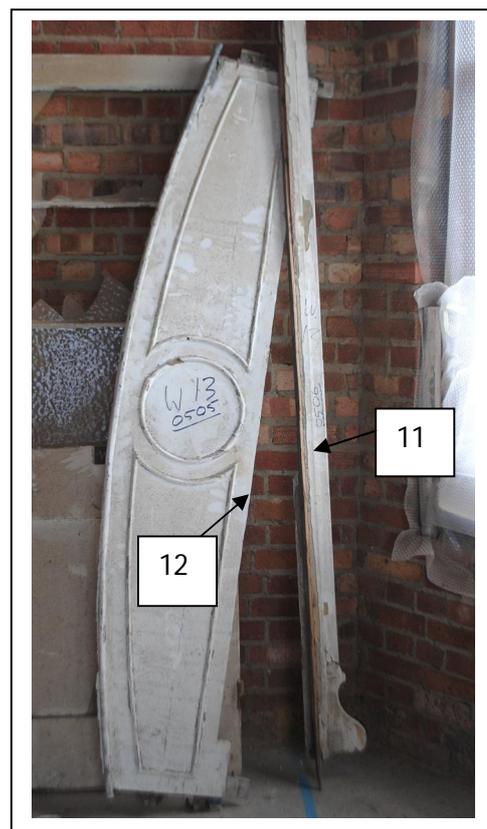
Glazed door

13a glazed door – metal edge [0305]

13b glazed door – wooden frame [0305]

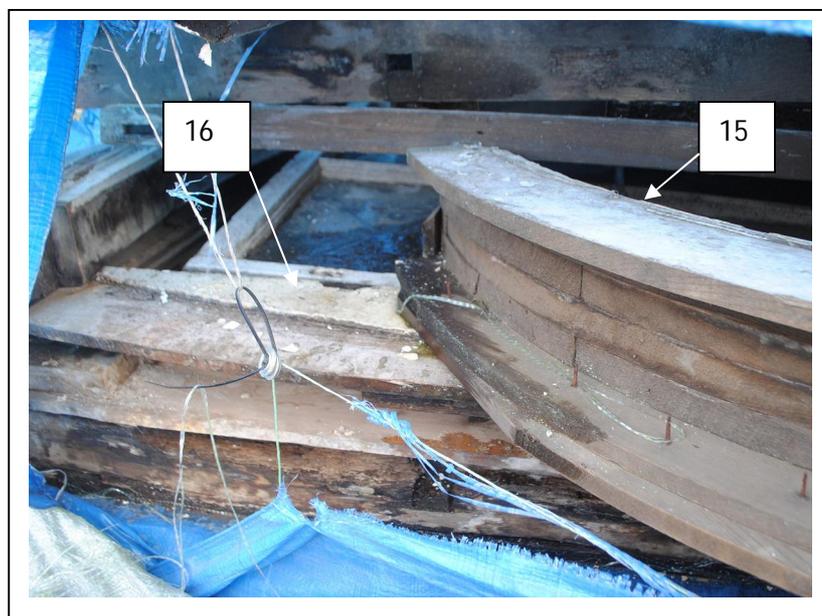
Sash box and window frame

- 15 arched top of window sash box
16 sash box with shape for arched top

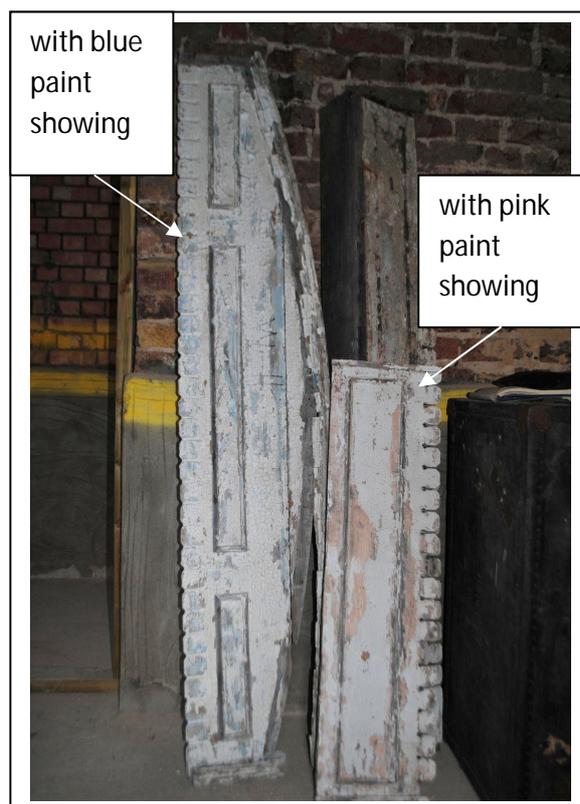
- Four examples of **wooden sun blinds**
17 With pink showing, [0397]
18 With blue showing [0400]
19 With pink showing, for window 7, [0399]
20 With pink showing, for window 4, [0500]

[These boards have been stripped, but old paint survives at the edges]

Some of the blinds have a different profile from the others, with the 'fretwork' more deeply cut. An attempt was made to compare them, and work out if some were later than others, but the paint stripping which took place in the later twentieth century has disturbed the layers and made close comparison difficult.

The impression from the samples was that there were more layers on sun blinds which have less deeply cut fretwork, but more investigation would be needed to be sure of this.
