Arboricultural Implications Report

Proposed re-development at

Witanhurst

Ref. SJA air 13050-01

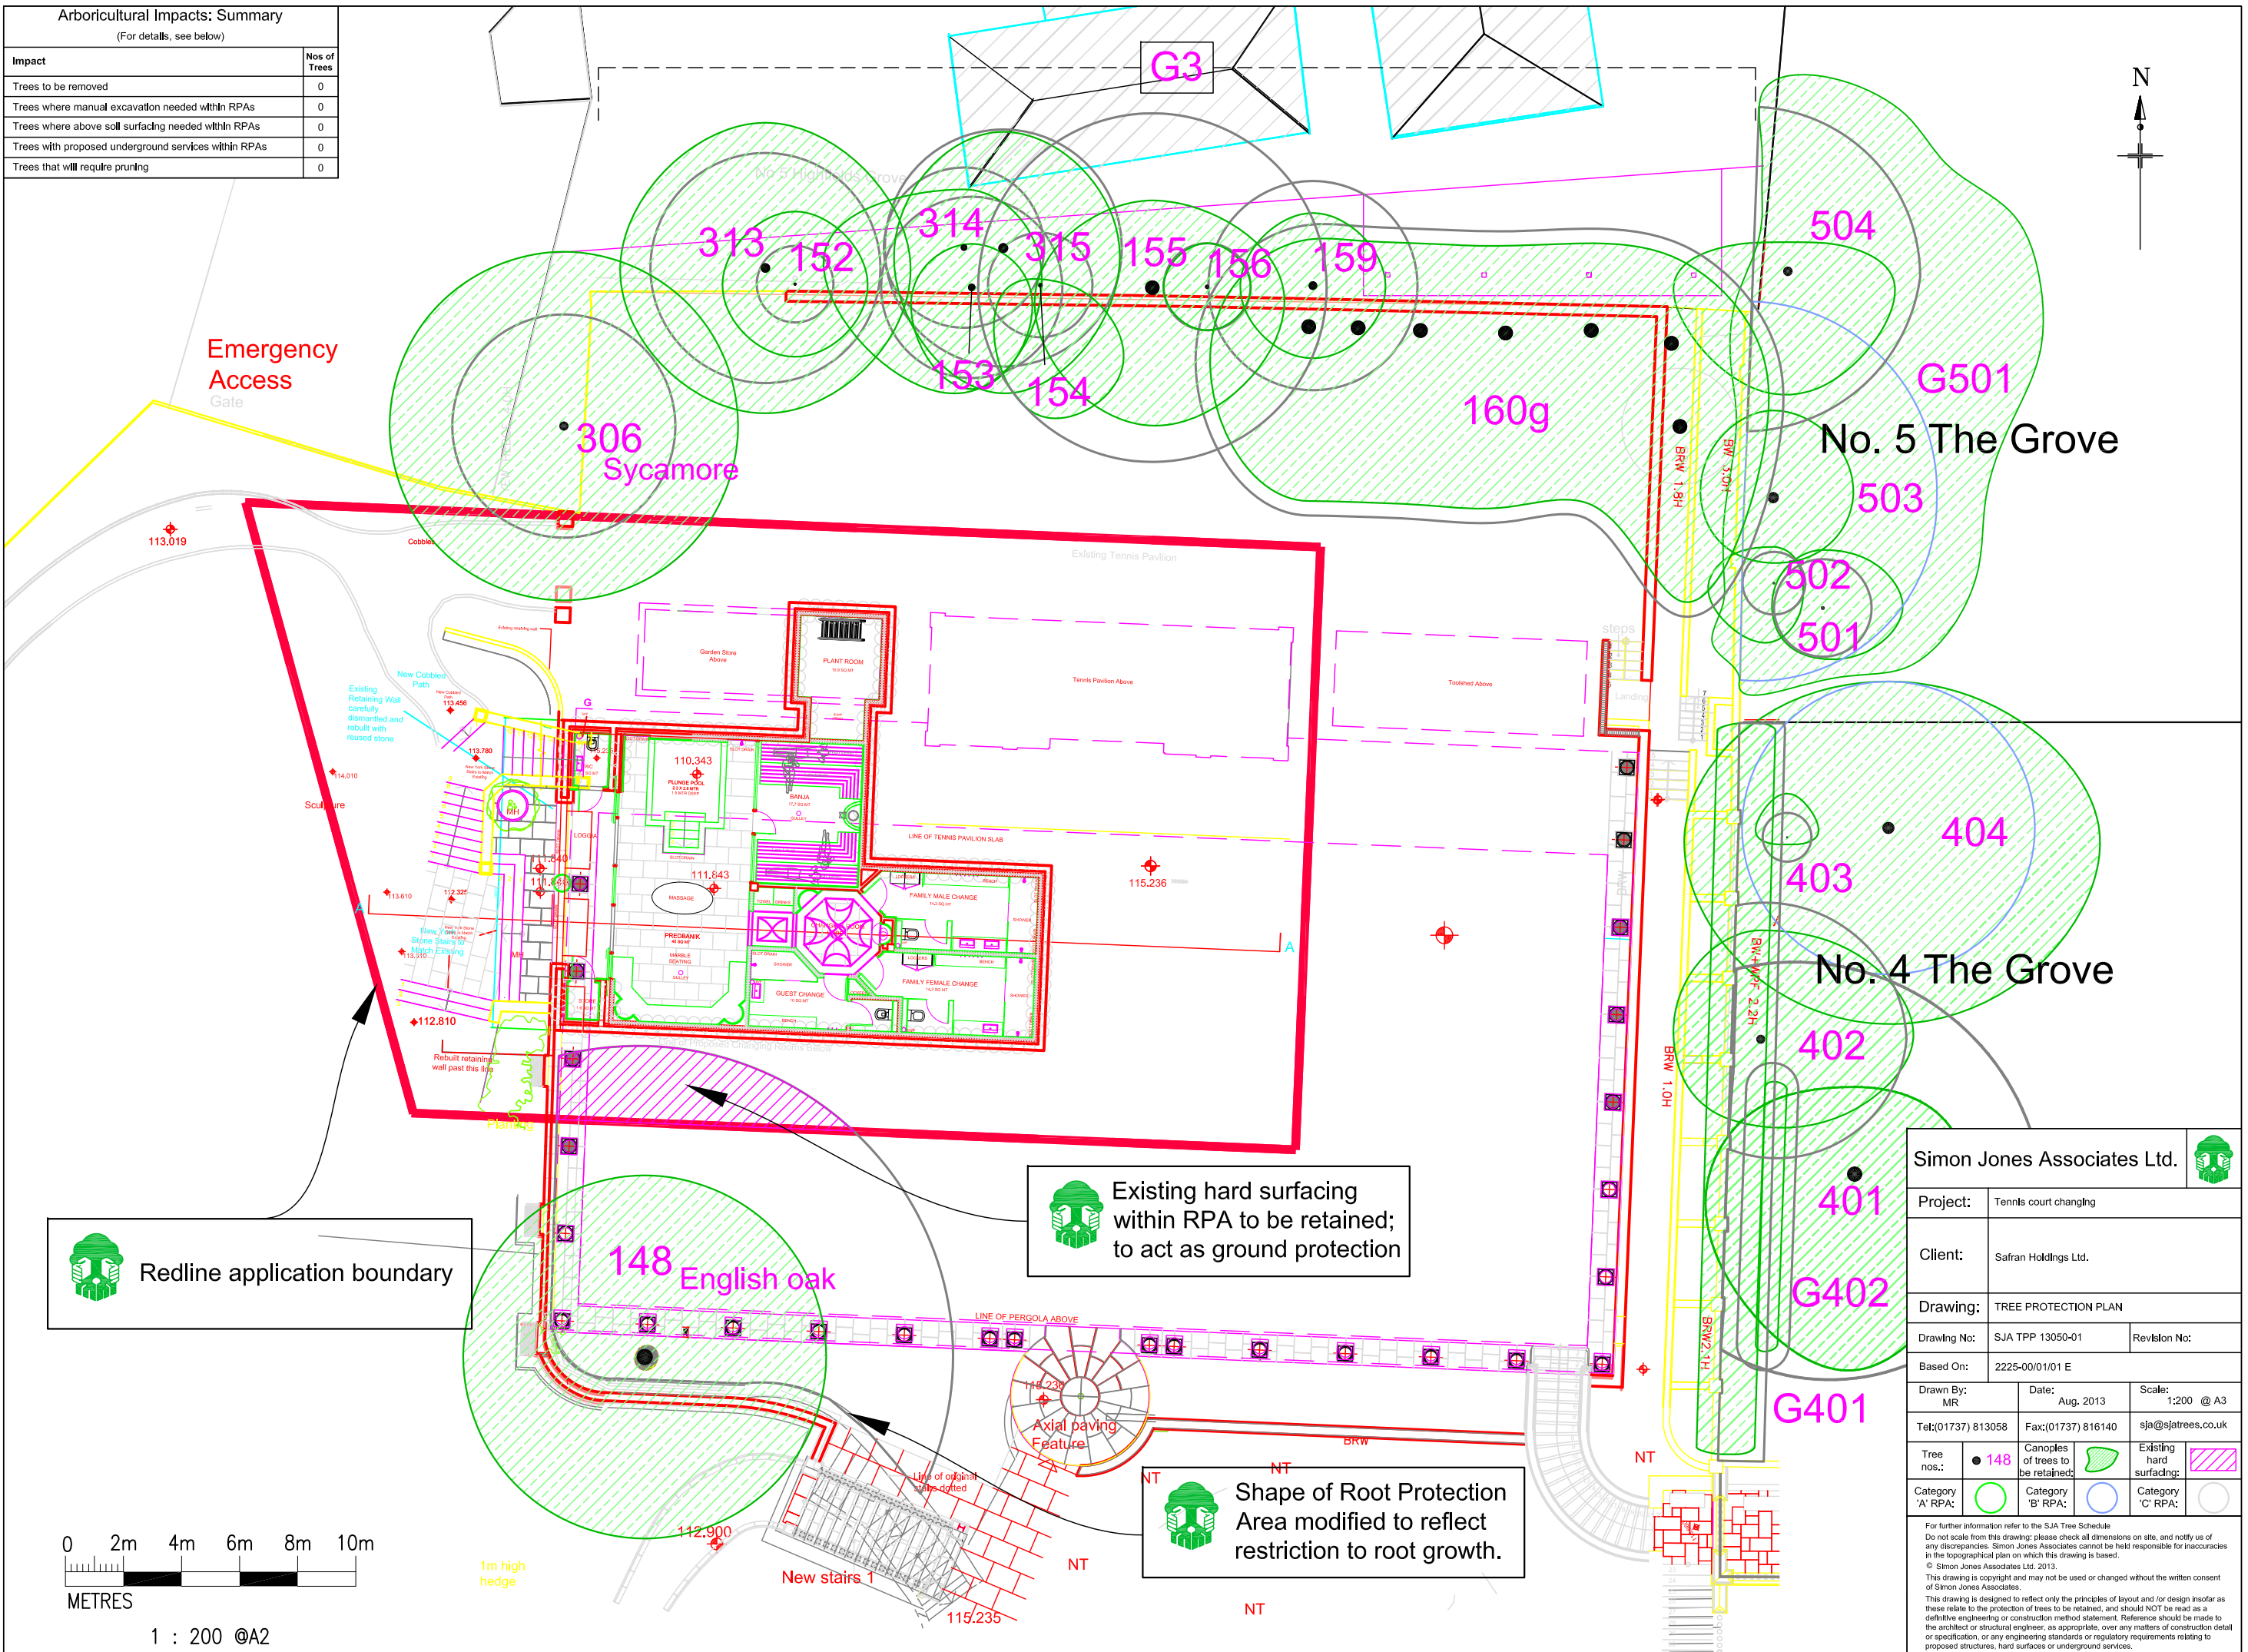
Arboricultural Impacts: Summary (For details, see below)	
Impact	Nos of Trees
Trees to be removed	0
Trees where manual excavation needed within RPAs	0
Trees where above soil surfacing needed within RPAs	0
Trees with proposed underground services within RPAs	0
Trees that will require pruning	0

Existing hard surfacing within RPA to be retained; to act as ground protection

Shape of Root Protection Area modified to reflect restriction to root growth.

3.3.2. As can be seen on the TPP, no parts of the proposed buildings or associated hard surfacing are within the RPAs of any of the trees to be retained.

4.3.2. The necessary precautions to protect the RPAs of retained trees during construction can be assured by the retention of existing hard surfacing, as shown on the TPP.

5.1.2. The TPP shows the general and specific provisions to be taken during construction of the proposed development, to ensure that no unacceptable damage is caused to the root systems, trunks or crowns of the trees identified for retention. These measures are indicated by coloured notations in areas where construction activities are to occur either within, or in close proximity to, retained trees, as described in the relevant panels on the drawing.
