Site:
Denmark Place, London

Client:
Consolidated Developments Limited

Job Number:	36237
Figure:	3

GROUND INVESTIGATION

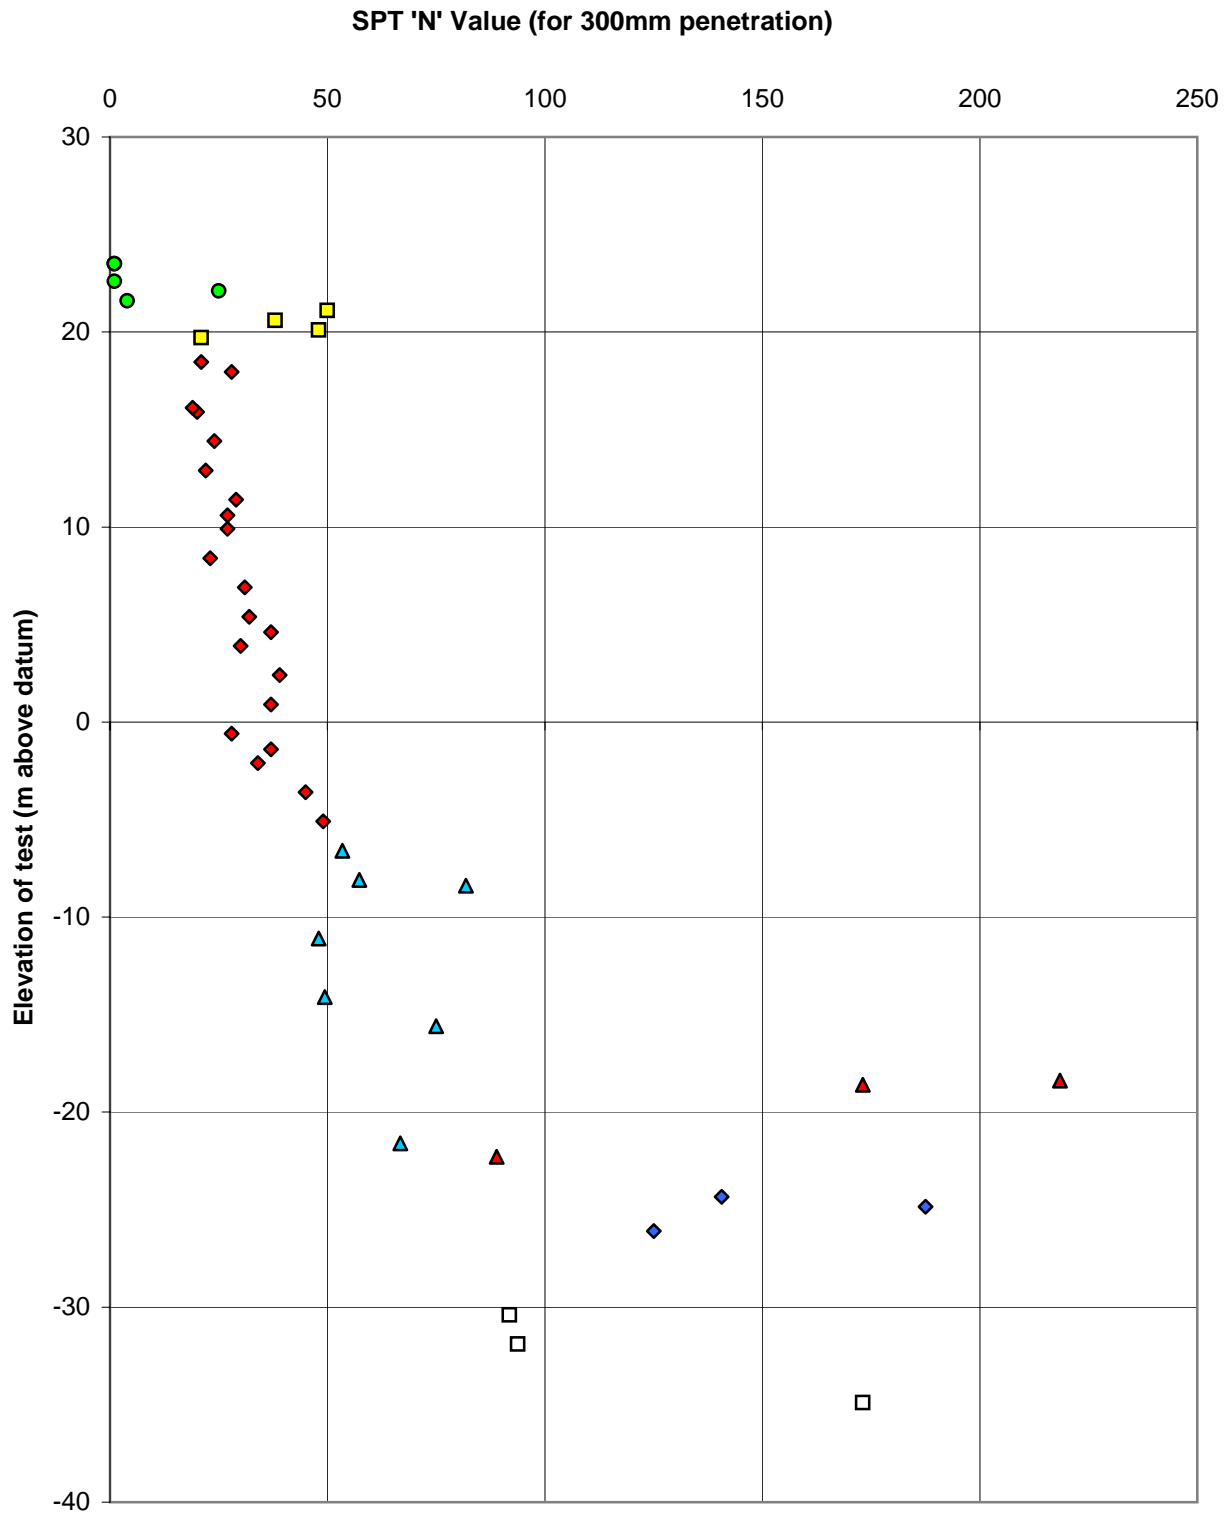
SPT 'N' VALUES vs Elevation

- ▲ Lambeth Group (Cohesive) ▲ Lambeth Group (Granular) ◆ London Clay
- Made Ground ■ River Terrace Deposits ◆ Thanet Sand Formation
- White Chalk

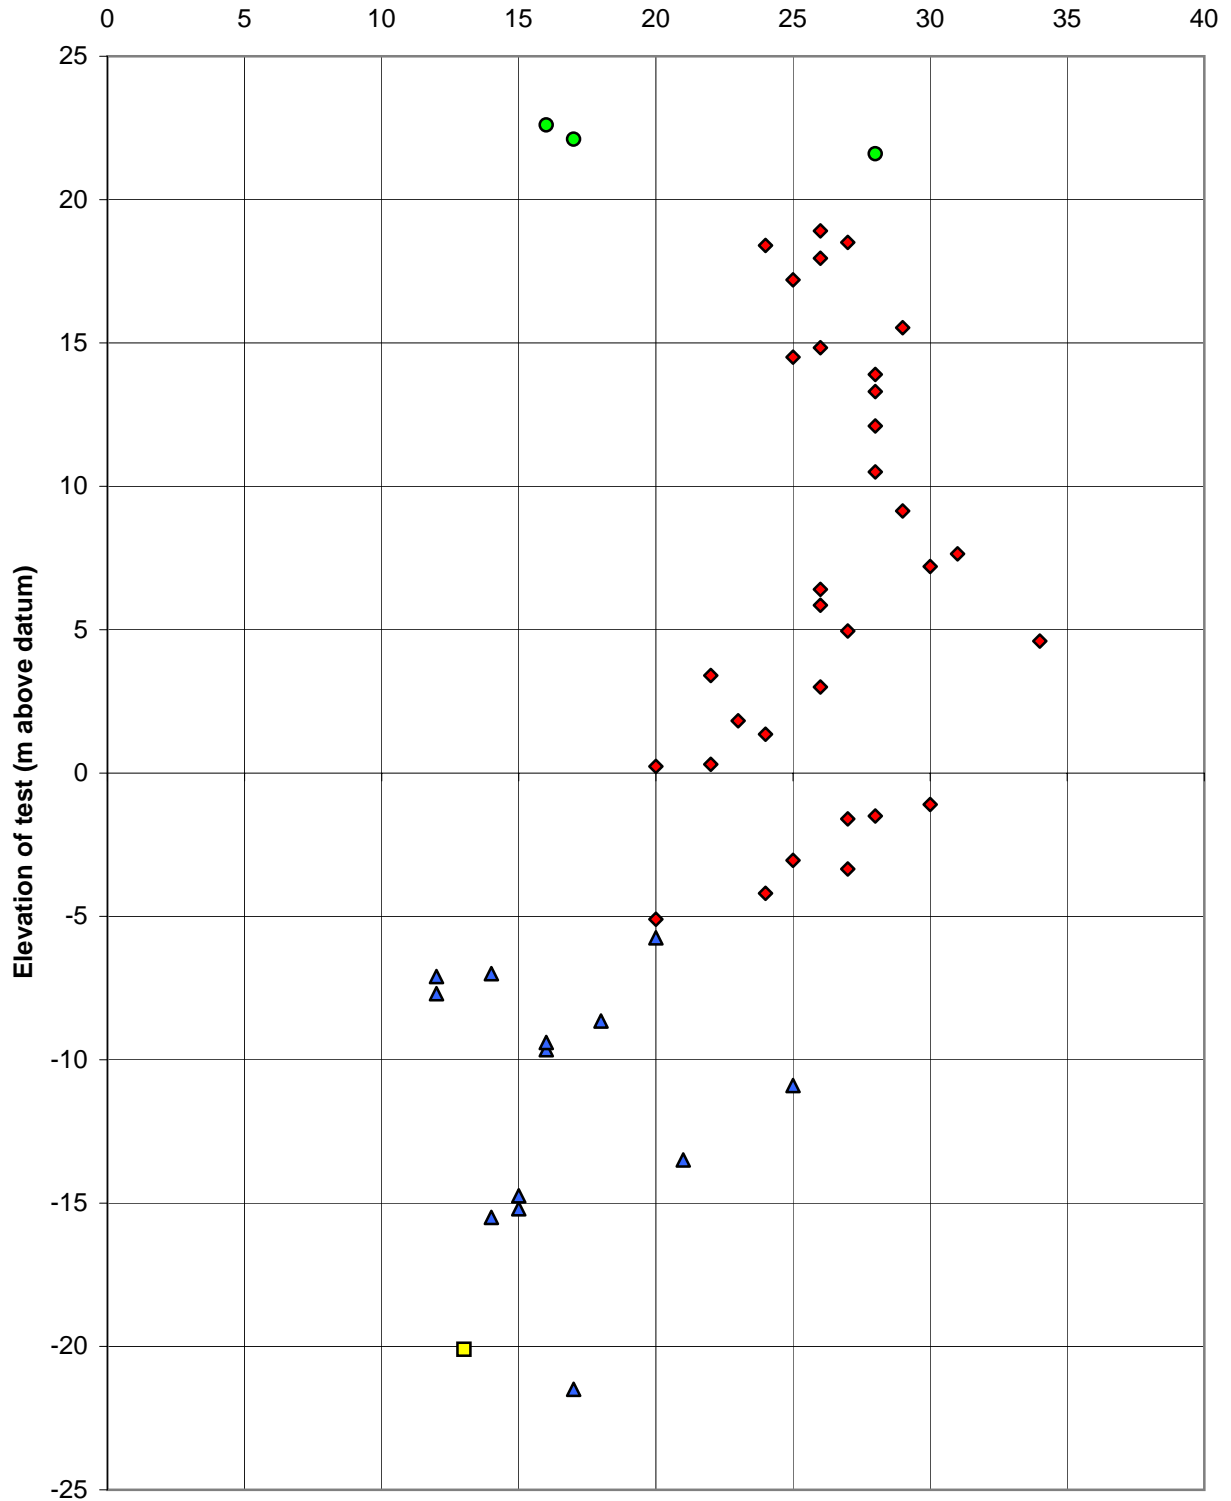
Job Number: 36237
Figure: 5

MOISTURE CONTENT vs ELEVATION

Natural Moisture Content (%)

▲ Lambeth Group (Cohesive) ■ Lambeth Group (Granular) ◆ London Clay ● Made Ground

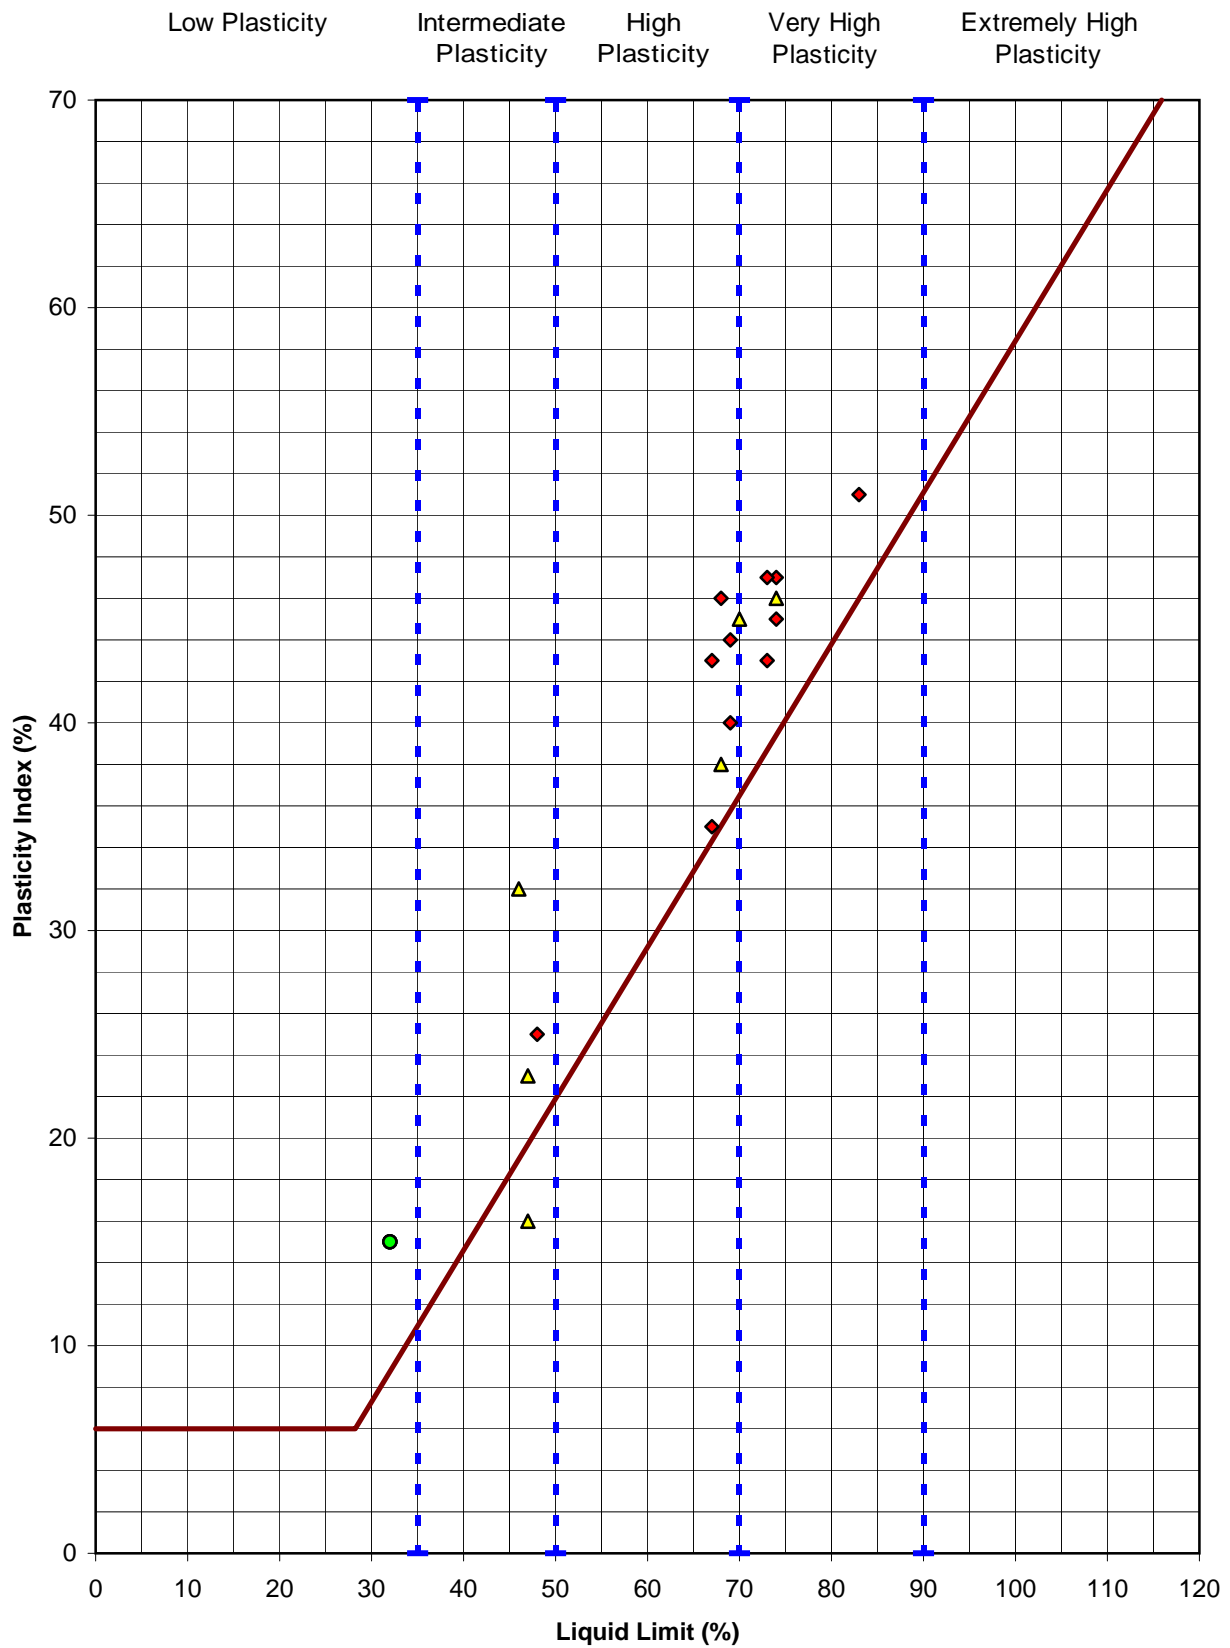
Job Number:	36237
Figure:	6

PLASTICITY CLASSIFICATION CHART

A - Line	Classifications	Lambeth Group (Cohesive)
London Clay	Made Ground

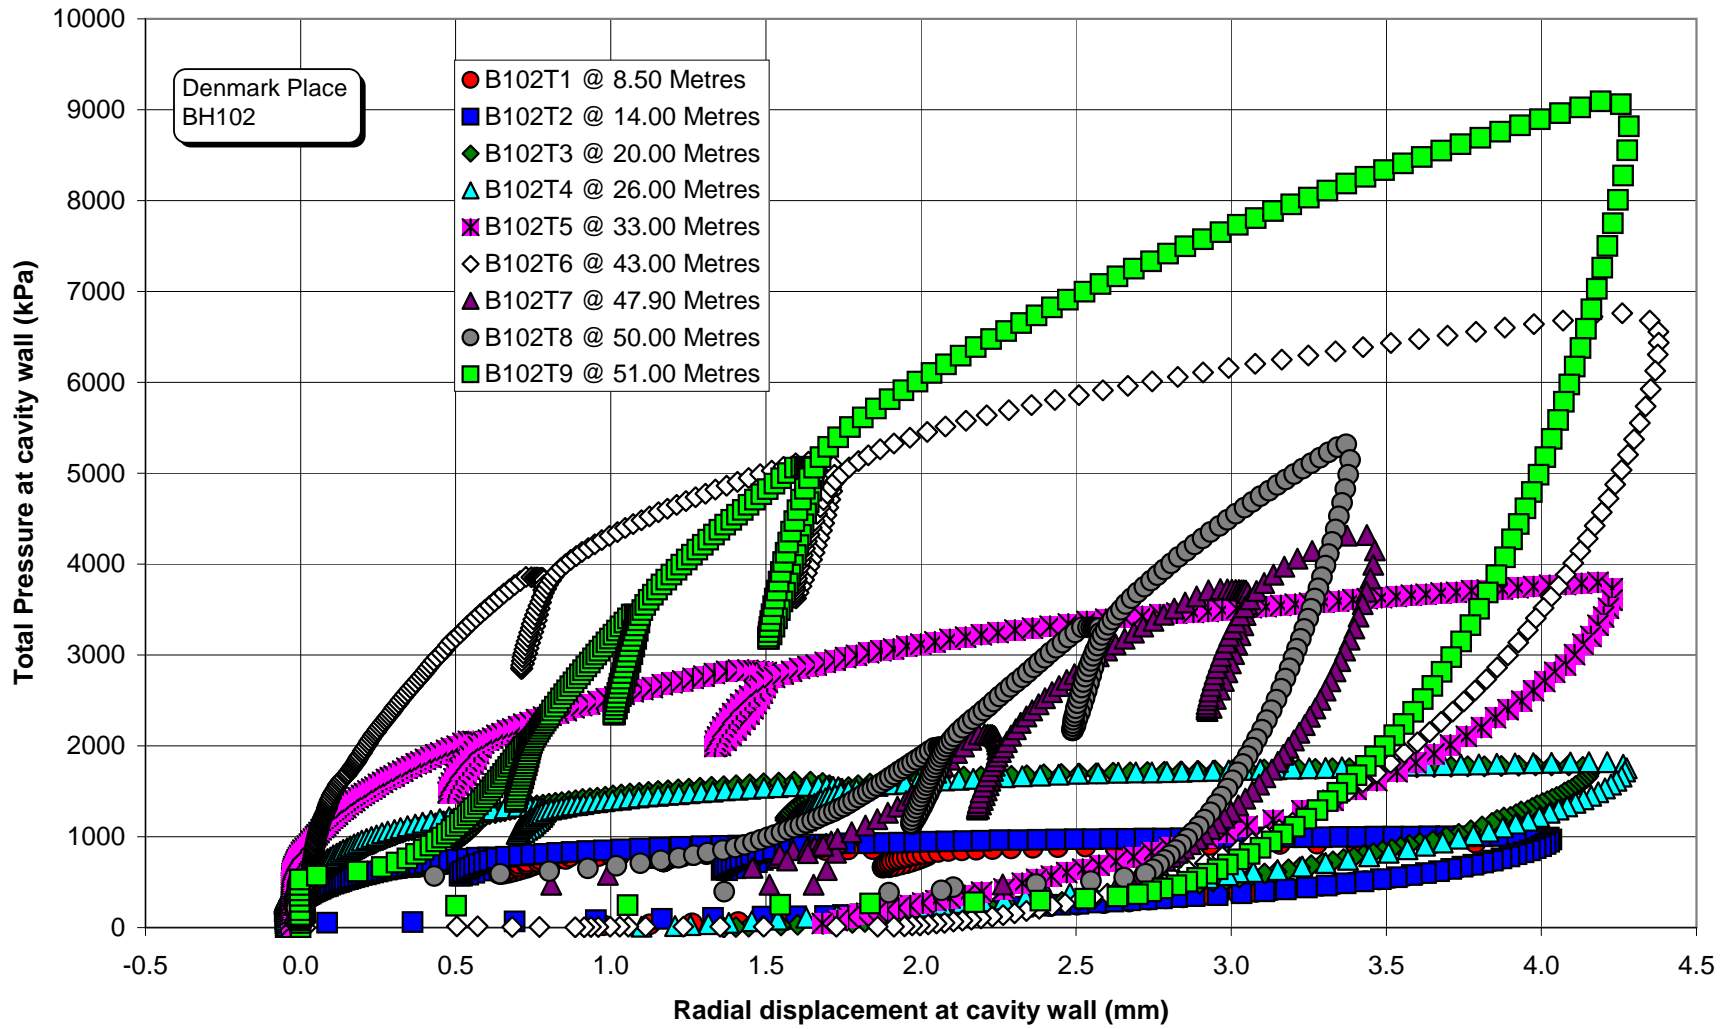
Total pressure vs Radial displacement

- a) A summary section showing various parameters plotted against depth. This starts with a plot showing the field curves of all tests on common axes of pressure and displacement.
- b) A detailed presentation of the shear modulus information gathered from unload/reload cycles. Some of these are summary plots.

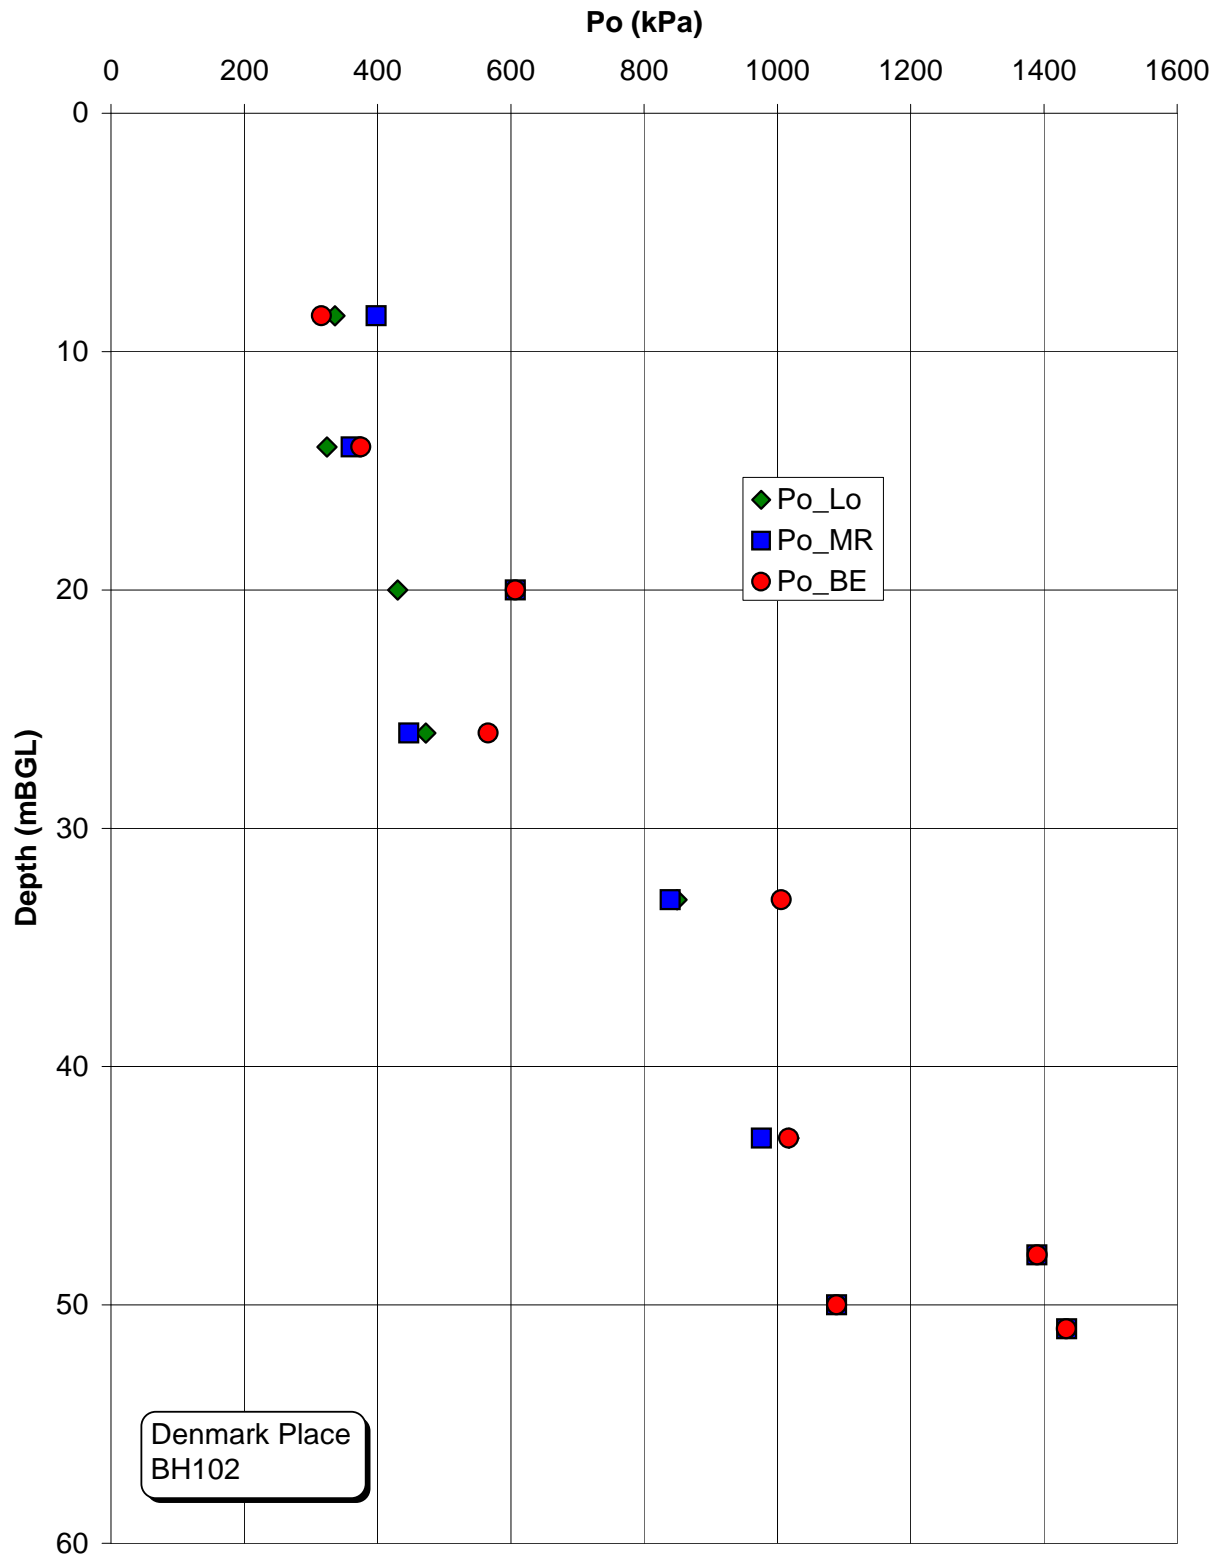
Insitu lateral stress vs Depth

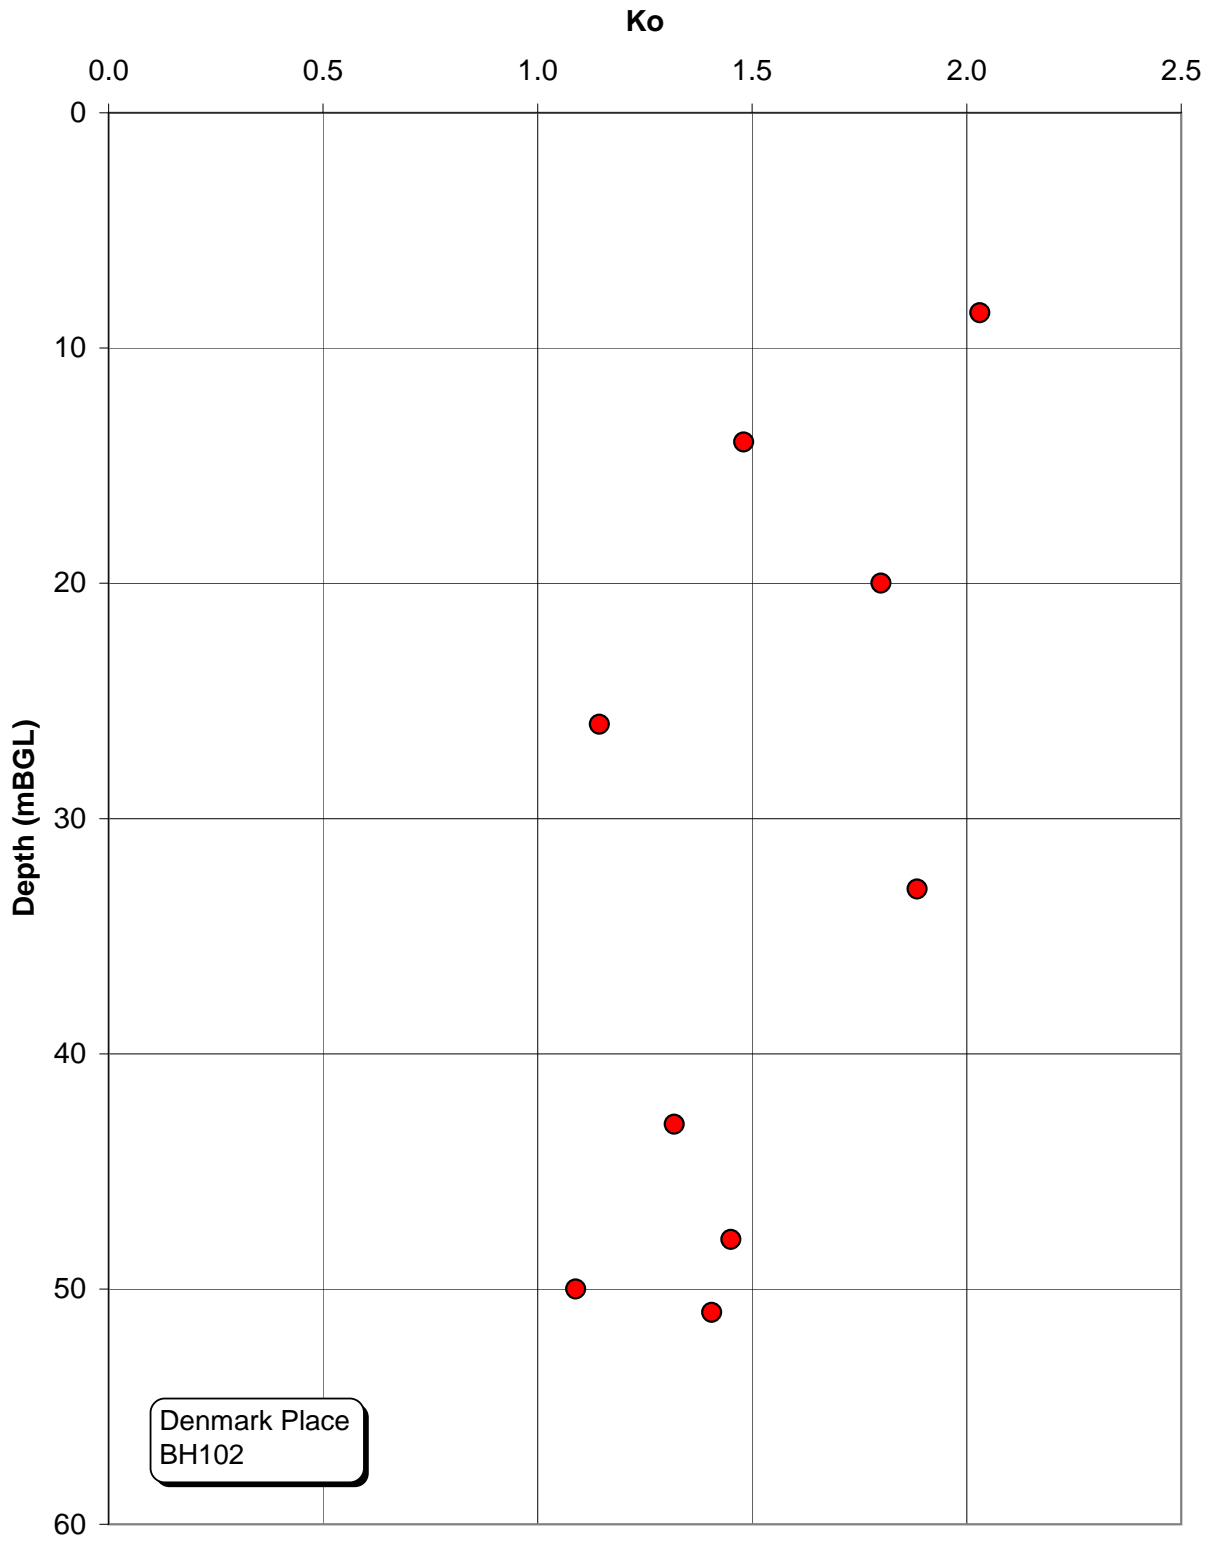
Coefficient of earth pressure at rest vs Depth

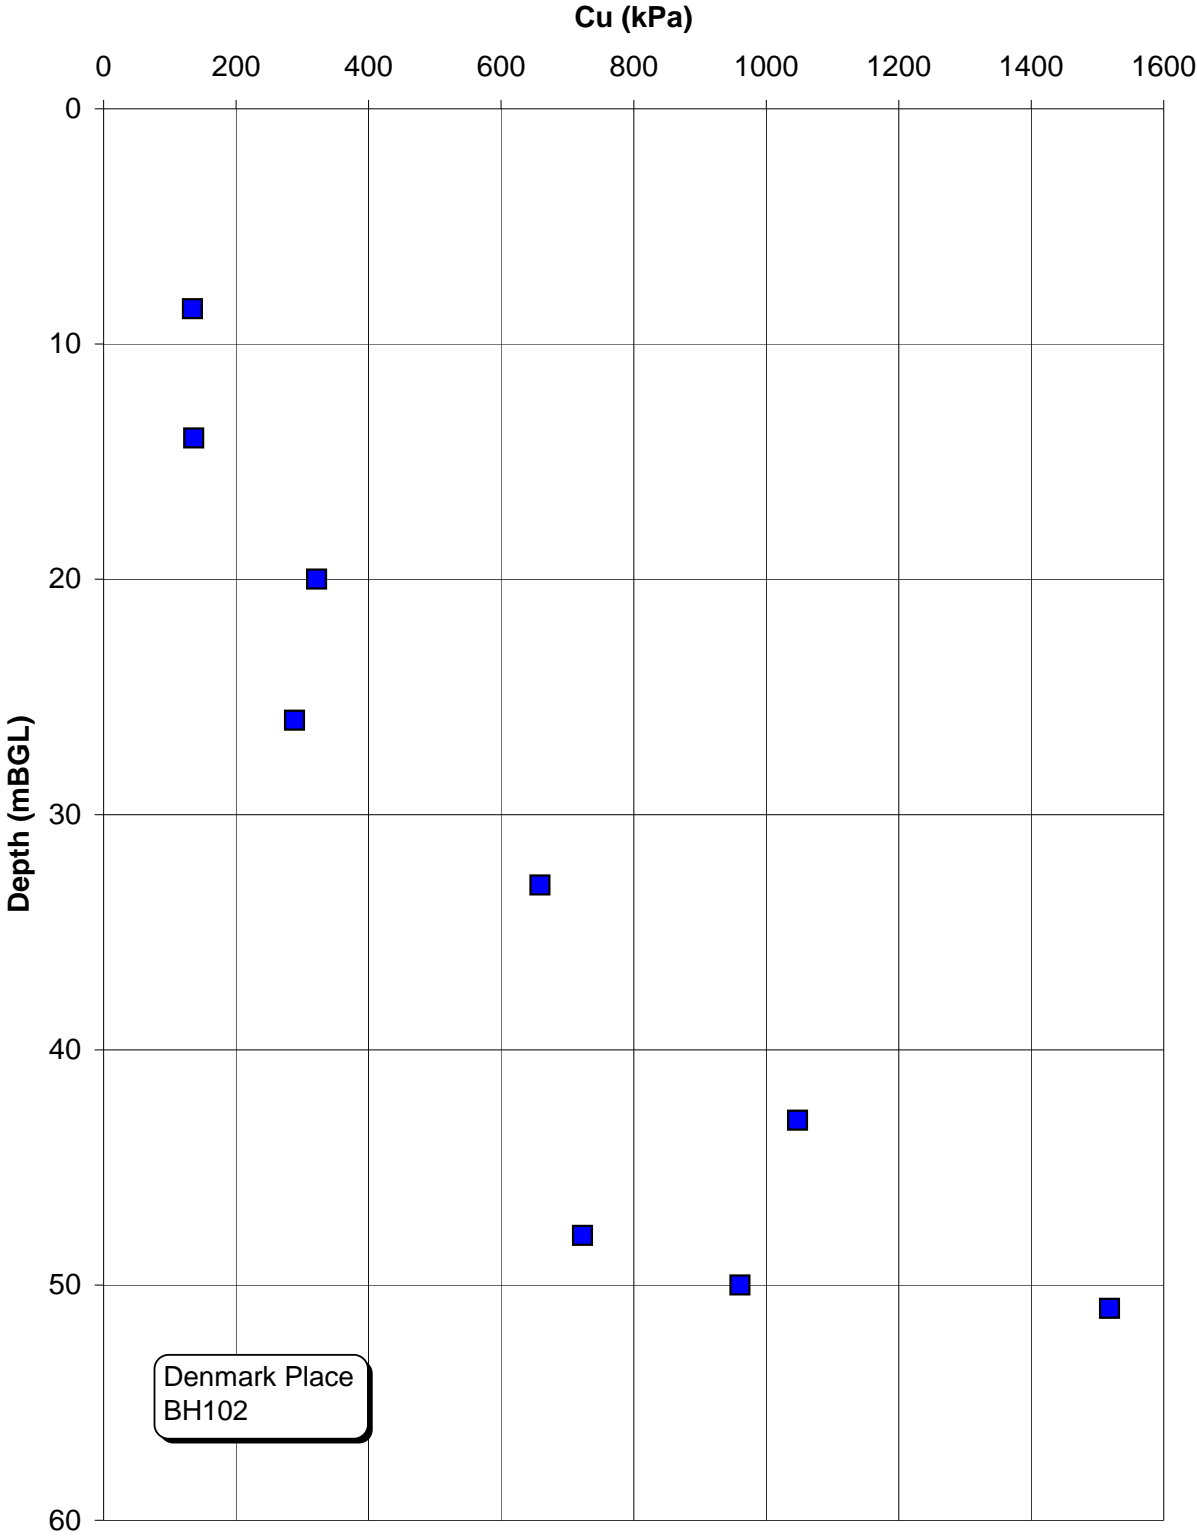
Undrained shear strength vs Depth

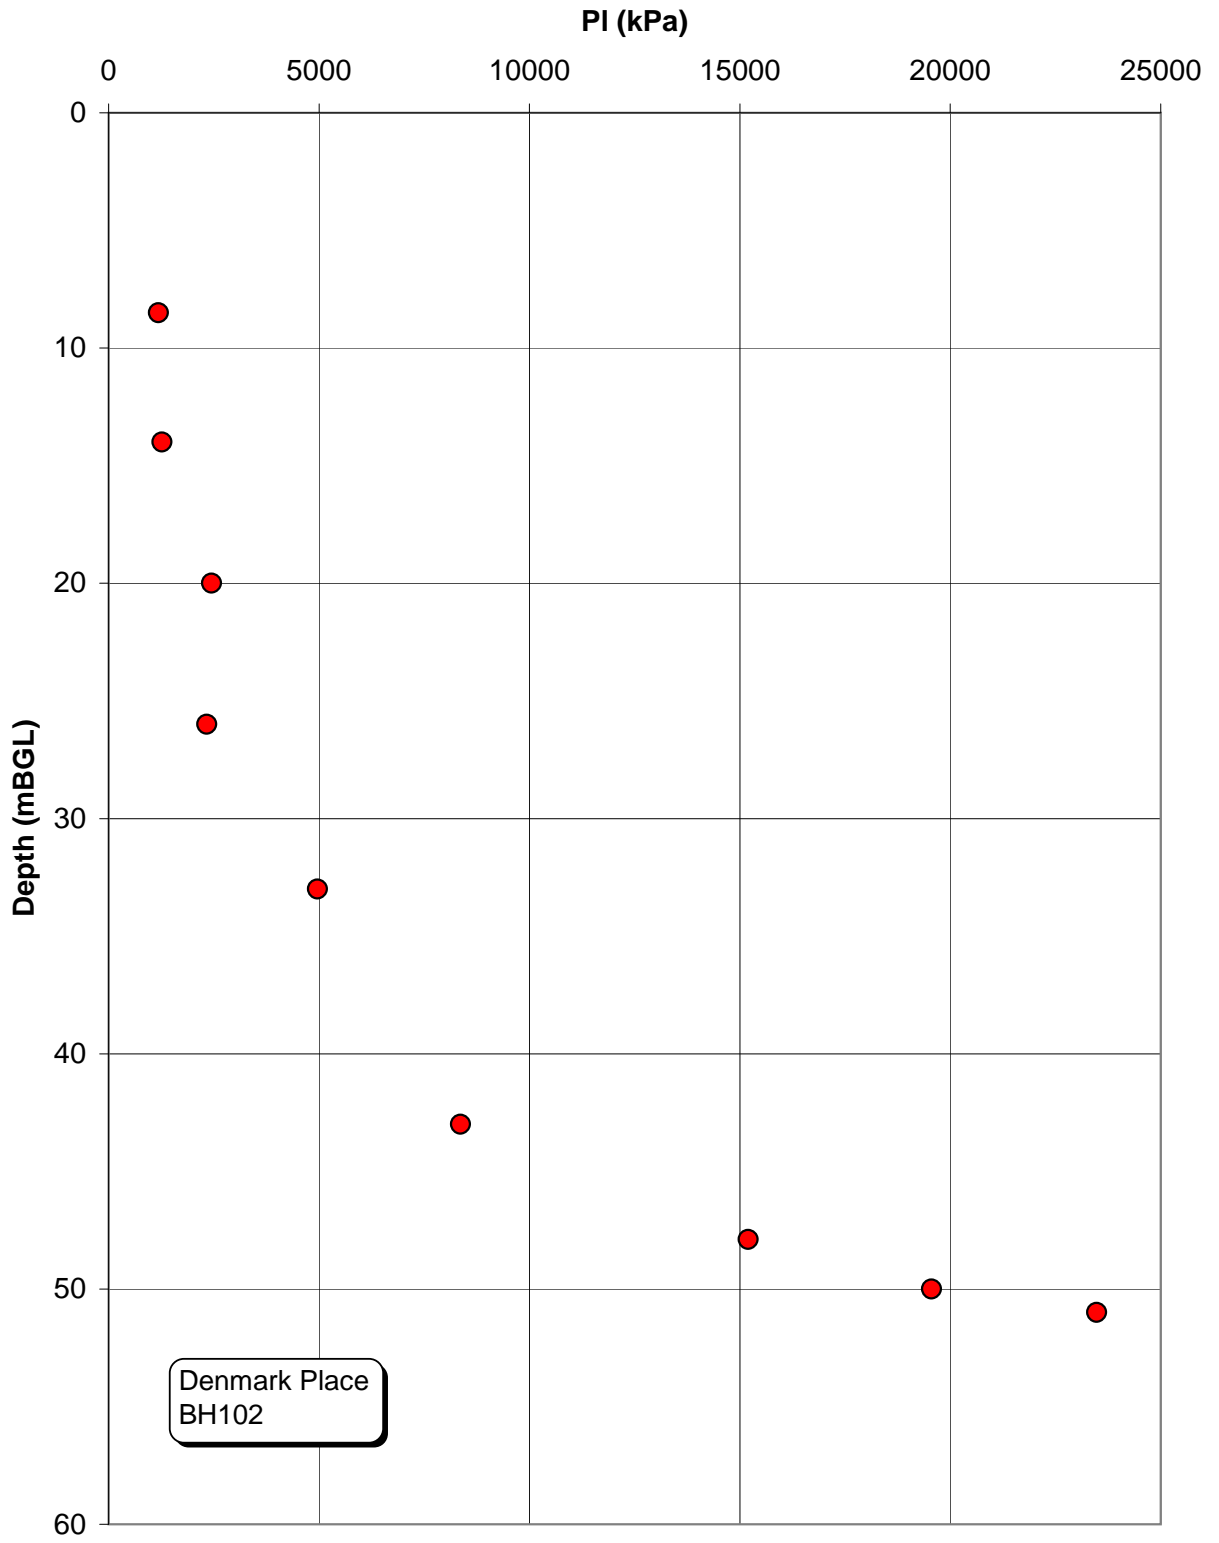
Limit pressure vs Depth

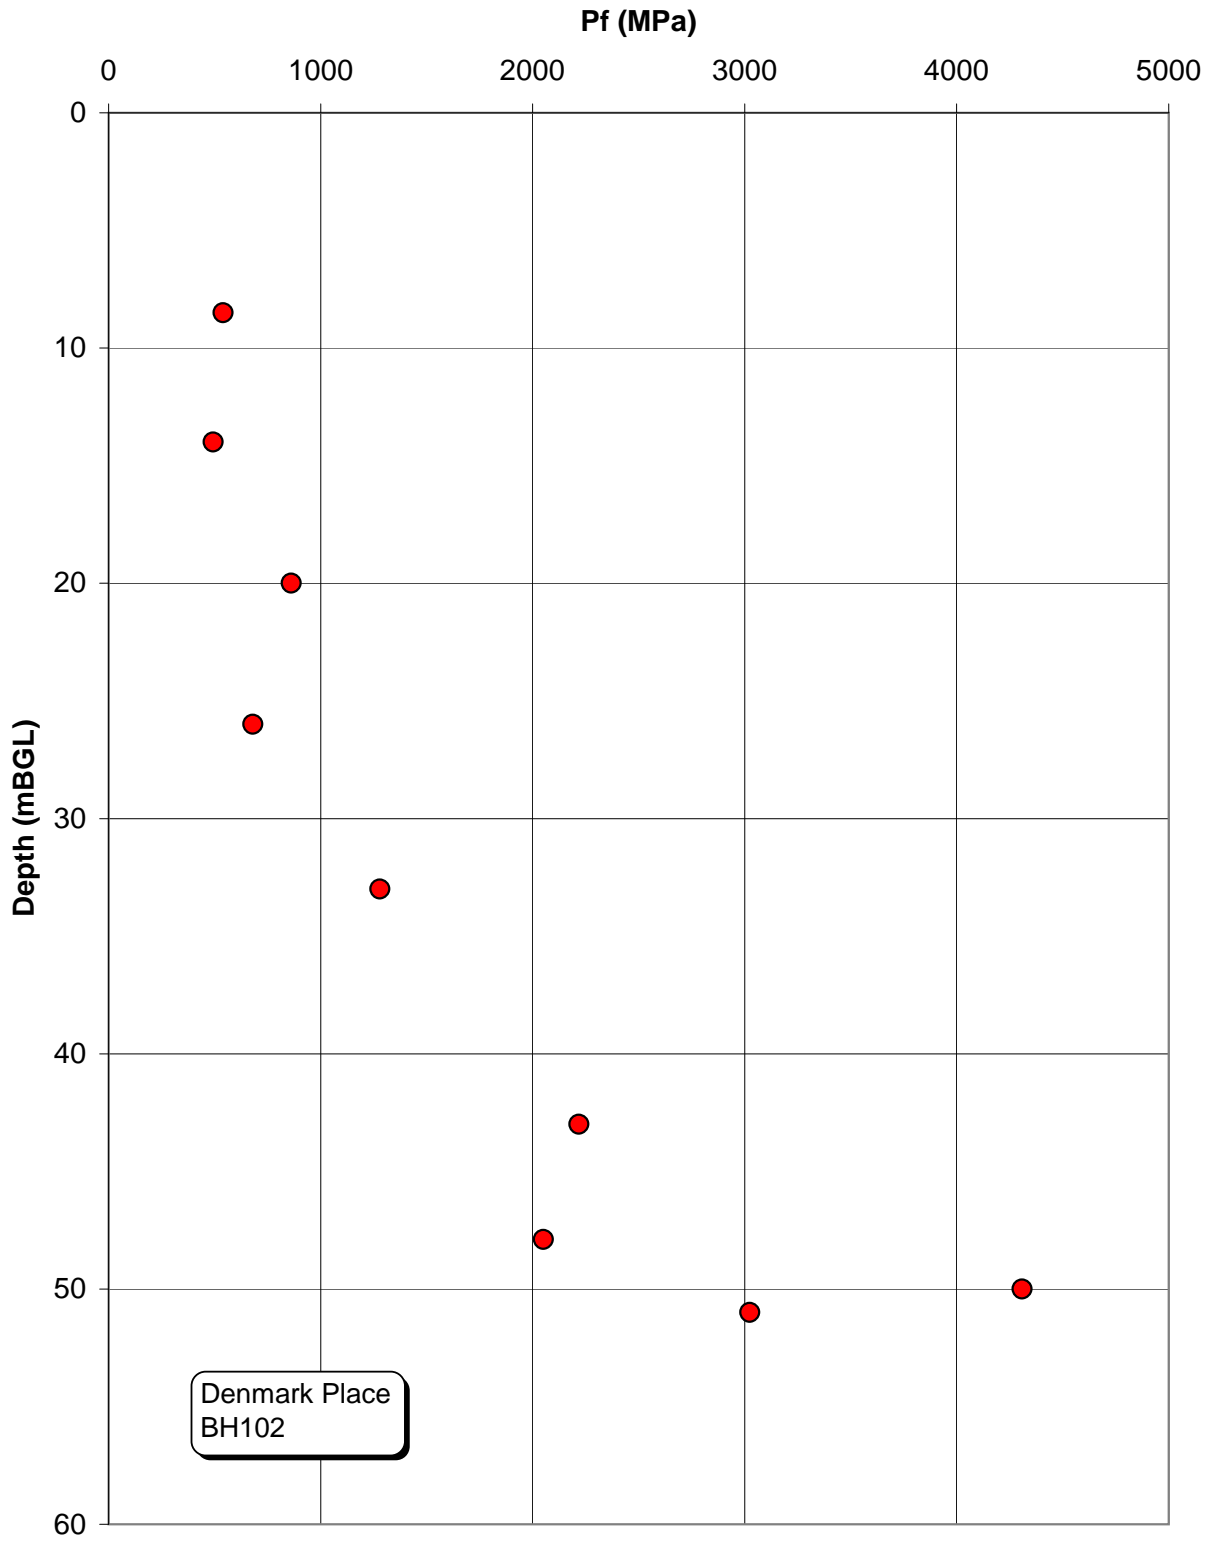
Yield stress vs Depth
