Bacton Low Rise Redevelopment

Transport Assessment

Appendix C – PERS Audit Technical Note

Subject: Pedestrian Environment Review System (PERS) Audit

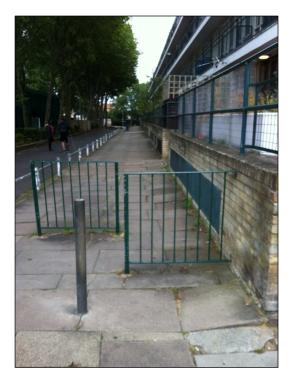
Photo 3.2.1: L20 (Pathway to South of Courts)

- 3.2.3 Those links identified as below average included three pedestrian paths. One of these paths was very close to the site and could be used to access Grafton Terrace bus stop. The link runs from Wellesley Road to Malden Road via the playing courts situated to the south-east of the southbound Grafton Terrace bus stop. As the link reaches the north-eastern corner of these courts it branches into two. The northern branch runs along the north of the courts and to Grafton Terrace bus stop. The southern branch runs parallel to the eastern and southern sides of the court. It is here that it meets Malden Road, at the junction to Grafton Terrace.

- 3.2.4 This link scored poorly overall with a steep gradient where both branches meet Malden Road and also barriers obstructing desire lines. On the southern branch there was a lack of legibility, low barriers and low levels of both personal security and surface quality (Photo 2.2.1). The northern branch was of a much better quality and compensated for the steep gradient with provision of seating, it would be a more direct route from the site to the bus stop so would be more likely to generate pedestrian trips than the southern branch.

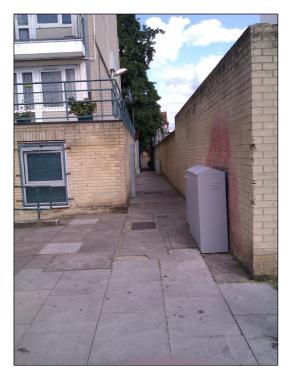
Photo 3.2.2: L13 (Pathway linking Weedington Road to Grafton Road)

- 3.2.5 The lowest scoring pedestrian path was L26; this could be used to link the site to Carlton Primary School (Photo 3.2.2). Link 26 connects Weedington Road and Grafton Road using a very narrow footpath with low levels of personal security. It lacks tactile paving at the crossing point on Weedington Road and has a steep gradient towards Grafton Road.

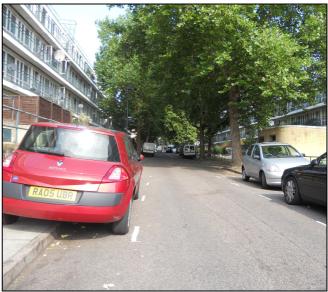
Photo 3.2.4: L29/30 (Weedington Road)

3.2.8 Weedington Road also obtained a scoring of 'Red' (Photo 3.2.4). The footpath on the east scored higher due to areas of footpath improvement and less footway parking provision at the southern end. Both links provided better access towards the south as footpaths were wider and there was less footway parking in place. Overall, parking on these links was obstructive and lack of tactile paving at crossing points was also noted.
