Ground Investigation
at

Bacton Low Rise, Gospel
Oak, North London.

Factual Report

Project Number : PC124991

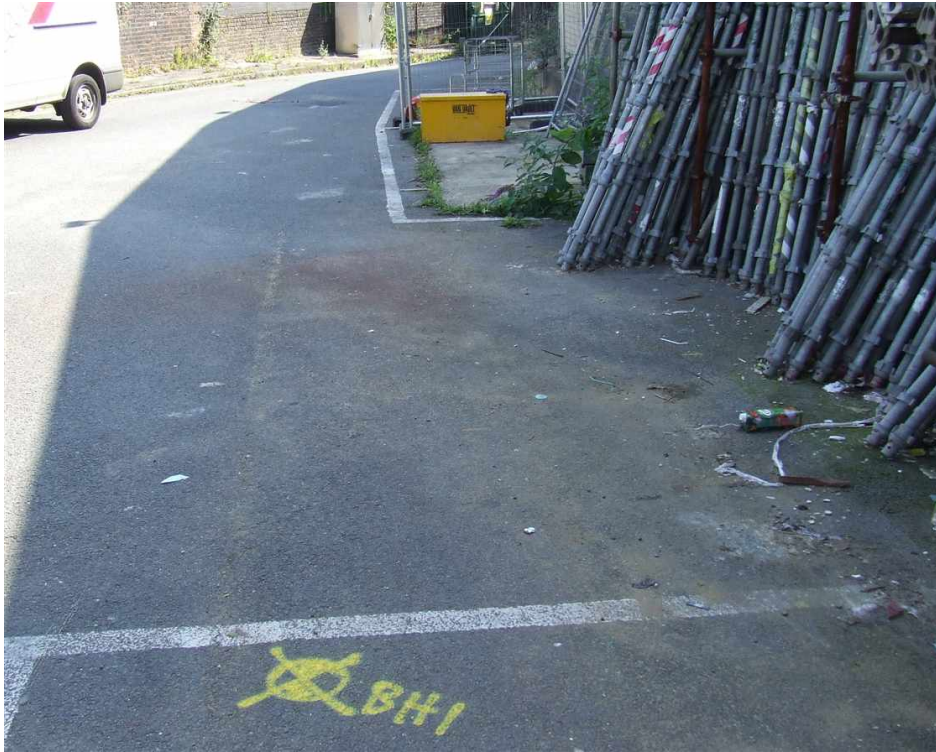
North East Area, BH1, looking east

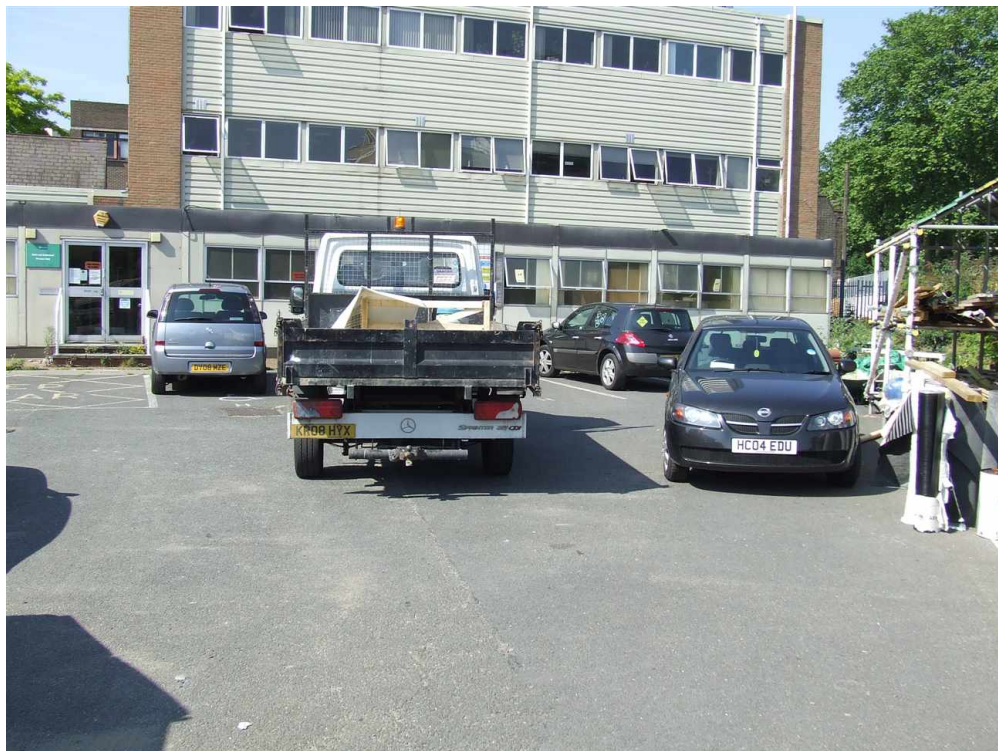
North East Area, BH2, looking west

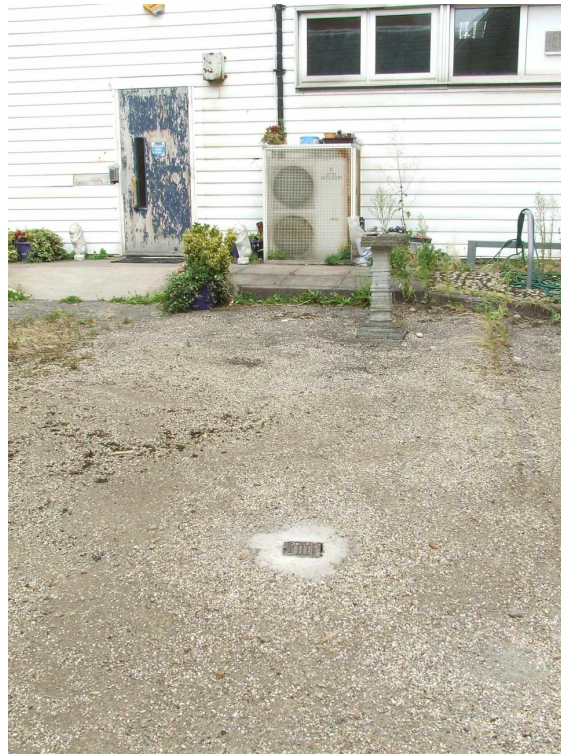
North East Area, BH3, looking north

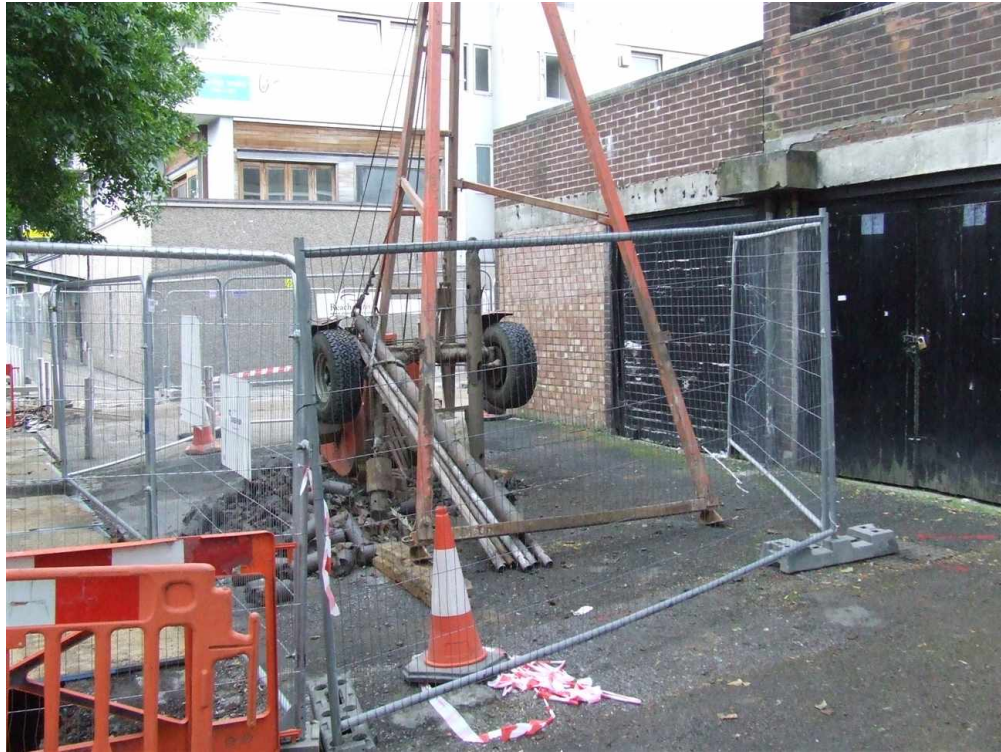
South West Area, BH5, looking north east

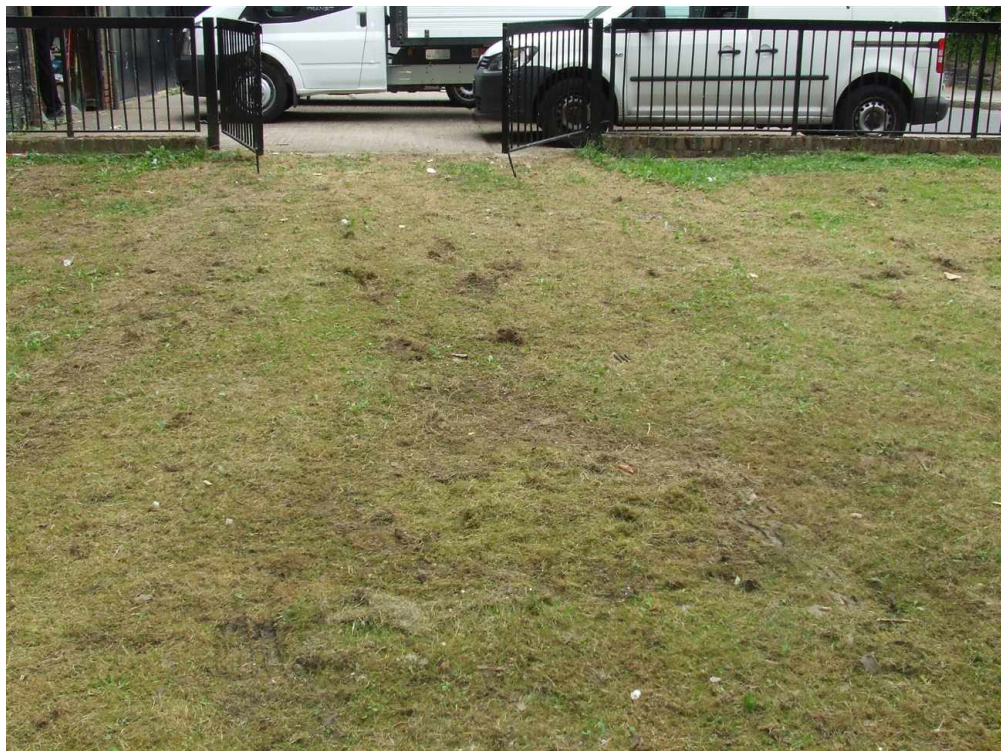
South West Area, BH6, looking north

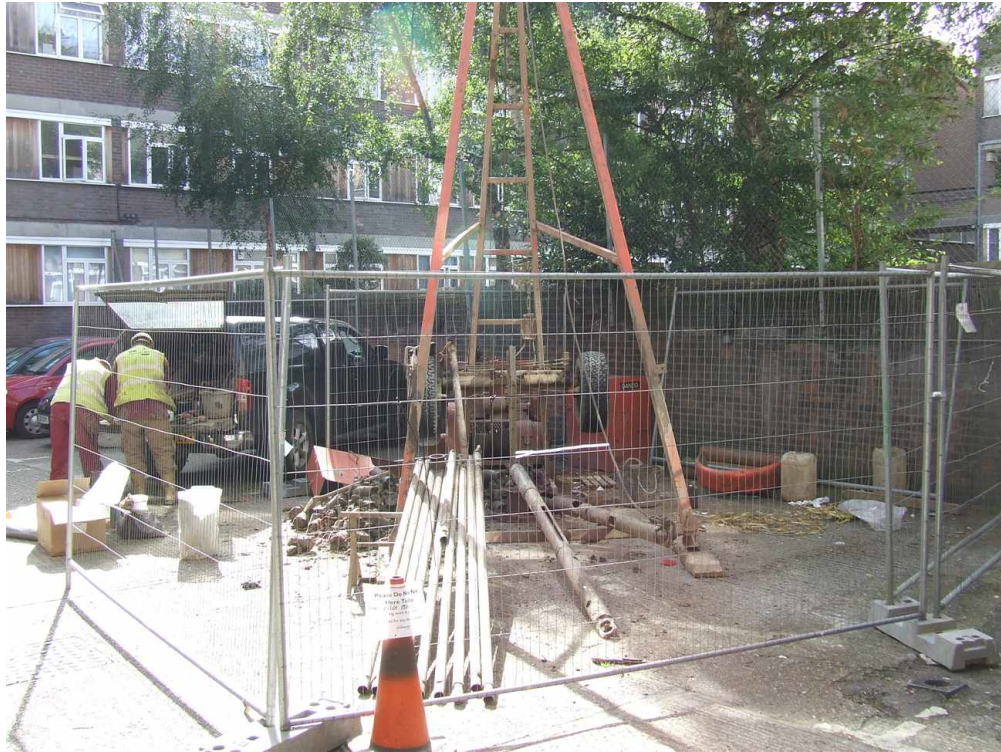
South West Area, BH7, looking south east

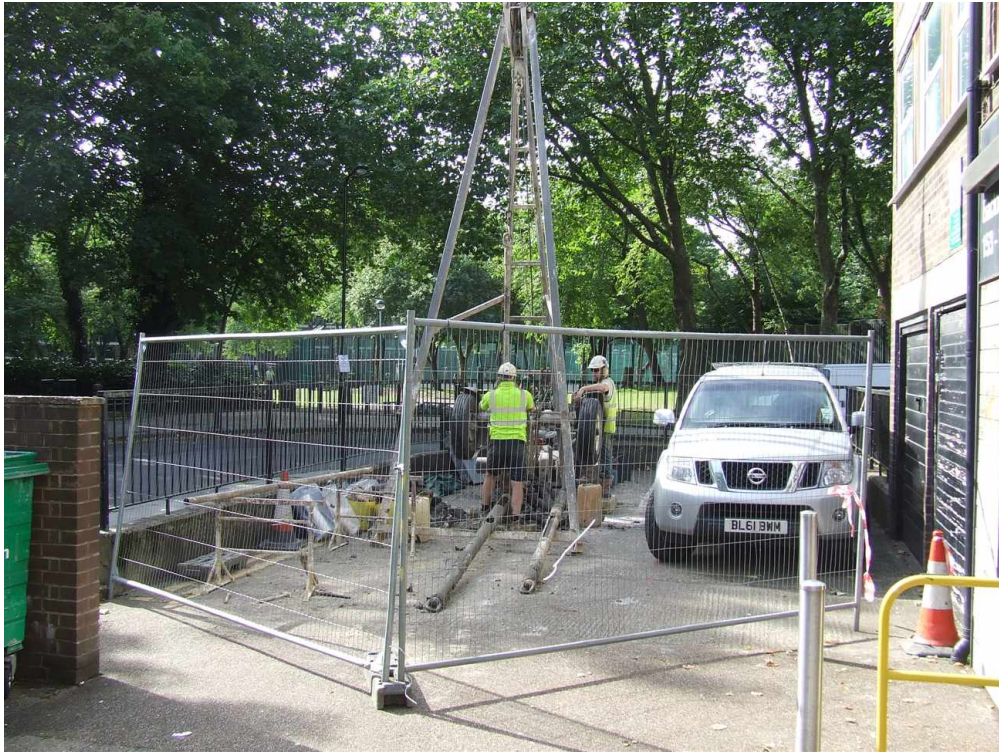
South West Area, BH9, looking south
