Desk Study & Basement Impact Assessment Report

Rear of 6 John Street London WC1N 2ES

J12197

October 2012

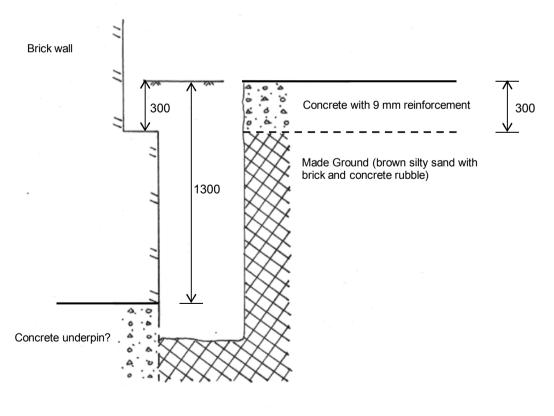
Section A - A: -

Remarks:		Scale:	
All dimensions in millimetres	Base of footing not proved	1:20	
Minor instabilities encountered within the made ground		Logged by:	
Groundwater: Not Encountered		ML

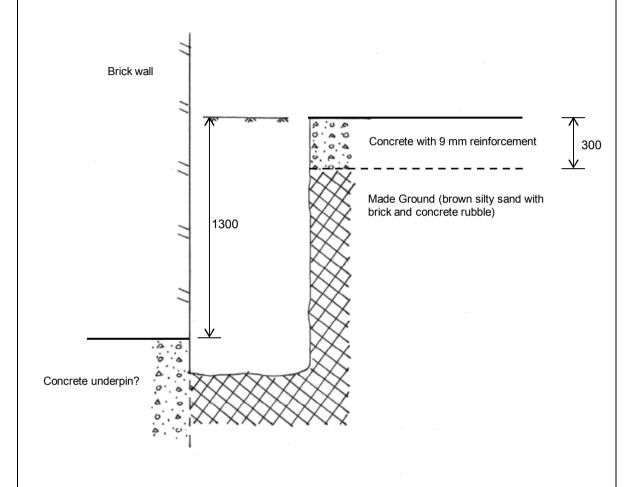
Section B - B: -

Remarks:		Scale:	
All dimensions in millimetres	Base of footing not proved	1:20	
Minor instabilities encountered within the made ground		Logged by:	
Groundwater: Not Encountered		ML

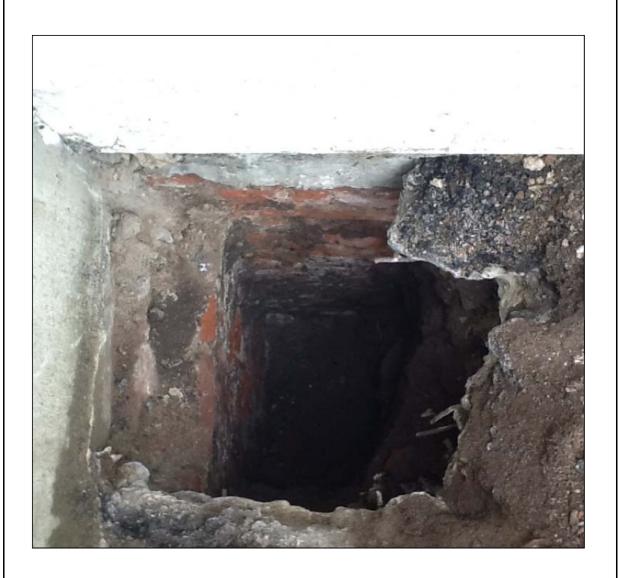
Geotechnical & Environmental Associates			Tyttenhanger House Coursers Road St Albans Herts AL4 0PG Site Site rear of 5 John Street, London WC1N 2ES		Trial Pit Number 1
Excavation Method Manual		Dimensions	,	Ollette	Job Number
		550 x 900 x 900	21.09		
				Mr Philip Lanaido	J12197
		Location	Dates	Engineer	Sheet
			28/09/2012	Fluid Structures	3/3

Remarks:		Scale:
All dimensions in millimetres	Base of footing not proved	1:20
Minor instabilities encountered within the made ground		Logged by:
Groundwater: Not Encountered		ML

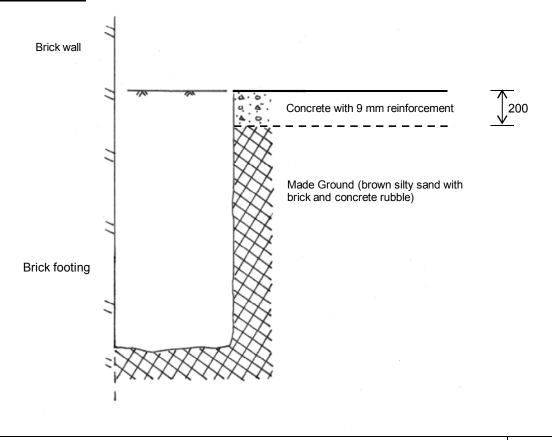
Section A - A: -

Remarks:		Scale:	
All dimensions in millimetres	Base of footing not proved	1:20	
Minor instabilities encountered within the made ground		Logged by:	
Groundwater: Not Encountered		ML

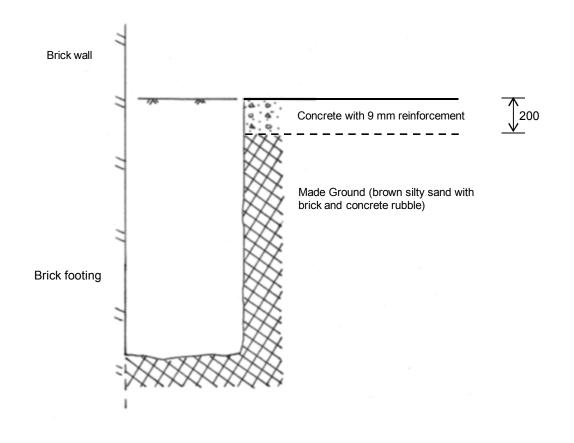
Section B - B: -

Remarks:		Scale:	
All dimensions in millimetres	Base of footing not proved	1:20	
Minor instabilities encountered within the made ground		Logged by:	
Groundwater: Not Encountered		ML

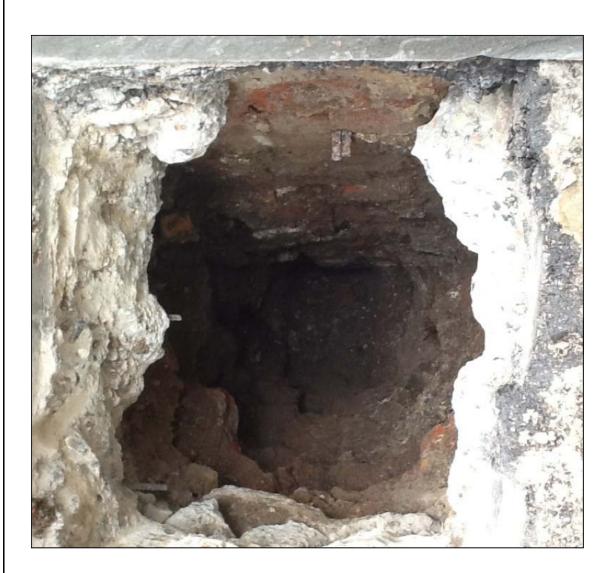
GEA Geotechnical & Environmental Associates		Tyttenhanger House Coursers Road St Albans Herts AL4 0PG	Site Site rear of 5 John Street, London WC1N 2ES	Trial Pit Number 2
Excavation Method Manual	Dimensions	, , ,	Client	Job Number
	700 x 600 x 1500	21.09	Mr Philip Lanaido	J12197
	Location	Dates	Engineer	Sheet
		28/09/2012	Fluid Structures	3/3

Remarks:		Scale:
All dimensions in millimetres	Base of footing not proved	1:20
Minor instabilities encountered within the made ground		Logged by:
Groundwater: Not Encountered		ML

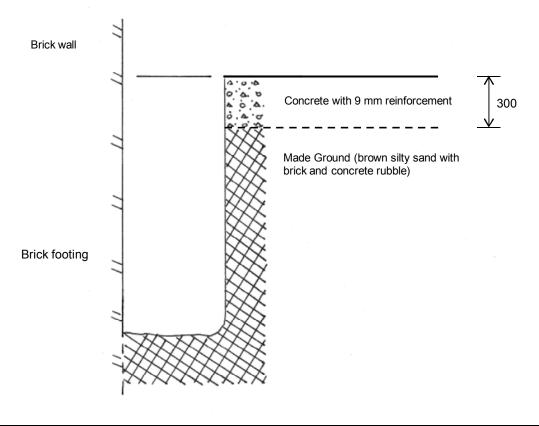
Section A - A: -

Remarks:		Scale:	
All dimensions in millimetres	Base of footing not proved	1:20	
Minor instabilities encountered within the made ground		Logged by:	
Groundwater: Not Encountered		ML
