**Proposed development at
159-167 Prince of Wales Road**

Tree survey and arboricultural statement

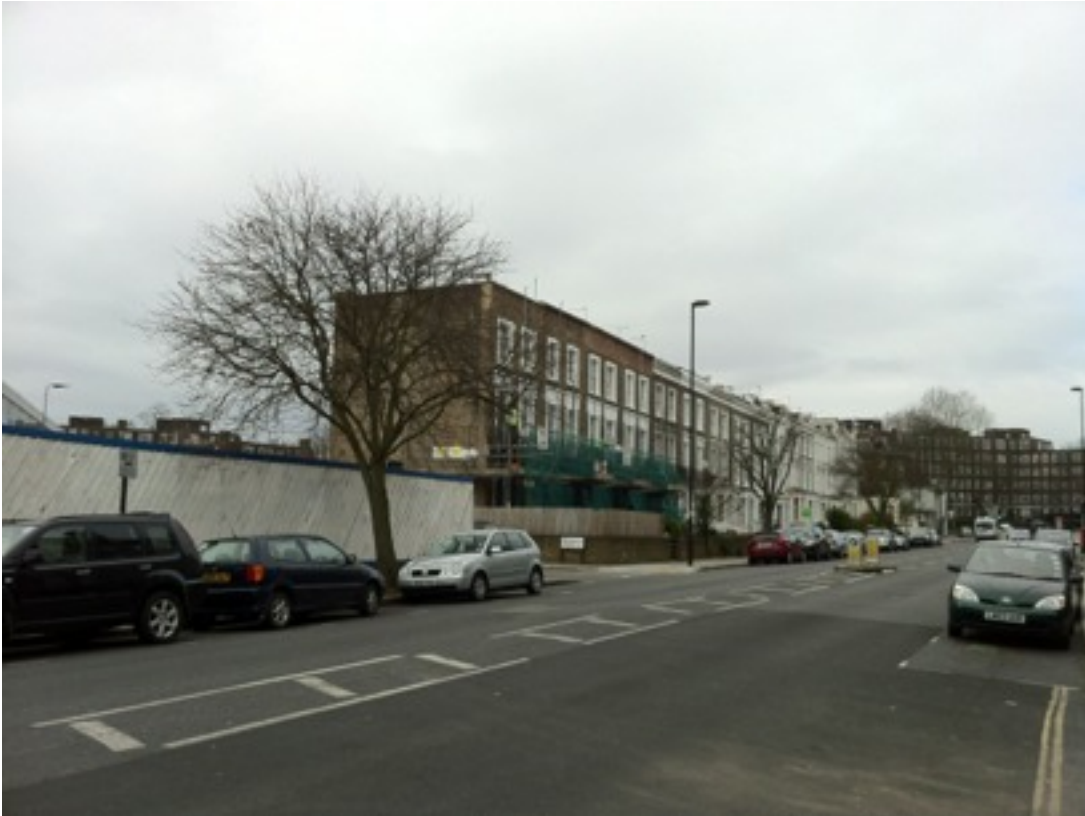
Photo 1: 08.03.2012; from north side of Prince of Wales Road, looking SW - development site to left (behind hoarding)

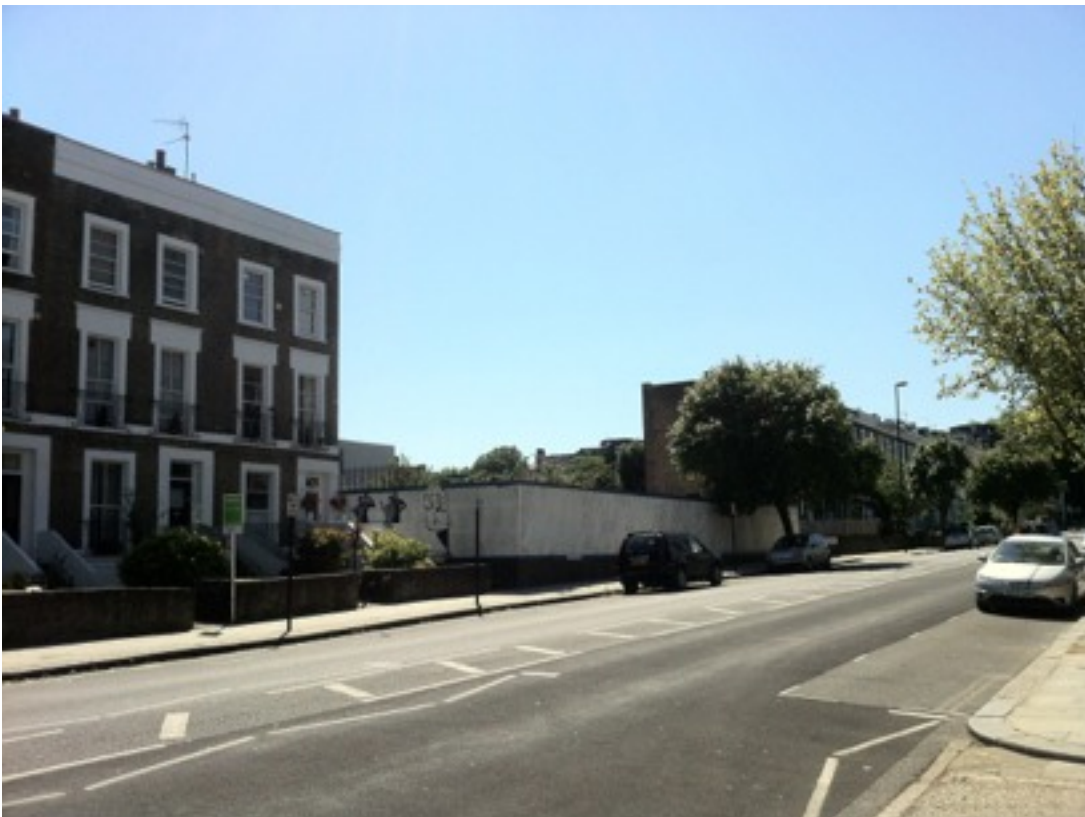
Photo 2: 23.07.2012; from north side of Prince of Wales Road, looking SW - development site in middle of shot (behind hoarding)

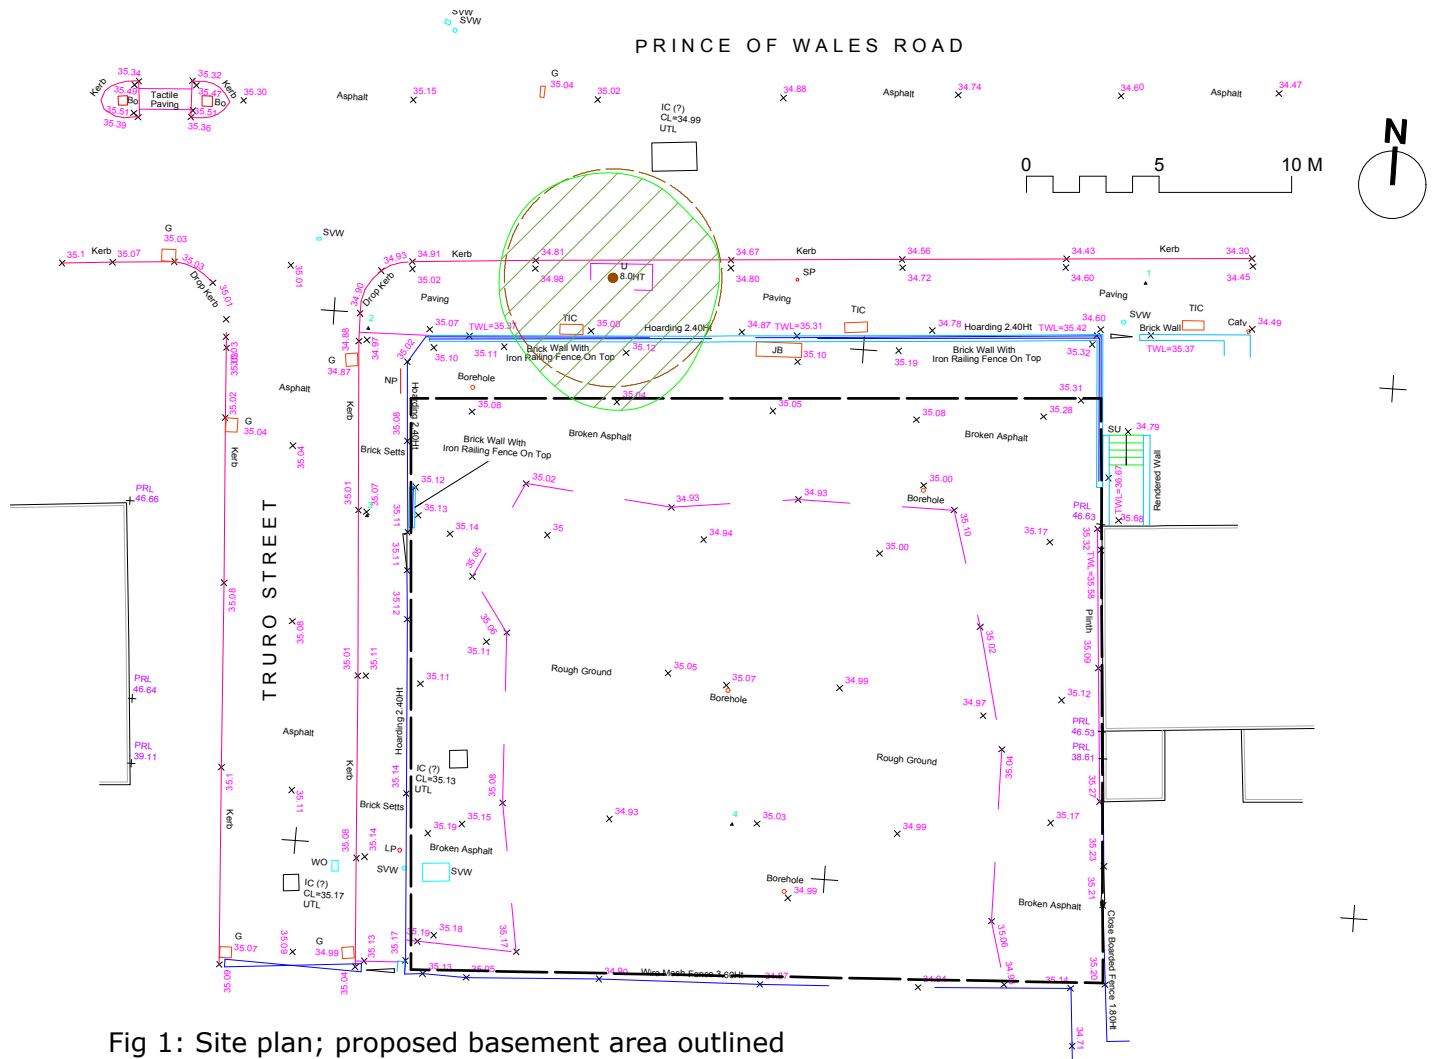
There is one tree in the the immediate vicinity; in the public footway to the north of the site (see Appendix B; fig.1 Site plan)

The stem centre is 4.5m from the proposed basement excavation.

Using a 'rule-of-thumb' (of 12 x stem diameter) to estimate the root protection area (RPA) , the RPA required by this tree is likely to be at 4.2m radius, and therefore outside the basement excavation area.

It is expected that the tree will be retained, and relatively unaffected by the proposed development.

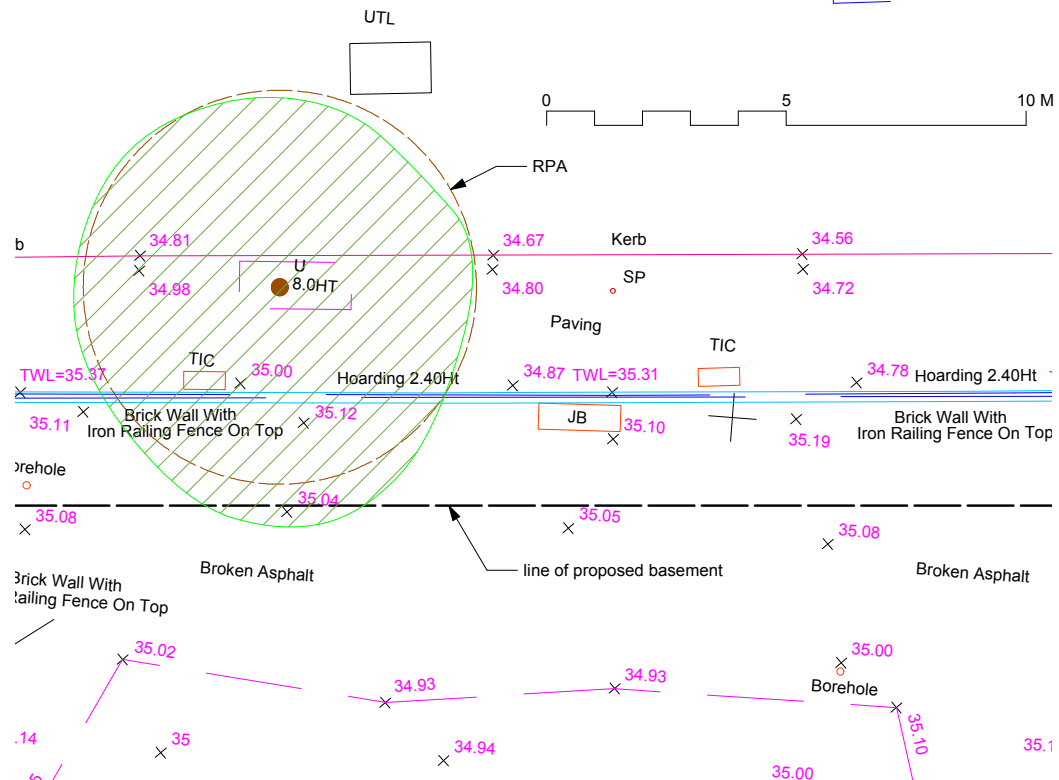
Fig 2: Detail plan

The RPA does extend into the site area; into an area currently occupied by a low-height brick wall (at the site perimeter) and covered in broken asphalt. The development proposes this area to be used for access walkways to the new property, and as raised planting areas.
