Twyman House
31 – 39 Camden Road
London
NW1 9LR

2011/2072/P

Report to outline constraints surrounding London Plane Tree (T1)

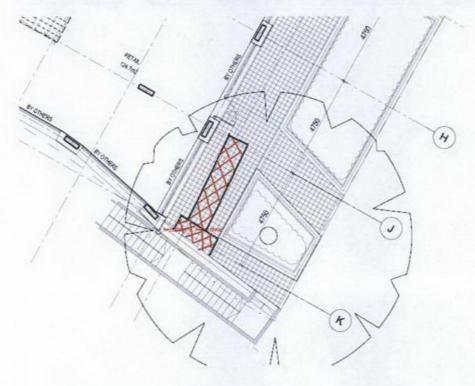
Due to extremely poor ground conditions trenches were not feasible as the ground collapsed. As such an area running through the man hole zone has been exposed and the tree-side face of the canal wall has been exposed. The area is illustrated on the below diagram. Note, the bricks are not builder's rubble as a result of our works; they are all taken from the made-ground that is present along Camden road.

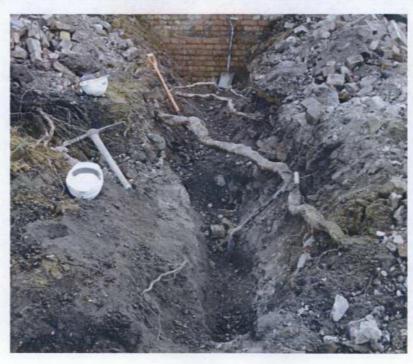
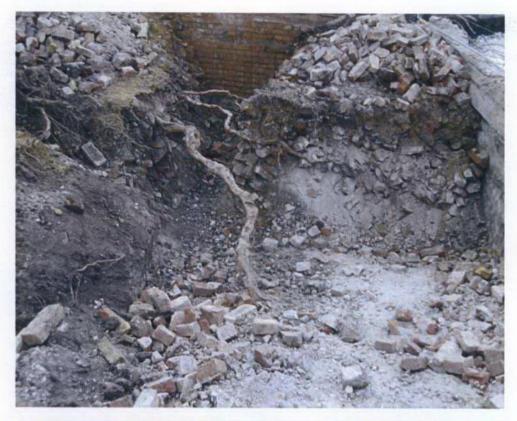
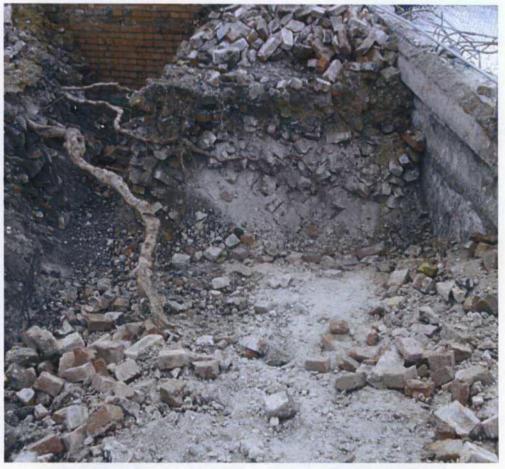
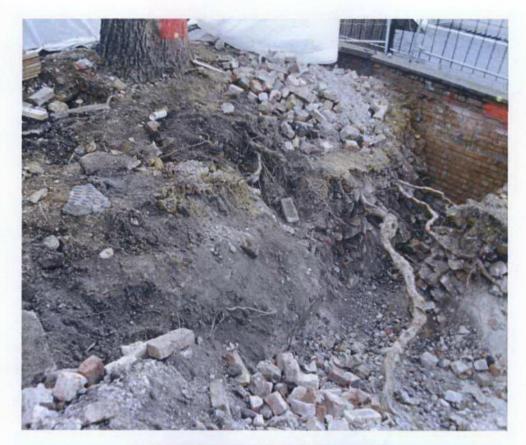
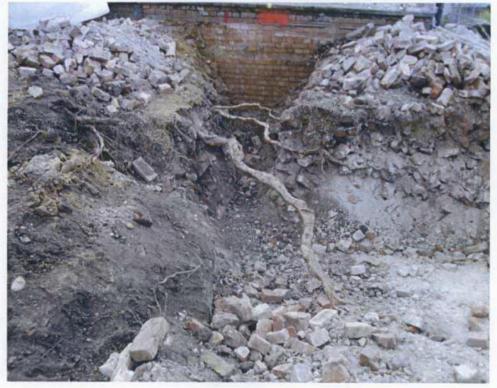
## Photographic evidence of trial pits excavated by hand on 2<sup>nd</sup> October 2012
