**80 Charlotte Street and 65
Whitfield Street Redevelopment**

Ground Contamination Investigation
Strategy

REP/207329/C/S001

Issue 2 | 24 September 2012

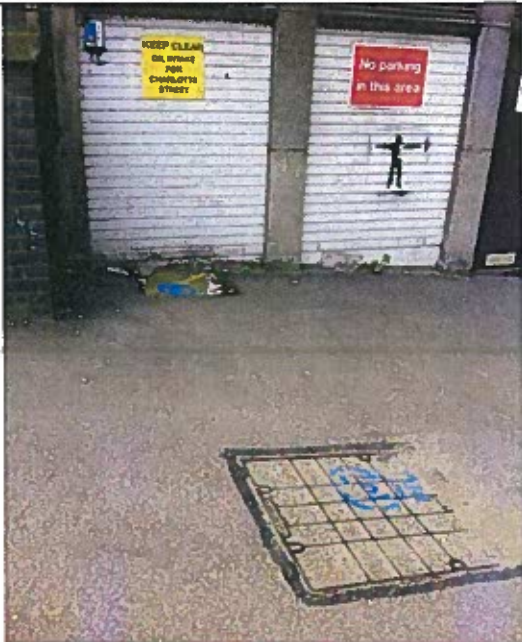
<p>Photograph 1: Chitty Street tank</p>

Notes	Action by
<p>~14:00 – 14:30</p> <p>Met with Richard Cage, Saatchi maintenance supervisor, on site to discuss tank status and conditions.</p> <p>Chitty Street tank (Southern corner of courtyard) (Photograph 1):</p> <ul style="list-style-type: none"> Tanks is still in use, it stores 6000 litres of oil. The oil used is called 35 Seconds Gas Oil. The oil in this tank is used for heating the Chitty Street portion of the building (Block K) The tank is filled at a separate filling point (Error! Reference source not found.). The tank would have been installed when the building was constructed in the late 1950s. About 12 years ago the tank was emptied for inspection as it was thought water was infiltrating into the tank. BH122 is located 3.9m south-west of the tank (Photograph 3).

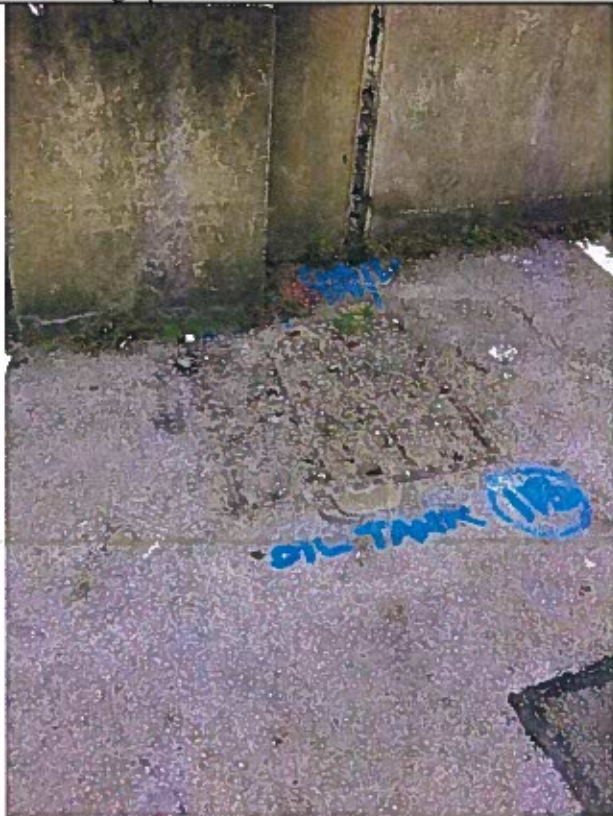
Photograph 4: Charlotte Street Tank

Project title	Fitzrovia Redevelopment		Job number	207329
Visit made by	Emma Fromant, Rena Maguire and Alex Chen	Place visited	Saatchi building - courtyard area	
Copy to	Chris Barrett	Person visited	Date of visit 13 th August 2012	
Purpose of visit	Site walkover to look at courtyard tanks Plan of Tank locations is attached as Figure 1			
Notes				Action by
Charlotte Street Tank (North-west in court yard) Photograph 4 <ul style="list-style-type: none"> • This tank stores 35,000 litres of 35 second gas oil. It is still in use. • The oil of this tank generates heating for the largest proportion of the Saatchi building (Block H). • The boiler room generated by this tank is located on the Howland Road side of the building. • There will be extensive pipe work connecting this tank to the boiler room. • It was emptied 12 years ago as it was thought the tank was losing oil. • The filling point is separate and is located behind a car park separator wall
