3.0 ASSESSMENT

3.1 SITE LOCATION AND ASSESSMENT

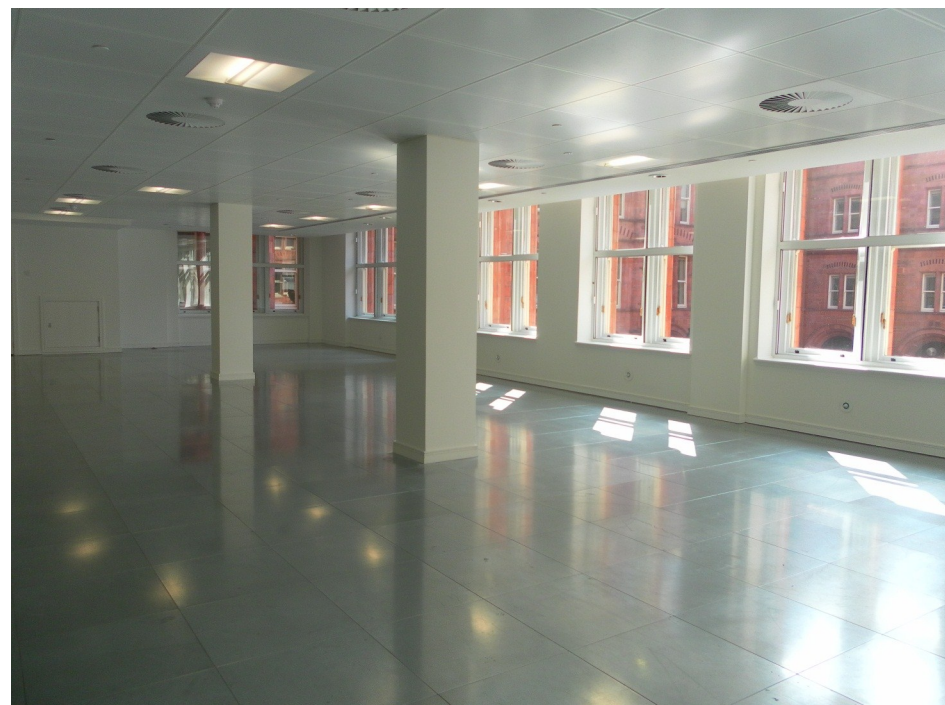
Figure 3: A view of the interior of the former 'Wood's Hotel Block, constructed 1895-6, but which now presents as formalised modern office accommodation, devoid of any obvious historic features.

It should be noted however, that while the application site largely consists of interiors within a late 1980s block, it also includes some spaces that date to earlier, late nineteenth century phases of construction on the site. These include the block to the southeast of the site fronting onto Leather Lane which was part of the former Leather Lane/Ridler's Hotel phase of 1895-1901; the small block to the southwest of the site, within the remains of the Waterhouse works of 1885-8; and the square block which faces Waterhouse Square, known as the 'Wood's Hotel Block', and constructed between 1895 and 1896. A small number of features remain within these parts of the building which contribute to the special interest of the listed building.

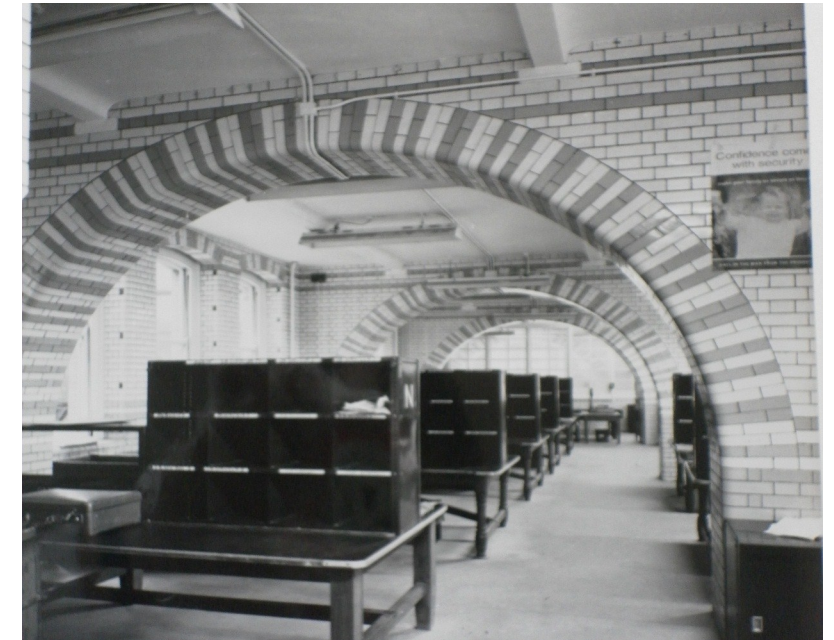
Figure 4: A view of the interiors of the former 'Ridler's Hotel' Block, in the south-east section of 2 Waterhouse Square, as they appeared in use by the Prudential in 1968. Glazed brick arches dominate here.

The original design and layout of the late nineteenth century parts of the building can be seen, for example, in the arched forms within the former Ridler's Hotel block, and which are illustrated in figures 4 and 5. Despite the original glazed brickwork having been concealed by plasterboard over in recent years, these structures attest to the reconstruction of this part of the site in the late nineteenth century.

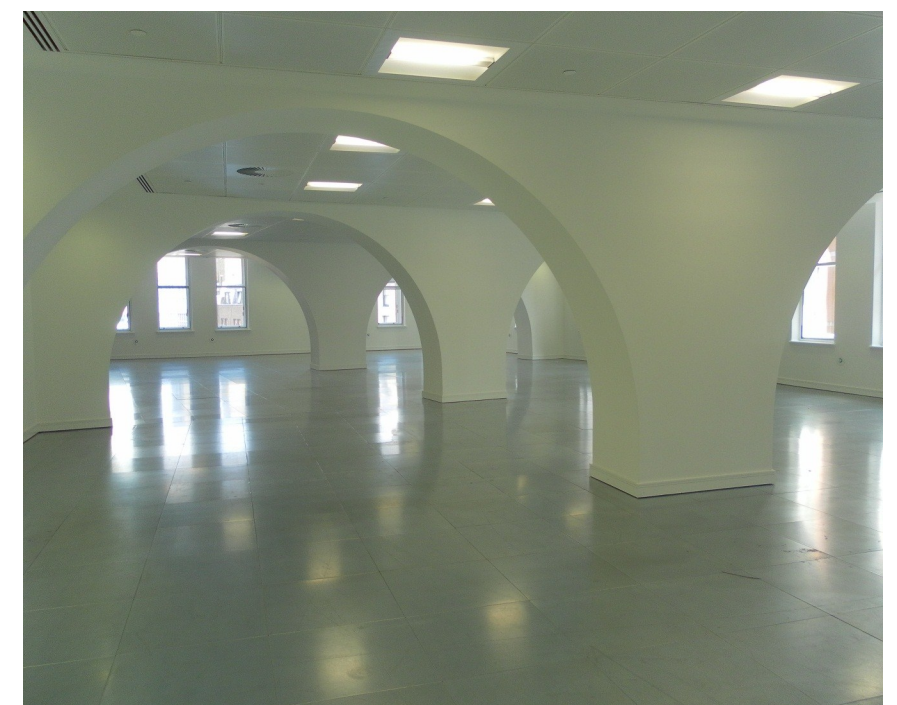
Figure 5: A view of the same space today, illustrating the extent to which historic features have now been concealed by plasterboard, raised floors and suspended ceilings.

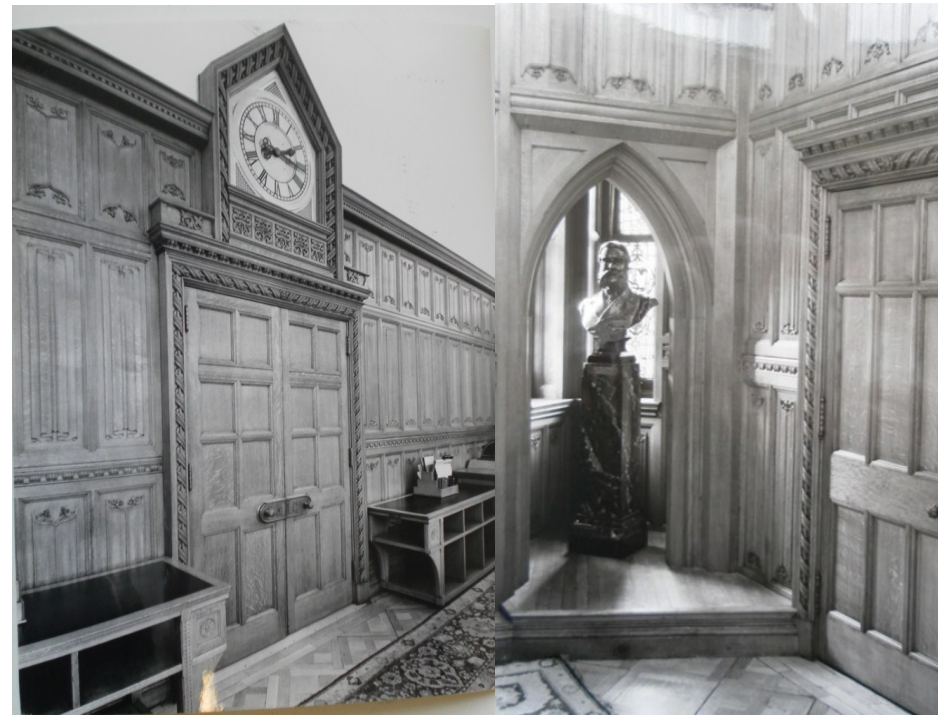
Figure 6: Internal views of panelled, directorial rooms within the former Prudential Offices. The 'linenfold' panelling found in these rooms matches that which Waterhouse designed for the original building's Boardroom in the late 1870s, and which can now be found in the former Director's Rest Room (figure 7).

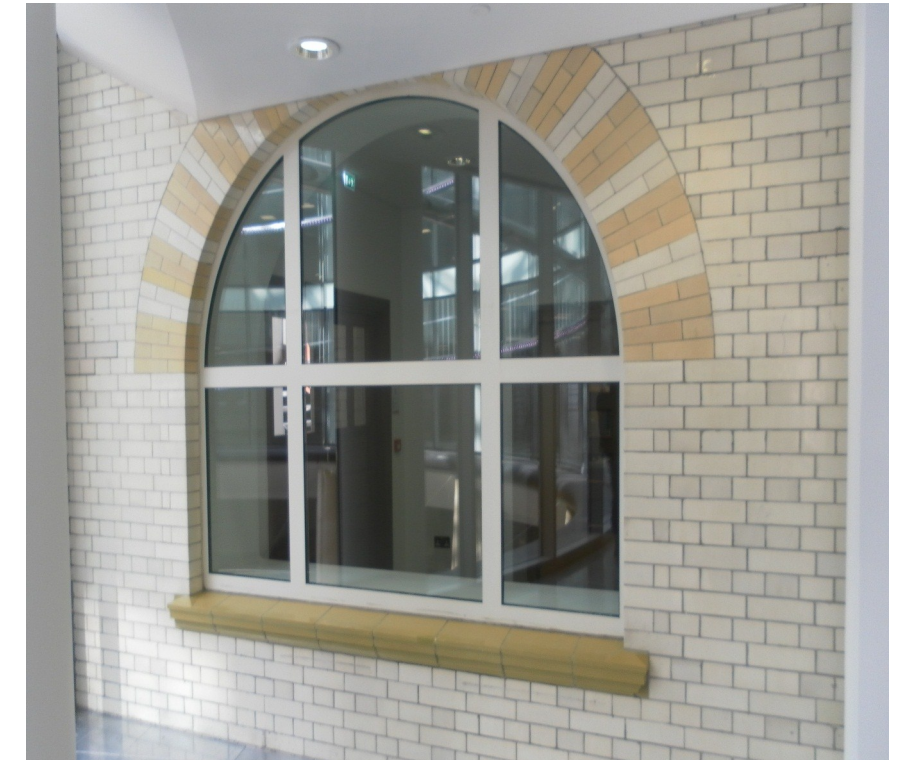
Figure 8: An example of some of the late-Victorian glazed brick that remains exposed within 2 Waterhouse Square.

Another important element of the history of the site at 2 Waterhouse Square is the legibility of those sections of the building which date to the late nineteenth century, and whose elements retained, without being concealed from view. In the south eastern quarter of the site, the glazed bricks of a late nineteenth century lightwell have been retained, with figure 9 illustrating the join between the original Waterhouse building and the addition made by EPR Architects in the late 1980s. Figure 8, meanwhile, reveals the sympathetic treatment of these original Victorian features and brickwork within the interior of the building. Such elements attest to the special interest of the building in these parts of the site.

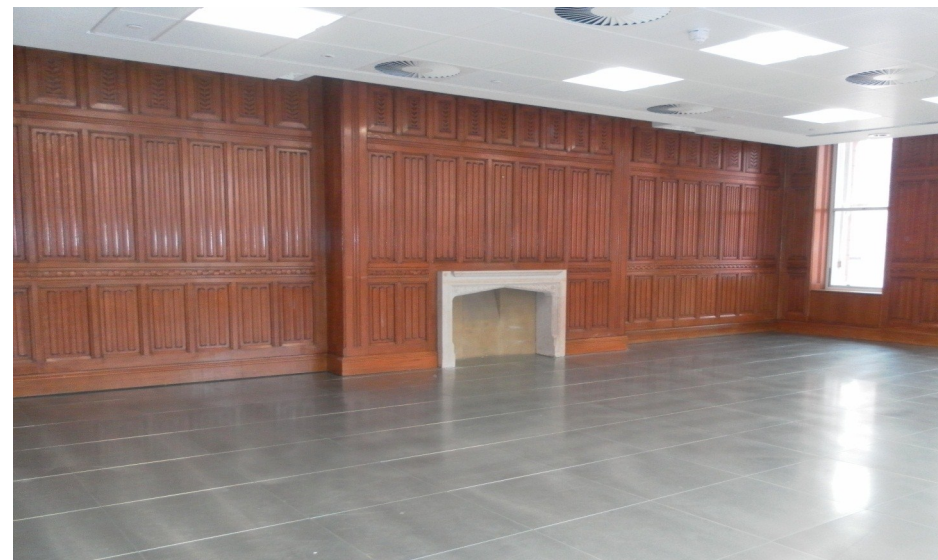
Figure 7: The former Director's Rest Room as it appears today. The appearance of its linenfold panelling and simple, stone Neo-Gothic fireplace has been harmed to an extent by the introduction of later office features, such as suspended ceilings.

Another important interior feature remains in a second floor room in the southwest corner of the site, identified as being the Director's Rest room. This room retains, it would appear, the oak panelling which was initially located in the Board room of the first Prudential Assurance building on this site, constructed from 1878. Photographs of this panelling in its original location is shown in figure 6, while figure 7 shows the current appearance of the former Director's Rest Room. This room is the only part of 2 Waterhouse Square to have survived with at least some of its internal features exposed, following recent redevelopment between 1988 and 2011.

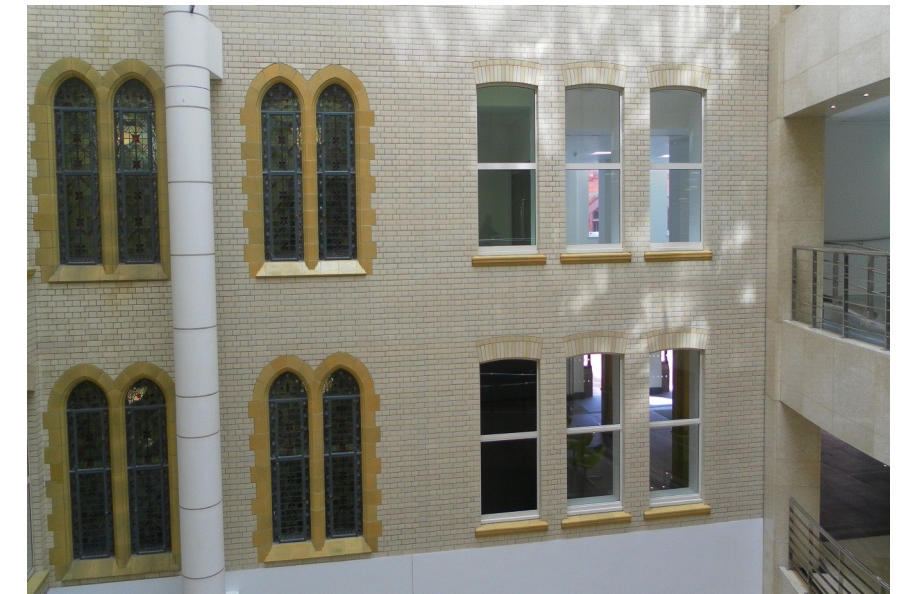
Figure 9: A view of the glazed brick, formerly open, lightwell, within 2 Waterhouse Square. The elaborate, stained glass Gothic windows to the left of this image relate to one of the staircases, to which no works are proposed.

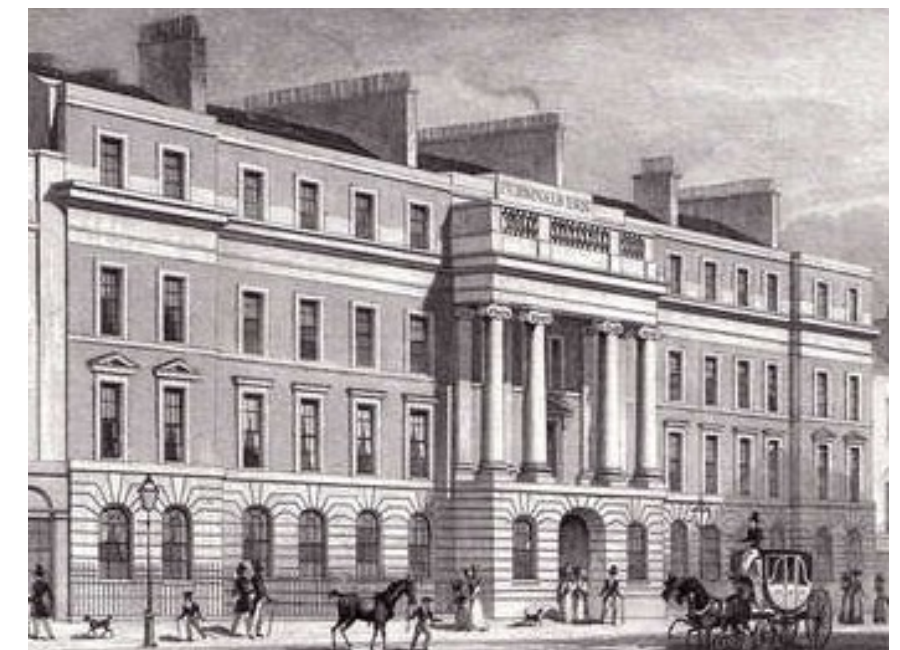
Figure 13: The imposing facade of Furnival's Inn in the early nineteenth century. This porticoed block was ultimately to be preplaced by the Prudential Building's ornate main front.
