# 19 PVW - Listed Building Impact Statement

The Crown Estate – Regent's Park 19 Park Villago West

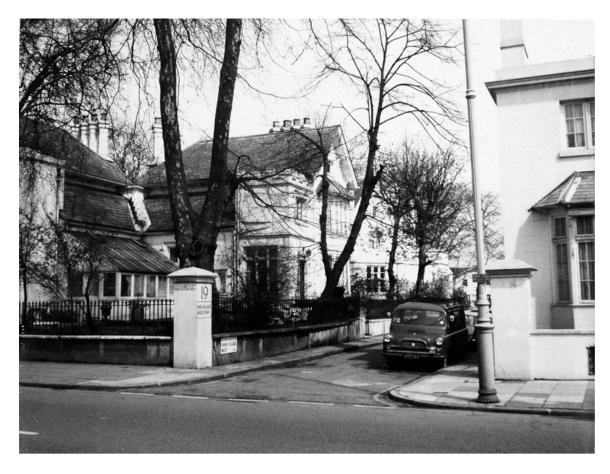
Further more the two entrances into Park Village West from Albany Street are identical and both having prominent corner posts, with street name attached to them. The post in question, in conjunction with the post at the other entrance into the park Village West, act as a stopping point for the retaining wall and the metal railing thus contributing to the street scene and setting of the Park Village West as a whole.

Corner of Albany Street and Park Village West showing corner post, wall and metal railing during second half of the twentieth century
