project
28 Mornington Crescent
London NW1 7RE

drawing title
Front and Rear Elevations
As Existing

date	drawn by	revision
July 11	BM	A
scale	checked by	drawing
1:50 @ A2	RW	143.120

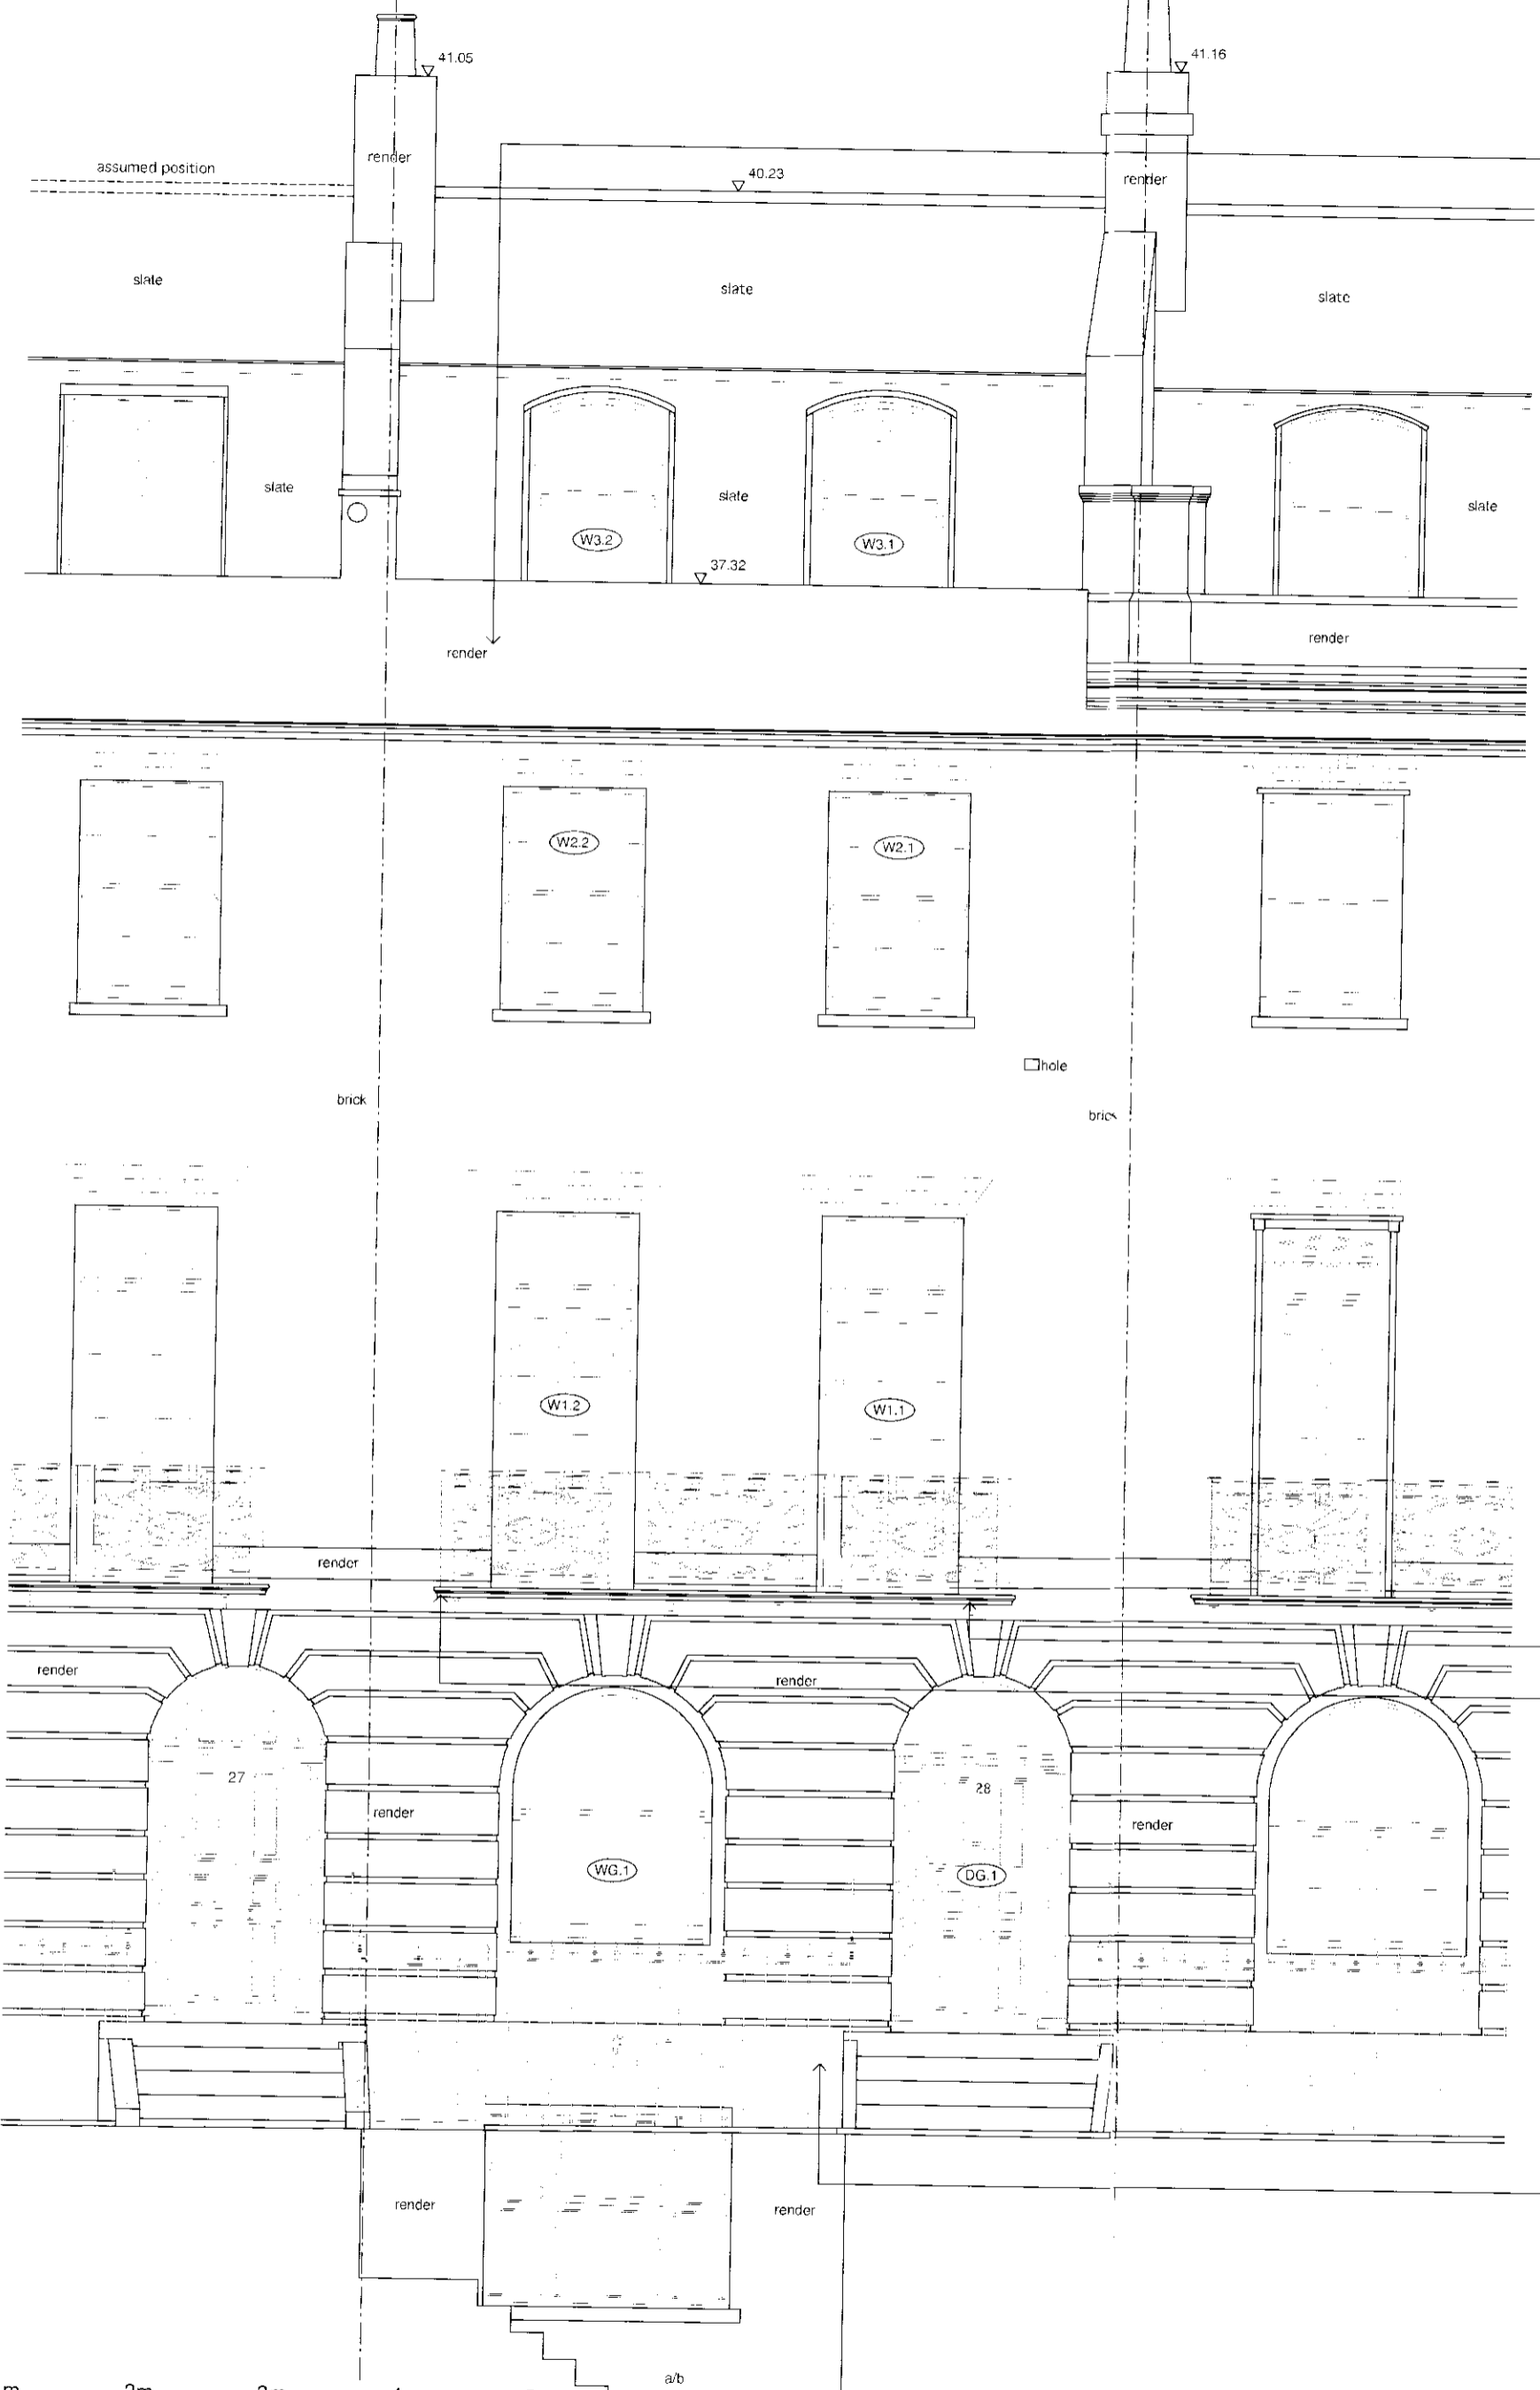
FRONT ELEVATION

Damaged and deteriorated render to existing blocking course.

Edge of existing stone balcony fractured above bracket.

Edge of existing stone balcony damaged.

Existing services distribution box.

Existing upvc window to be removed and replaced

Existing waste pipe to be removed

Existing upvc door to be removed and replaced
