239 HAVERSTOCK HILL LONDON NW3 4PR

Geotechnical Investigation

Report No. 3770

15 May 2012

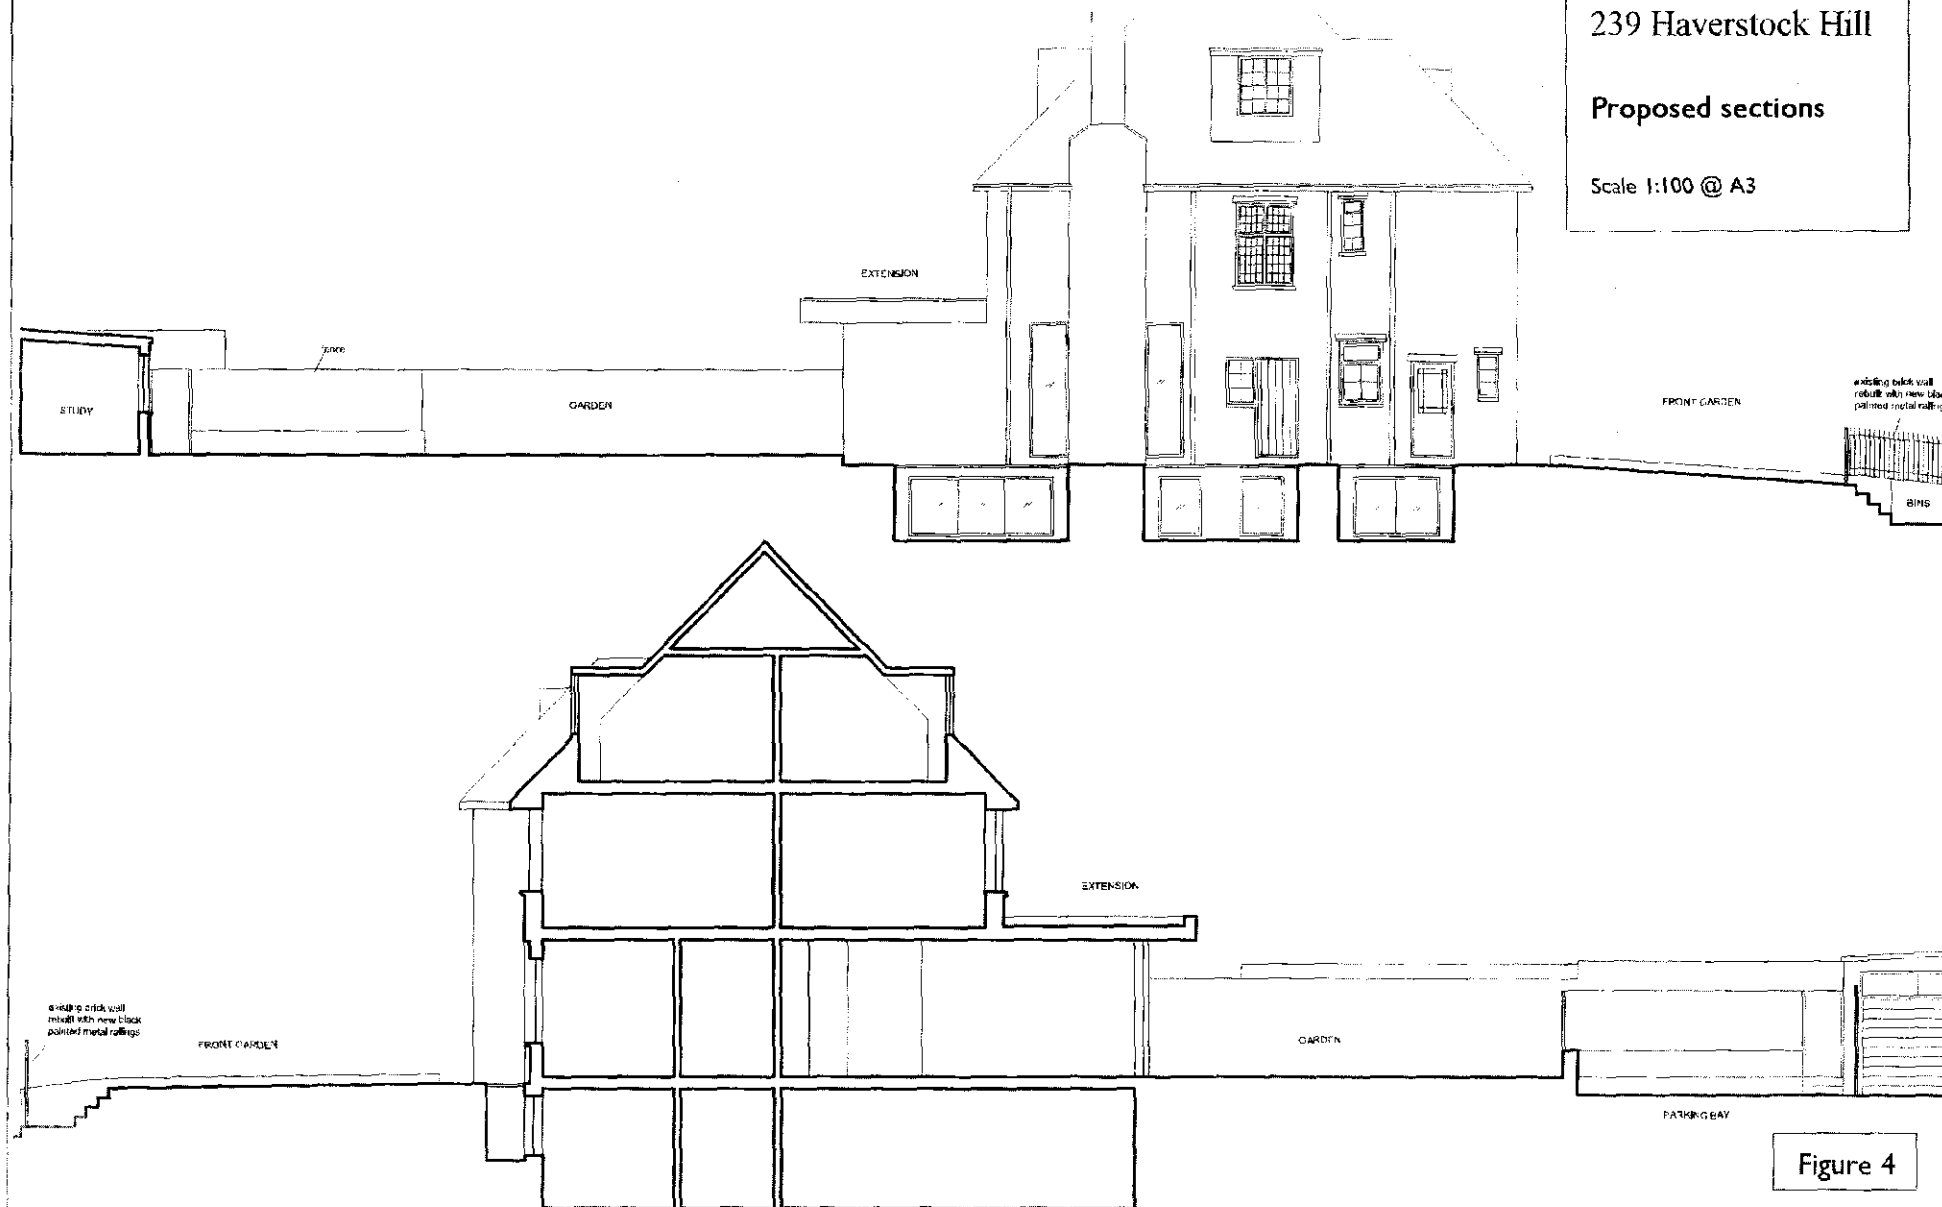
Figure 4

Proposed sections

The proposal is to construct a single level of basement some 13 m long and 9 m wide, thus beneath the full width of the property and extending about 3 m beyond the rear elevation as shown at Figures 3 & 4. Light wells will be provided on the front and left flank elevations.
