# **Desk Study and Ground Investigation Report**

**30a Highgate Road  
London NW5**

Client Mr Colin Serlin

J12041

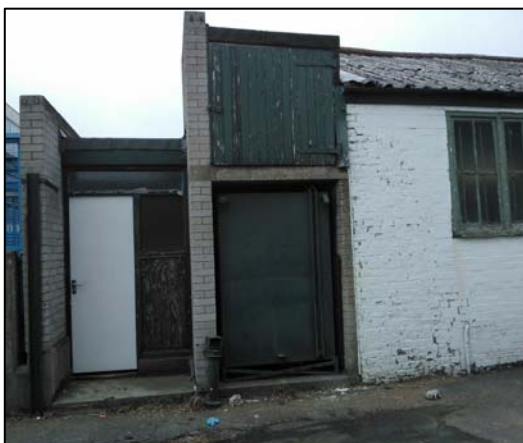
An old metal tank is located close to the western boundary of the site, positioned on a concrete slab which is covered by an open fronted brick shed, as shown below. The tank contains liquid hydrocarbon fuel, although the exact contents are not known. It is not known if the tank is still in use but it appears to be in a good condition and there are no obvious stains on the ground around the tank. .

Photograph showing green coloured metal tank containing hydrocarbon

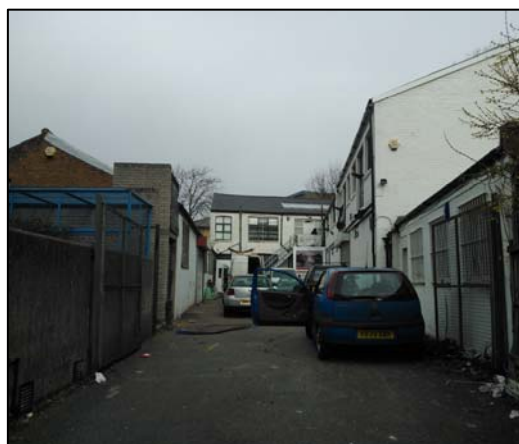
Photograph showing general arrangement of the site, looking northeast from access road
