ARBORICULTURAL REPORT

103 Camley Street

Reference: MPH0372/RHB **Date:** 29 February 2012

Re: Root investigations outside Number 103 Camley Street, Camden, London

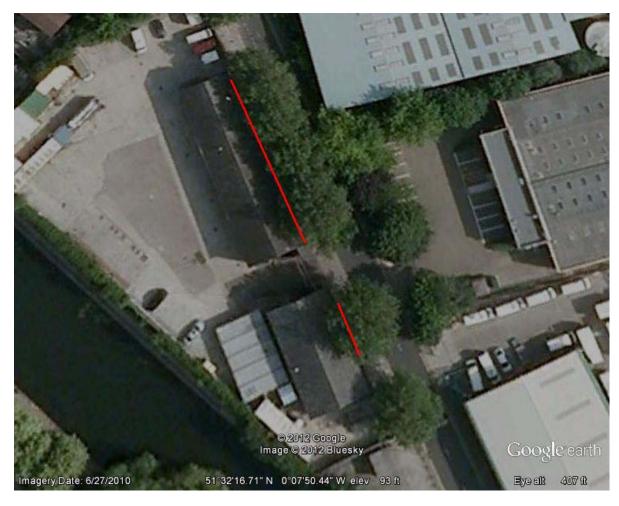
<u>Figure 1: Google earth image with red line identifying location of root investigation trenches on Camley Street, Camden, London</u>

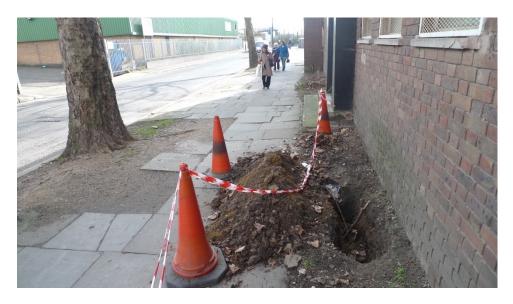
<u>Figure 2: Southern section of trench, an electrical cable was uncovered at 50cm, digging stopped at this point. No roots were discovered in this trial drench</u>

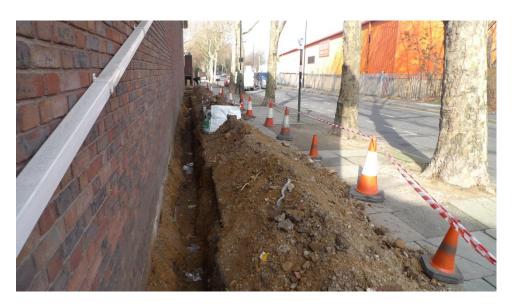
$\underline{\textbf{Figure 3: Looking north down trench uncovered to a depth of 900cm, no roots were discovered}\\ \underline{\textbf{greater than 10mm}}$

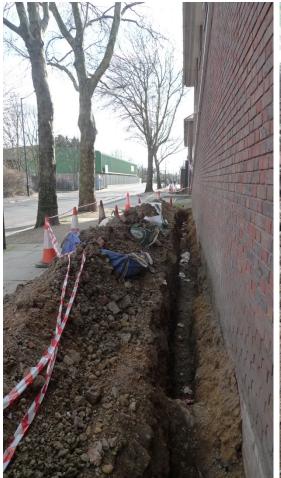
Figure 4: Trench viewed from north 900cm

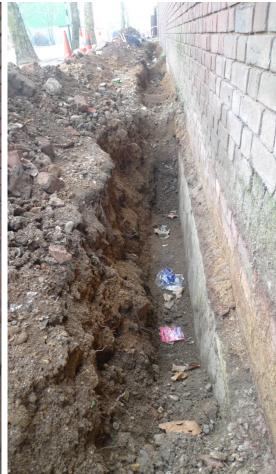
Figure 5: Close up view of trench to a depth of
