**Listed Building Report****King's Cross Package 6****Western Range Building Stone Proposal**

This document has been prepared for the discharge of conditions 14 and 17 of Listed Building Consent 2006/3394/L.

This document has been prepared for the discharge of conditions 14 and 17. It covers all of the stone to be repaired within the Western Range Building.

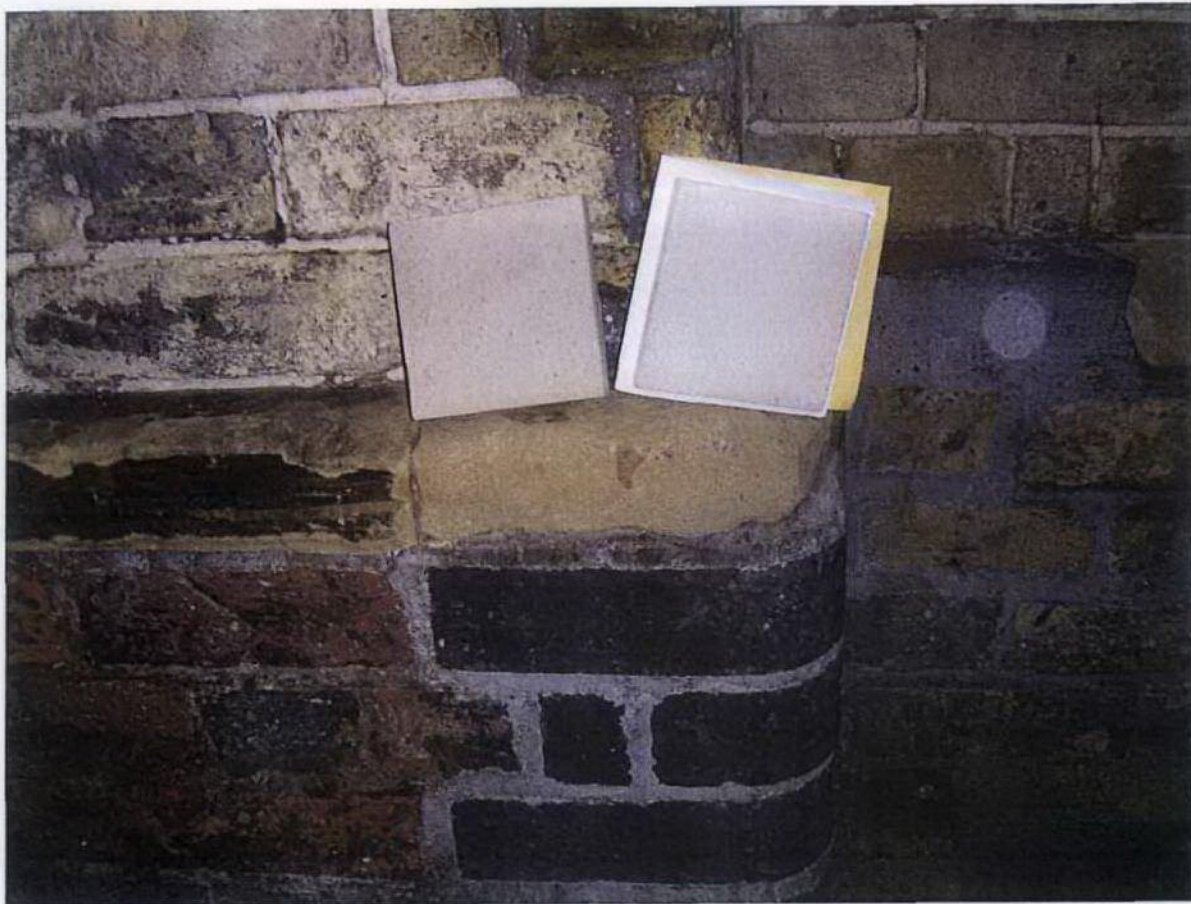
The stone sample was taken from the plinth on gridline W10 on Platform 8. The plinth extends along the length of the platform as well as along the Central Block on the West Elevation and it is capped in rectangular profiled stone lengths.

The petrographic report (Jefferson Consulting Ltd, dated September 2009) states that the stone is "a relatively fine-grained and laminated sandstone, probably from the Rough Rock Flags of the Silesian 'Millstone Grit' of West Yorkshire". Although readily available at the time the station was built supplies of stone are limited now. The report suggests Rawdon stone as a very close match or Witton Fell Fine Grit as an alternative.

Photo 1: Existing plinth with a sample of Dunhouse Blaxter on the left and Witton Fell Fine Grit on the right. It has been agreed that Dunhouse Blaxter is the best match.

It was agreed on site on 20/01/10 with the Conservation Officer of LB Camden that Dunhouse Blaxter is the best new stone for the plinths.

Salvaged sandstone was used for repairs to the plinths.

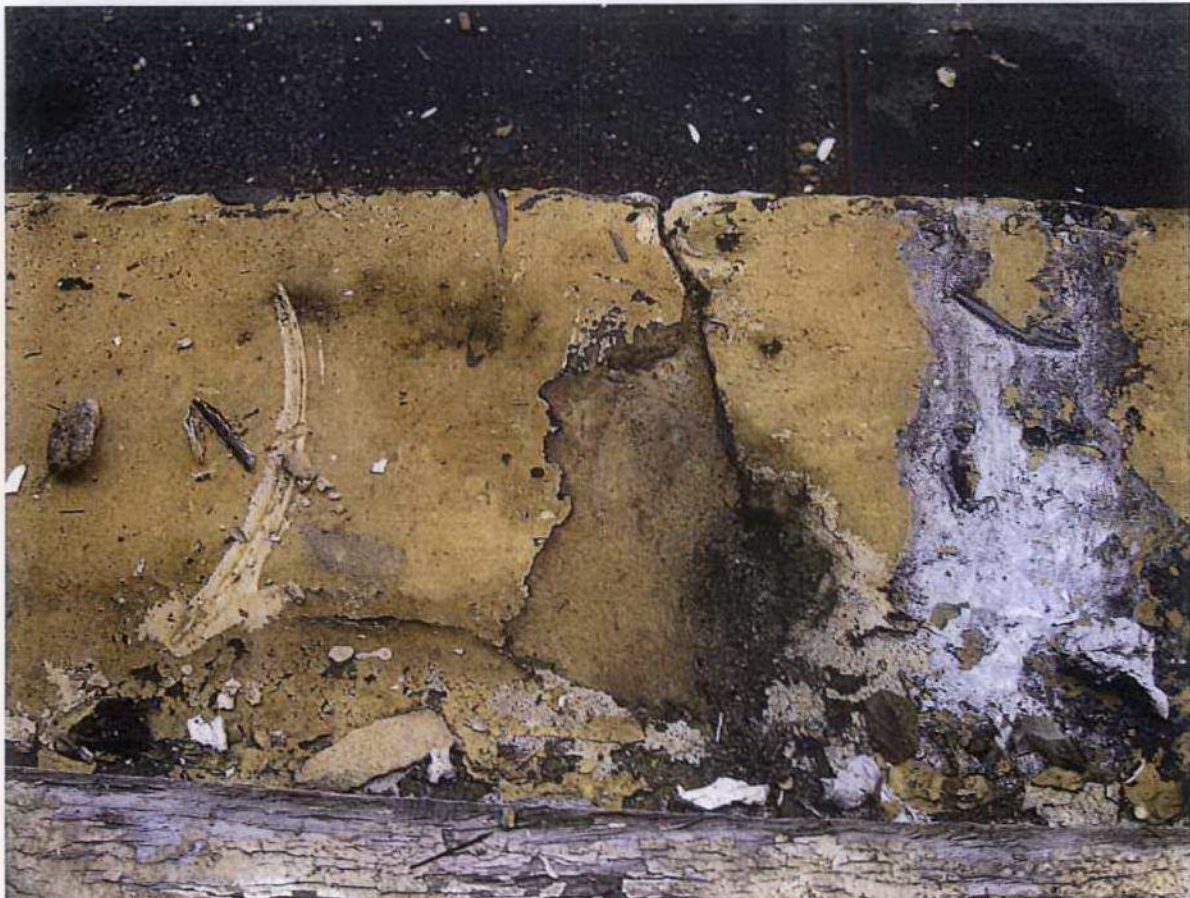
Two samples were taken from sills above the Main Trainshed roof. The stone sample 1 was taken from the sill of window 215/W2e which is on the second floor between gridlines W8 and W9. Stone

sample 2 was taken from the sill of window 230/W1e between gridlines W20 and W21. The sills above the trainshed roof are completely blackened with age (not painted) and some, close to the gutter, are covered in lead.

The petrographic report (Sandberg Consulting Engineers, no. 41378/G/1) states that the two stone samples are "similar buff to beige fine to medium grained sandstone/gritstone generally exhibiting similar composition and textures but slightly different structures"

Photo 2: Sill of window 215/W2e showing from where sample 1 was taken.

It was agreed on site on 02/03/10 with the conservation officer for LB Camden that Dunhouse Blaxter is the best match for sills above the Trainshed roof.

Salvaged sandstone was used for repairs to the sills.

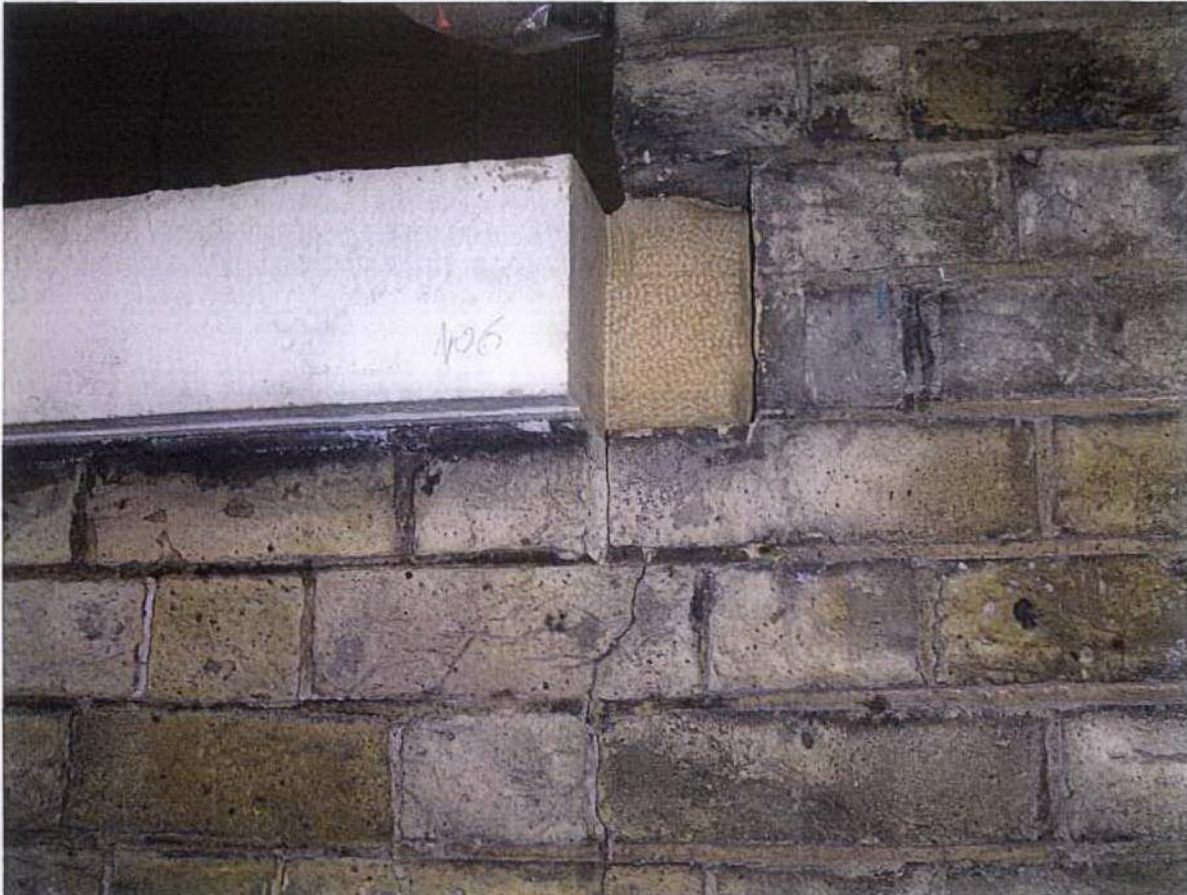
The stone sample was taken from one of the sills at Ground Floor level between gridlines W22-23.

The petrographic report (Jefferson Consulting Ltd, June 2009) states that the stone is "a fine-grained sandstone, probably from the Silesian 'Coal Measures' of West Yorkshire". Although readily available at the time the station was built supplies of stone are limited now. The report suggests a very close match is Woodkirk stone.

Photo 3: Painted sill of window 108/W2e showing cut out ready for an indent repair.

It is anticipated that most stone sill replacement will be done using sills salvaged from the ground floor alterations to the Western Range. However, the sills are painted and it is difficult to be sure of their condition so new stone may be needed. Following visual matching on site with English Heritage and the Conservation Officer of LB Camden Woodkirk Stripy was chosen as the best match for the West Elevation window sills.

Salvaged sandstone was used for repairs to the sills.

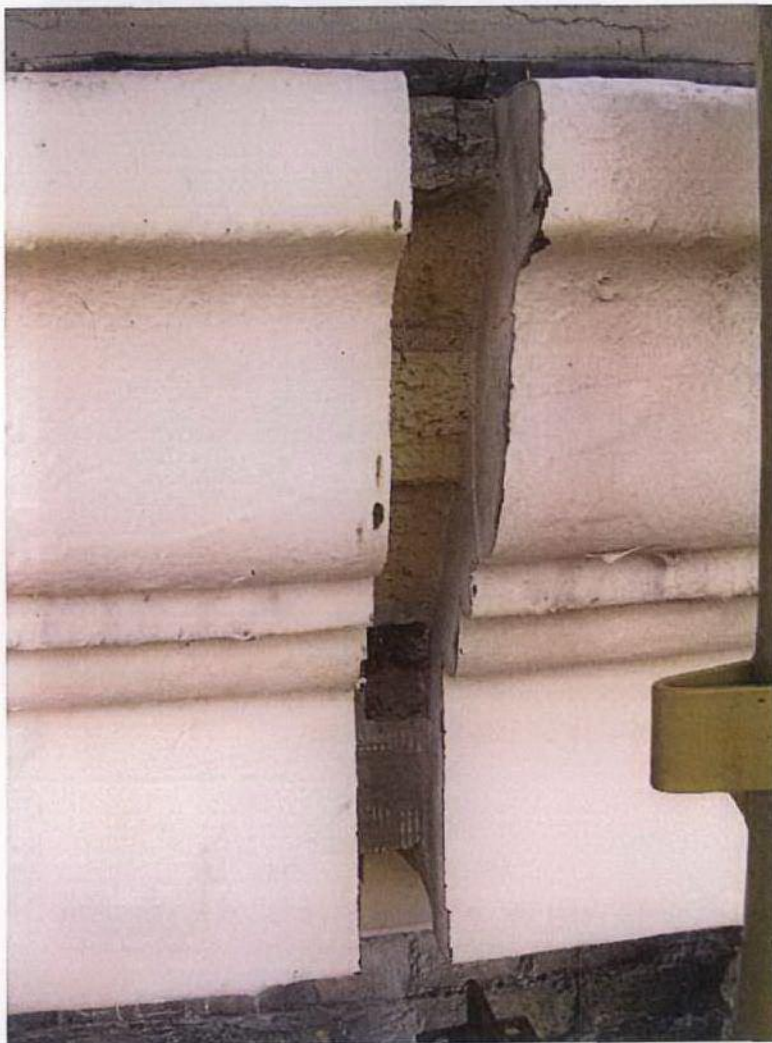
Two stone samples were taken from cornices on the West elevation. The first (sample A) was taken from above the second floor on gridline 19 (Northern Wing). The second (sample B) was taken from the large cornice at the top of the Central Block.

For sample A, the petrographic report (Sandberg Consulting Engineers, no. 41260/G) states that the stone is a "pale beige to buff, fine to medium grained, bedded sandstone, well compacted, hard and strong". No suggestions are made for replacement stone within the petrographic report.

Photo 5: Location of Northern Wing sample (sample A) analysed.

Following visual matching on site with English Heritage and the Conservation Officer of LB Camden Woodkirk Stripey was chosen as the best match for the cornice repairs.

Woodkirk stone was used for the large flags of the Central Block cornice lid. Elsewhere salvaged stone was used.

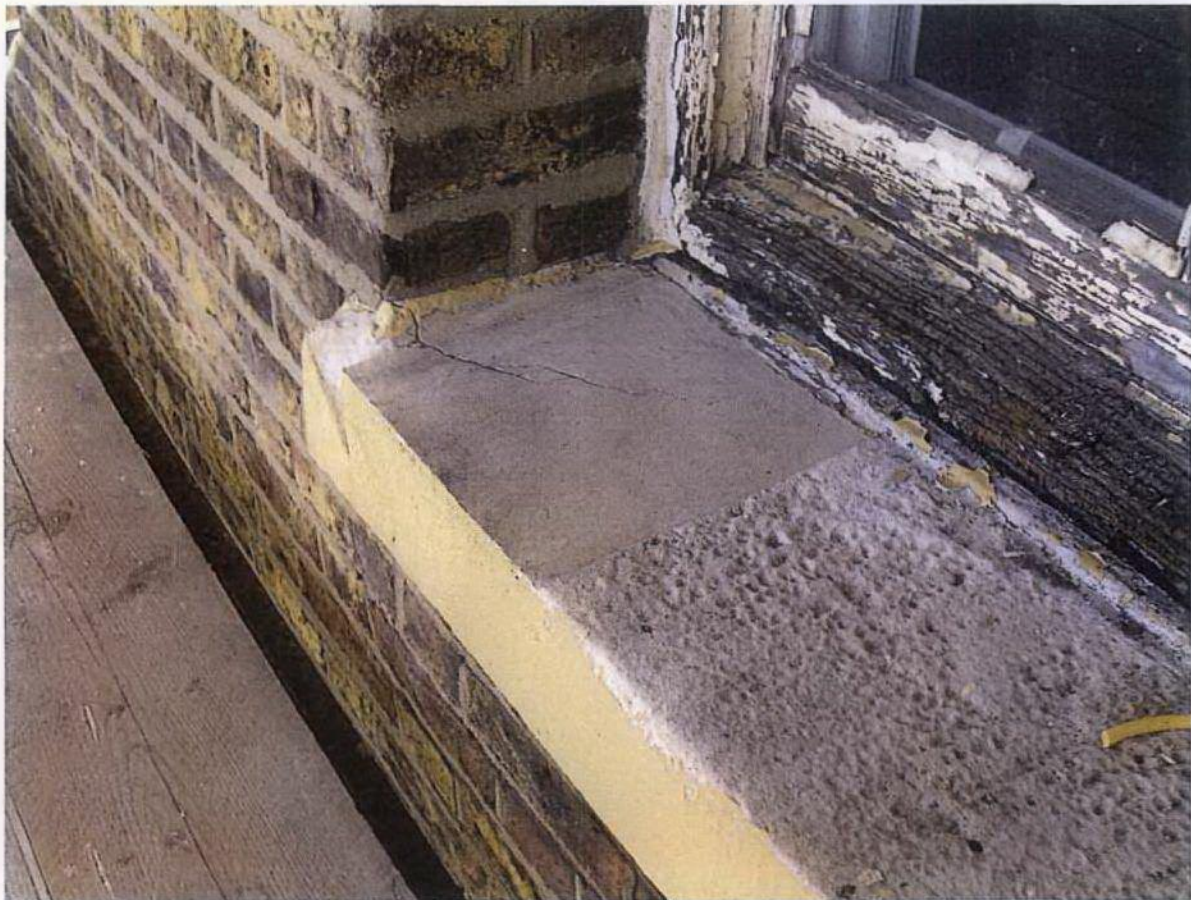
The stone sample was taken from the stone sill of the third floor window just north of gridline W24 (Link Building).

The petrographic report (Sandberg Consulting Engineers, no. 41378/G/3) states that the stone is an 'off-white to faint cream, fine to medium grained Oolitic Limestone'. The suggested match is Portland Albion Stone. The third floor of the Link Building was built later than the rest of the building which may explain why a different type of stone was used for the sills.

Photo 7: Sill of window 313/W1e showing from where stone sample was taken.

It was agreed on 22/03/10 by LB Camden that Portland Jordans Basebed is to be used for repairs.

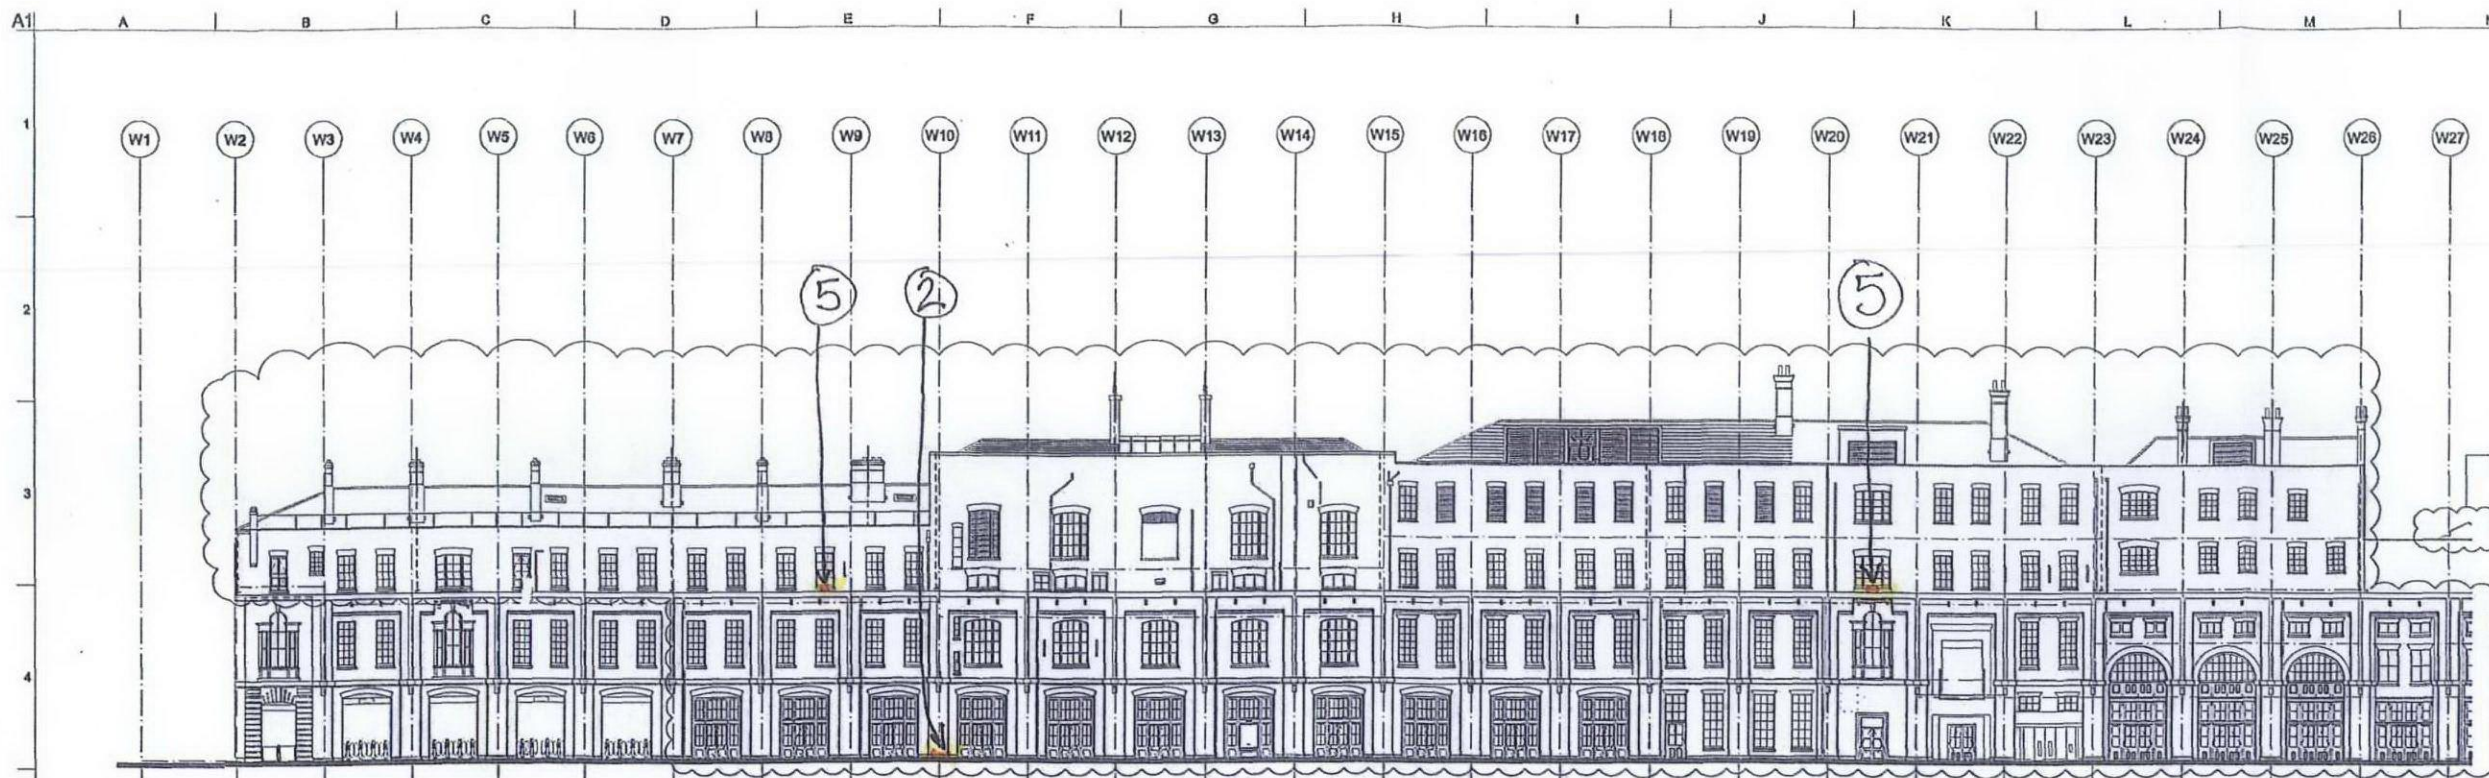
# STONE SAMPLE LOCATIONS: EAST ELEVATION

- ① Jefferson report dated June 2009
- ② Jefferson report dated Sept 2009
- ③ Sandberg report no 41260/G
- ④ Sandberg report no 41378/G
- ⑤ Sandberg report no 41378/G/11
- ⑥ Sandberg report no 41378/G/12
- ⑦ Sandberg report no 41378/G/13
