ARBORICULTURAL ASSESSMENT

41 Camden Mews
LONDON
NW1 9BY

Ref: 874

Date: 4 September 2008

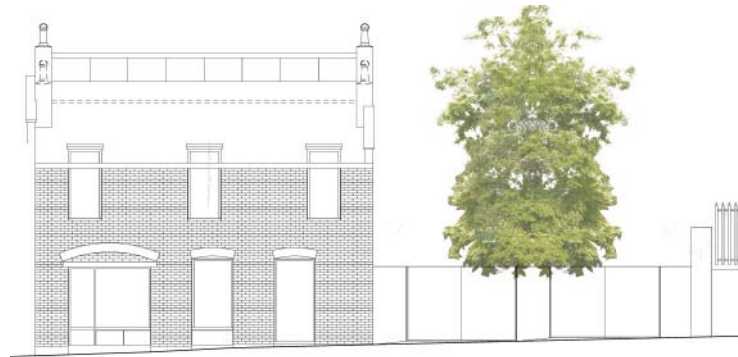
Existing Elevation showing location of Robinia

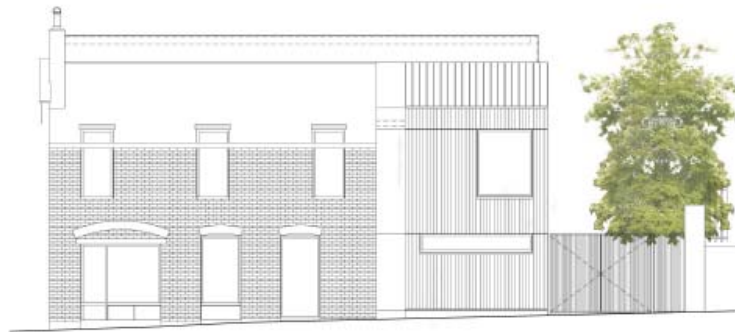
Proposed Elevation showing location of replacement planting
