### 2801 - Camden Lock Village Light Pollution Report

IS4-2801

Lit areas which are visible and not visible from sensitive receptors - Roofs

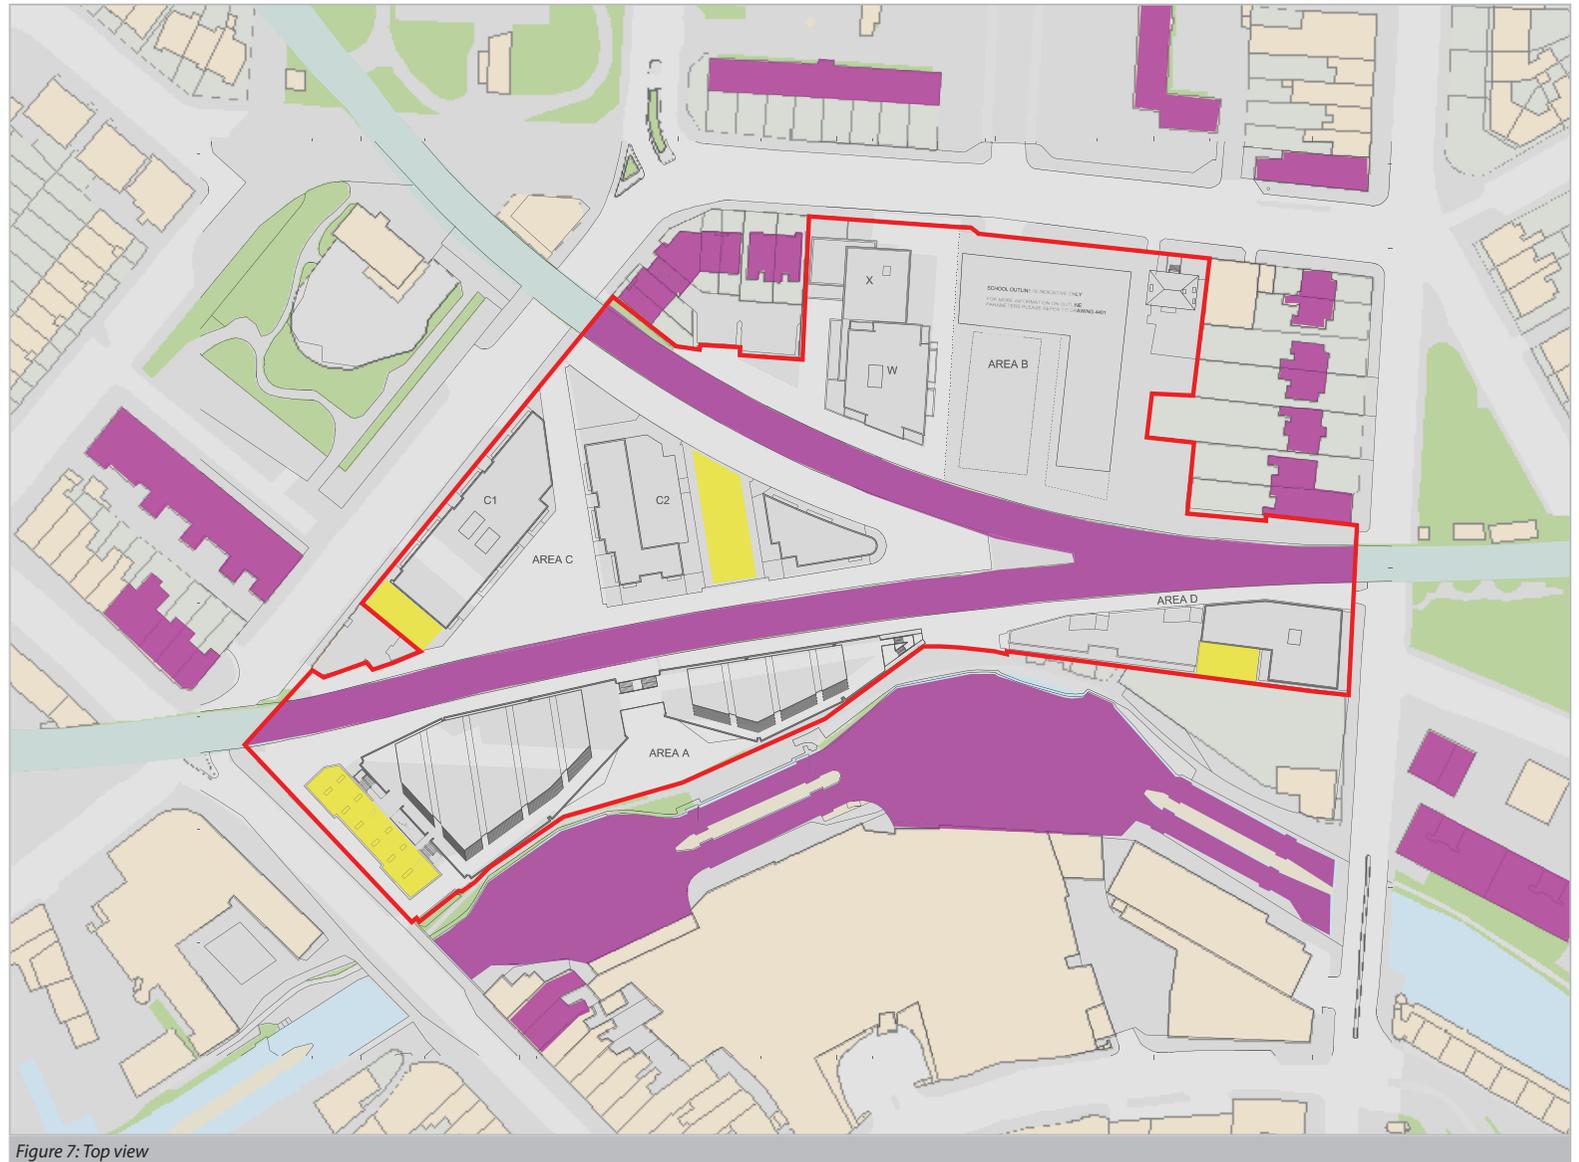
Figure 7: Top view

- Relevant sensitive receptors
- Lit areas visible (tested)
- Lit areas not visible (part of strategy)

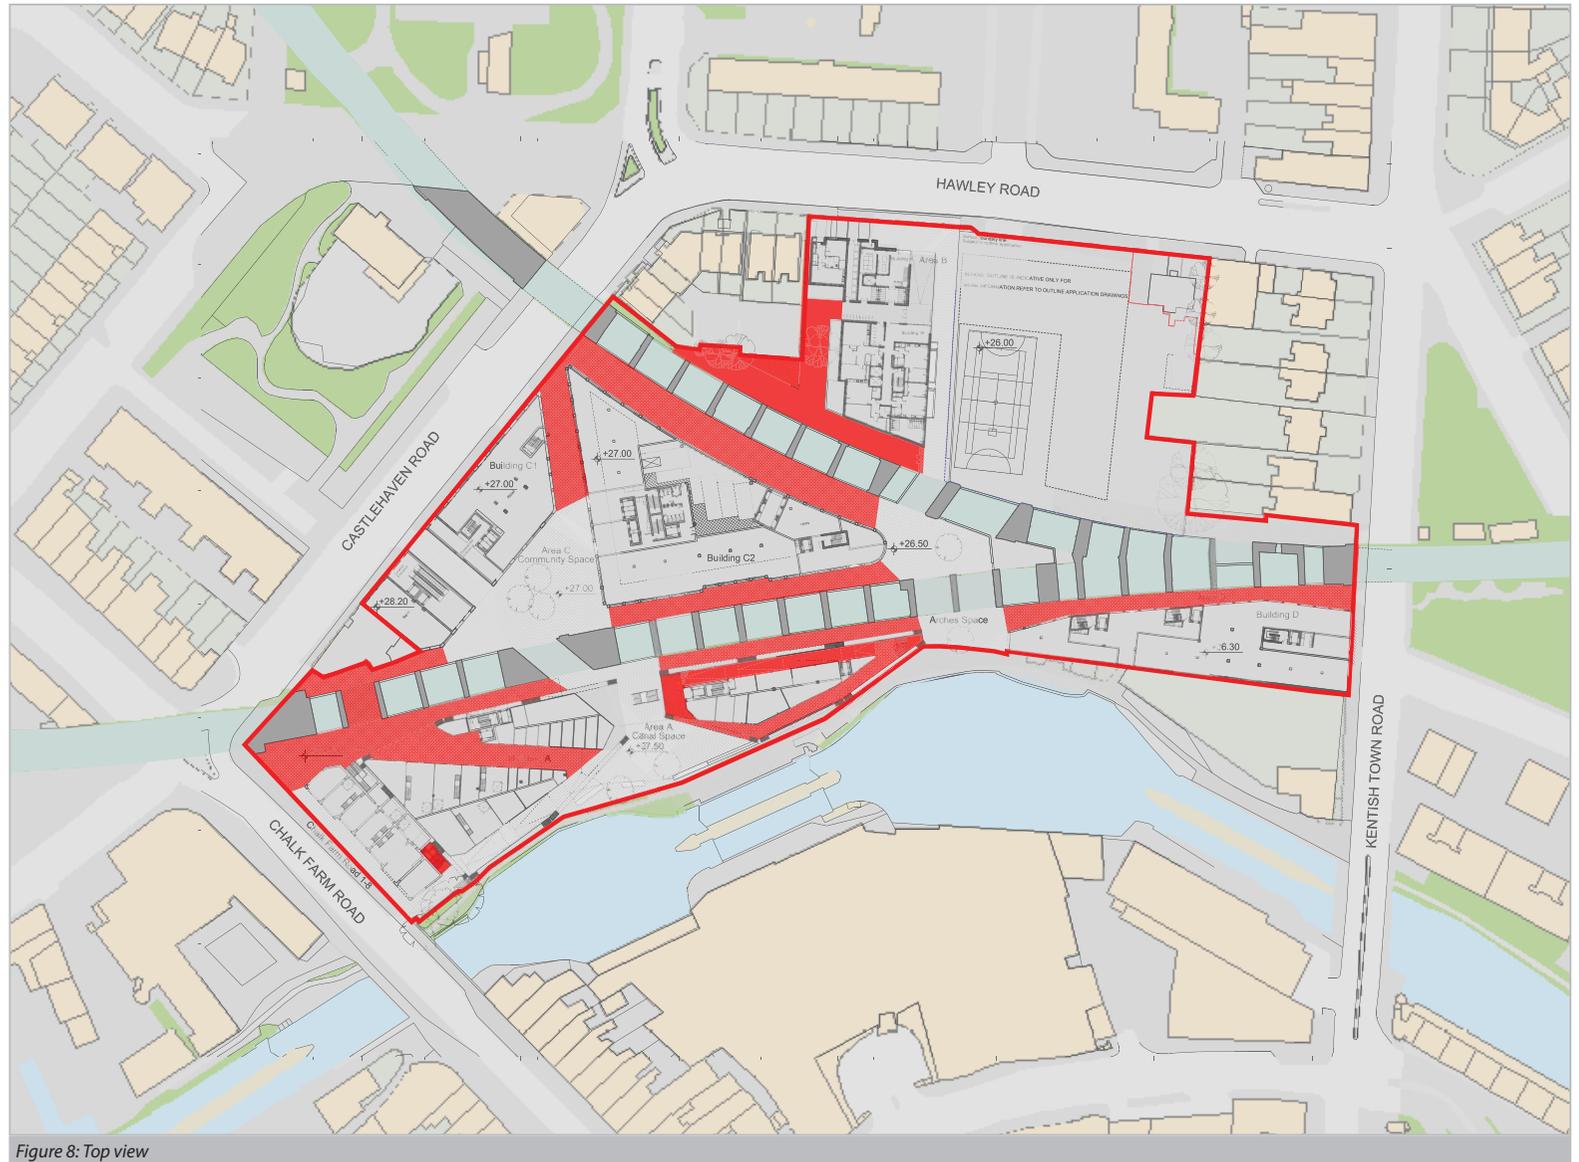
Figure 8: Top view

Night-time road closure

■ Road closed after 8.30pm

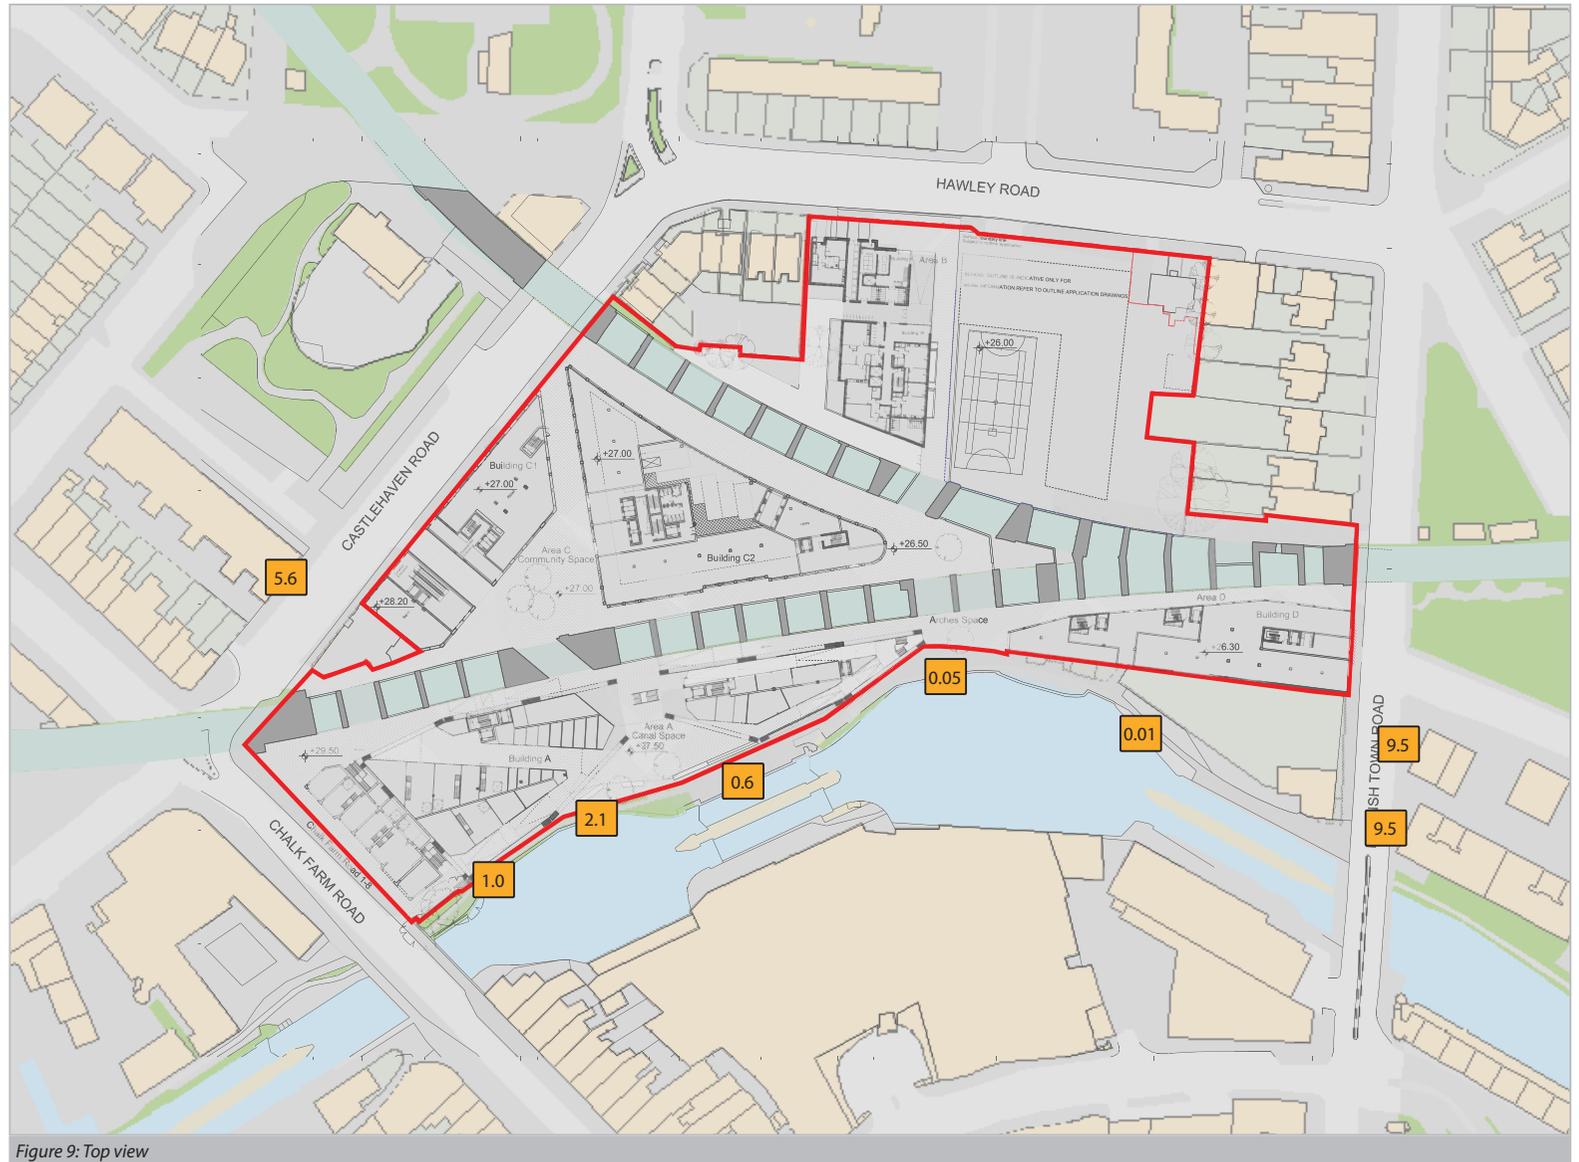
Figure 9: Top view

Night-time survey readings

■ Spot reading in Lux

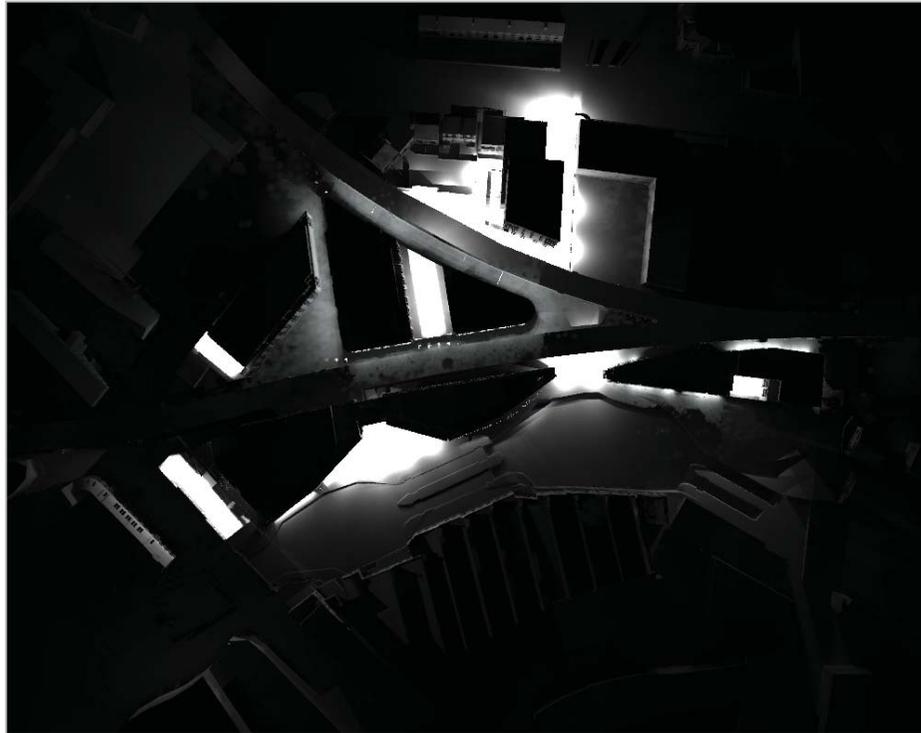
Figure 10: Night-time render

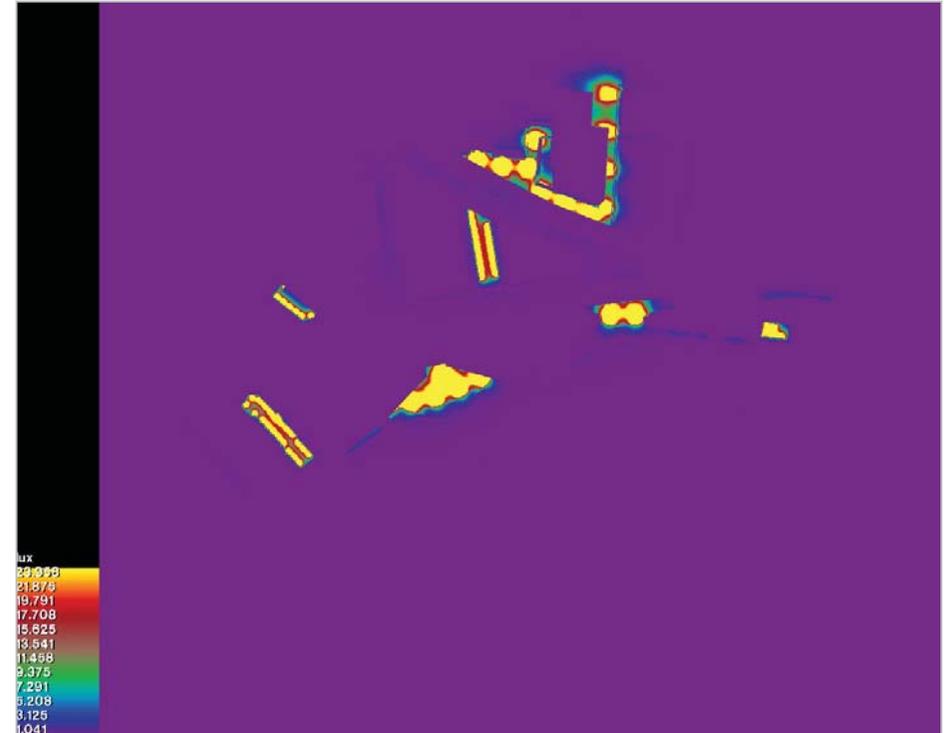
Figure 11: Falsecolour view
