Appendix 6: Method Statements

BAP1130
Kings Cross Central: SEFI – Granary Square
Restoration of Crane Base Coping Stones
Activity Plan Ref: BAP1130/MS/513 Rev P

BAP1060
Kings Cross Central: Eastern Goods Yard
Refurbishment and installation of Turntable B
Activity Plan Ref: BAP1130/MS/535 Rev P

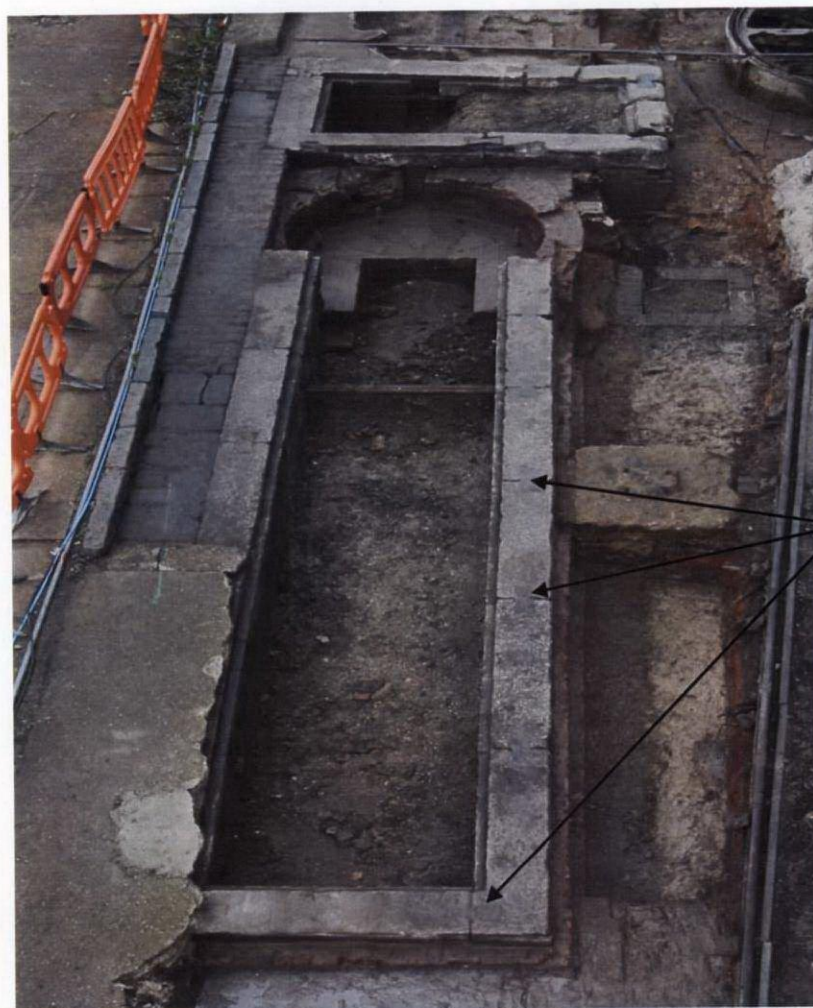
Figure 1. The above photo shows the crane base in its original location before removal

Butterfly
cramps

- Only damaged sections of coping stone which would form a significant trip hazard if left untreated will be repaired.
- Where stones are split, holes will be drilled into the damaged coping stones and stainless steel pins of suitable size will be inserted. The hole/pin size will be determined by the masons on site. A stainless steel pin will be inserted and resin fixed.
- Where the surface of the stone is significantly damaged stones complimentary sized and shaped stones will be formed by the on-site masons to return the affected stones to a reasonably square profile. These 'inserts' will be cut from site-won granite kerbs which match the crane base coping stones in both colouration and texture. The inserts will be mortared to the base stone; where the size of stone allows the insert will also be secured with a resin fixed stainless steel pin.

- The butterfly cramps will then be carefully removed from the coping stones. The cramps will be individually inspected once removed to determine if repairs are required. A full condition survey will be produced and repair regime established.
- As the butterfly cramps no-longer serve a structural function it is suggested that the cramps are either:
 - plated back together where sheared; or
 - where small cracks are visible repaired with a metal filler and smoothed

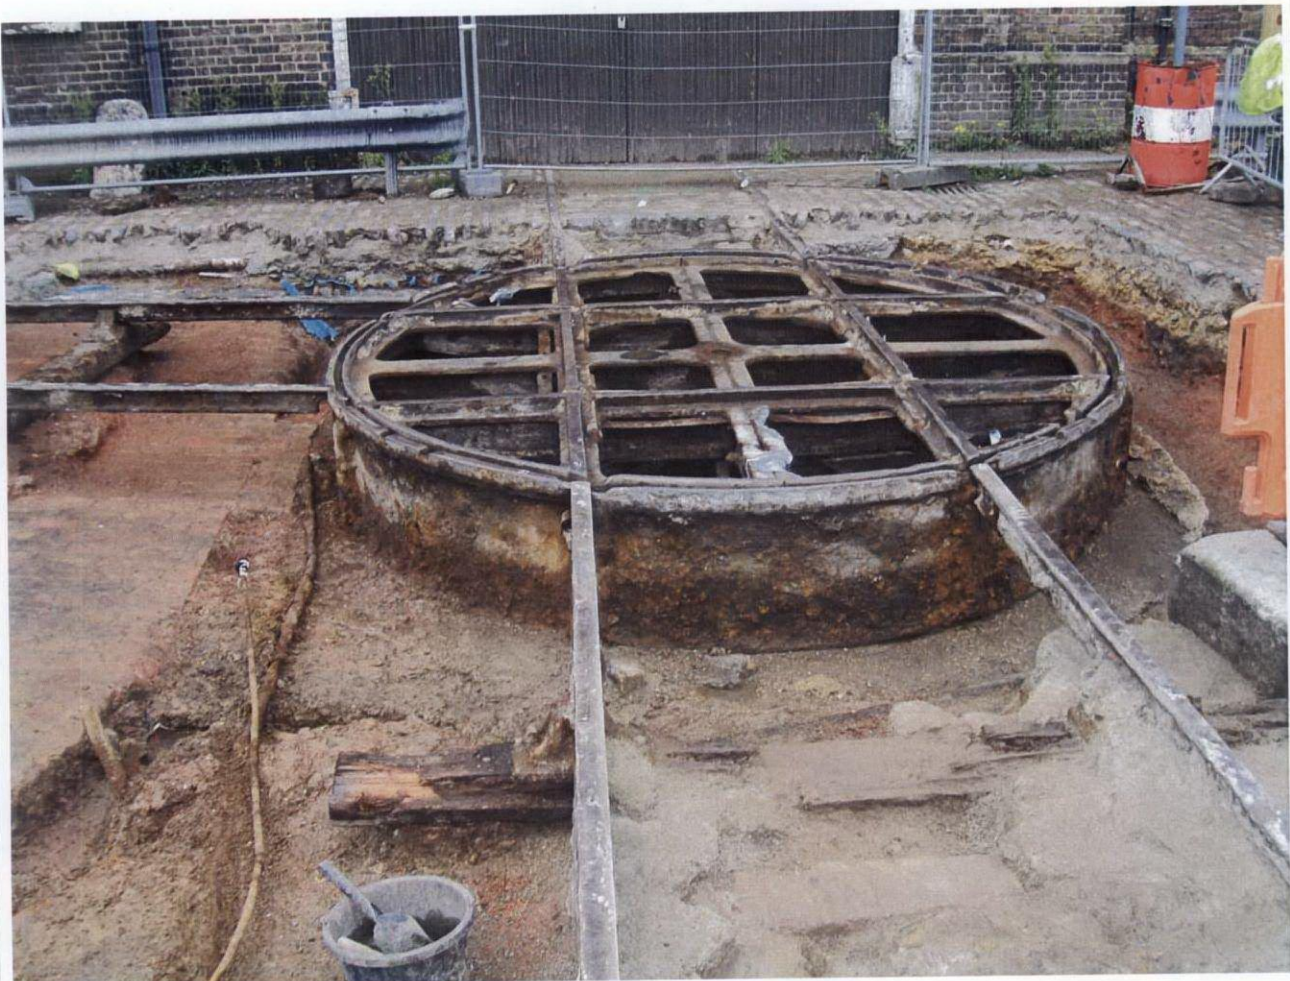
The above photo shows the turntable in its original location before removal.

- Modern low carbon steels (Grade S275) of the equivalent section will be used for replacements.
- Most of the wrought-iron elements are rivet fixed. Therefore where replacements are required existing fixing points within the retained structure can be used, with the inserted steel shaped, profiled and drilled to match these fixing holes.
- The replacement member will then be mechanically fixed utilising a tension control bolt which replicates the 'domed' rivet head.
- Where mechanical fixing is not viable (where the section is too small or is not the most advantageous for the repair) then a welded joint will be utilised. Shepley Engineering Ltd have extensive experience of this.

- Repairing the retained elements of the structure will mainly take the form of reuniting broken/failed elements of the structure. A number of repair scenarios may be utilised dependant on the outcome of the detailed condition survey:
